| <b>How to Identify Modified HV Batteries</b> | | <b>USA</b> |
| All HV Vehicles | | |

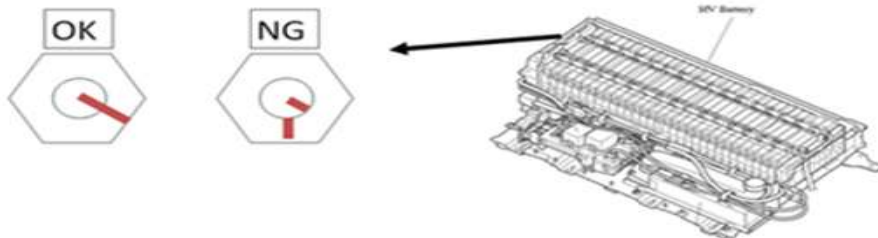
- For vehicles produced up to September 2008
  - Remove HV Battery cover and check for offset mar on the bus bar nut and bolt

A vehicle may arrive to the dealer with a MIL "ON" condition and P0A80 or P1AC000 stored in the memory. Some cases have been identified with internal modification done to the HV Battery. Modified or altered parts are not covered under warranty.

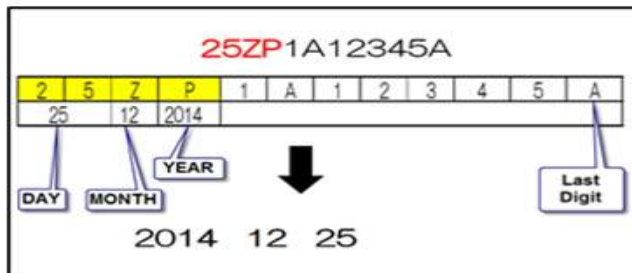
### CELL SERIAL# EXAMPLE

- For Vehicles produced after September 2008
  - Remove HV Battery Cover and inspect cells for physical signs of modifications
    - Signs of previous removal of cover and or bus bar
    - Check that the last digit of the serial #s of all cells are the same letter
    - Check all cell serial #s and make sure they are all within 3 months of production date from each other
