# DTC U0323/U0423/U3000 Cannot be Deleted

**Service Category** Audio/Visual/Telematics

**Section** Navigation/Multi Info Display

| YEAR(S) | MODEL(S) | ADDITIONAL INFORMATION |
|---|---|---|
| 2016 | iA | |

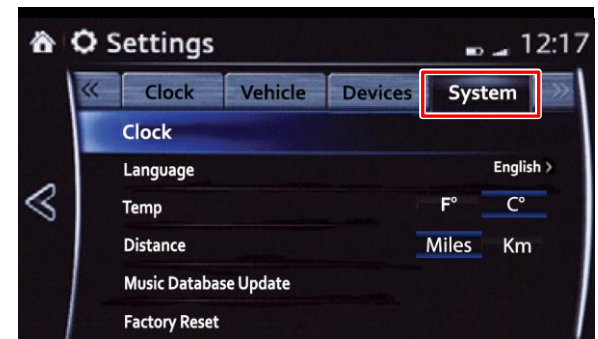
**Figure 4.**

8. In the “Settings” menu, press *System*.

The change to the “Settings” menu can be made using either the *Temp* or *Distance* submenu. If *Distance* is selected, go to substep B.

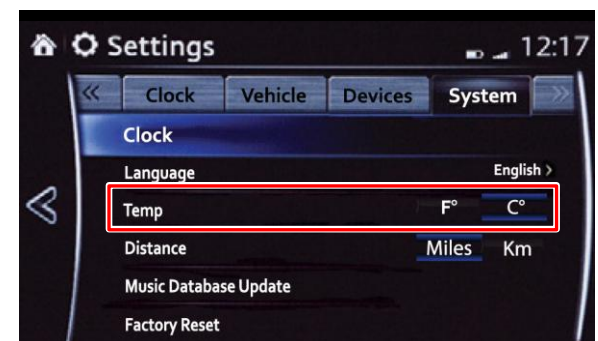
**Figure 5.**

- A. In the “System” submenu, press *Temp* and Select  $F^{\circ}$  or  $C^{\circ}$  to change the temperature units. Choose the alternate setting from the previously selected measurement unit.

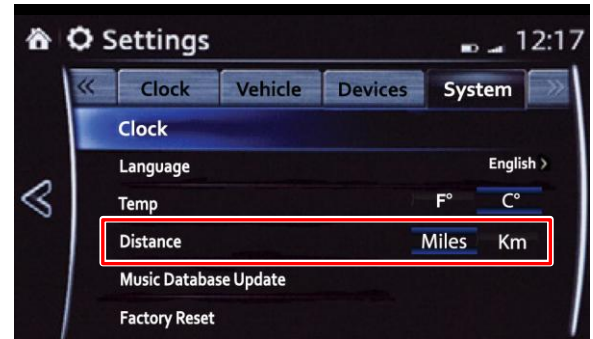
**Figure 6.**

- B. In the “System” submenu, press *Distance* and select *Miles* or *Km* to change the mileage units. Choose the alternate setting from the previously selected measurement unit.

9. Turn the ignition key to the OFF position.
10. Turn the ignition key to the ON position and delete the DTCs using Techstream.
11. Confirm that the DTCs have been cleared using Techstream.
12. Return the original temperature and/or mileage units using the multimedia menu system.
13. Confirm that the DTCs do NOT reset.
