| | GROUP<br><b>FUE</b> | MODEL<br><b>2012-2017MY<br/>Rio (UB)</b> |
| | NUMBER<br><b>040</b> | DATE<br><b>April 2018</b> |
| <b>TECHNICAL SERVICE BULLETIN</b> | | |
| <b>SUBJECT: CANISTER CLOSE VALVE (CCV) REPLACEMENT</b> | | |

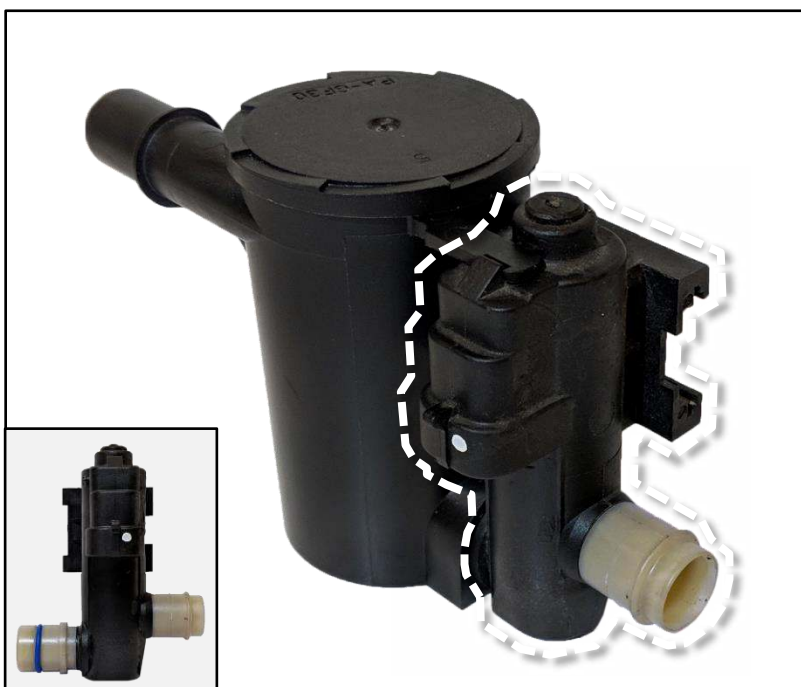
This bulletin provides the procedure to replace the Canister Close Valve (CCV) on some 2012-2017MY Rio (UB) vehicles, produced from June 21, 2011 through March 28, 2016, which may exhibit the engine warning lamp DTCs P0455 and P0456 for an evaporative emission system leak due to the Canister Close Valve (CCV) stuck open. Follow the procedure outlined in this bulletin to replace the CCV with an improved part. Before conducting the procedure, verify that the vehicle is within the affected production date range.

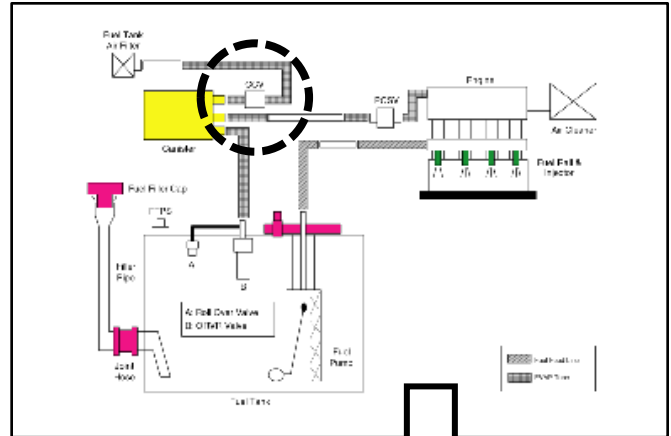
The Canister Close Valve (A) is a separate part from the Fuel Tank Air Filter assembly (B) where it is inserted.

1. Replace the Canister Close Valve (A) by referring to the “Engine Control / Fuel System → Engine Control System → Canister Close Valve (CCV) → Repair procedures” chapter in the applicable Shop Manual on KGIS.

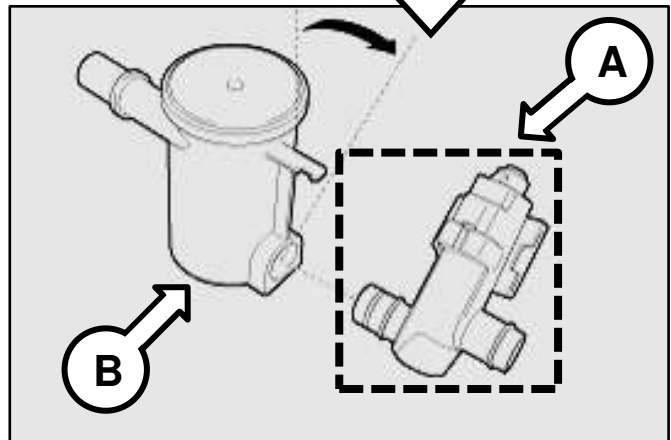
Improved CCV: Rubber seal material change and port color change (black to tan) as shown.

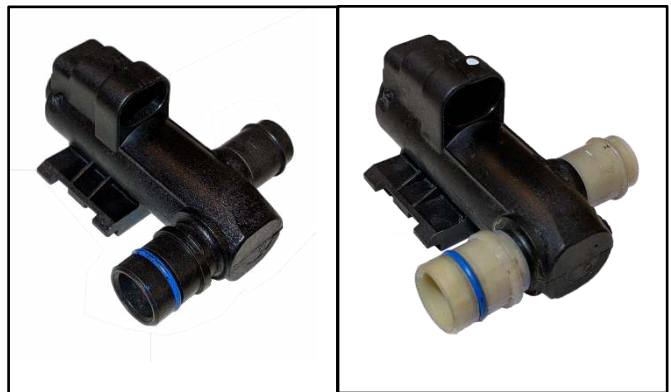
Old CCV

New CCV
