# Service Bulletin

Bulletin No.: 17-NA-383

**Subject:** Malfunction Indicator Lamp (MIL) Illuminated with DTC P0446 or P0455 Set

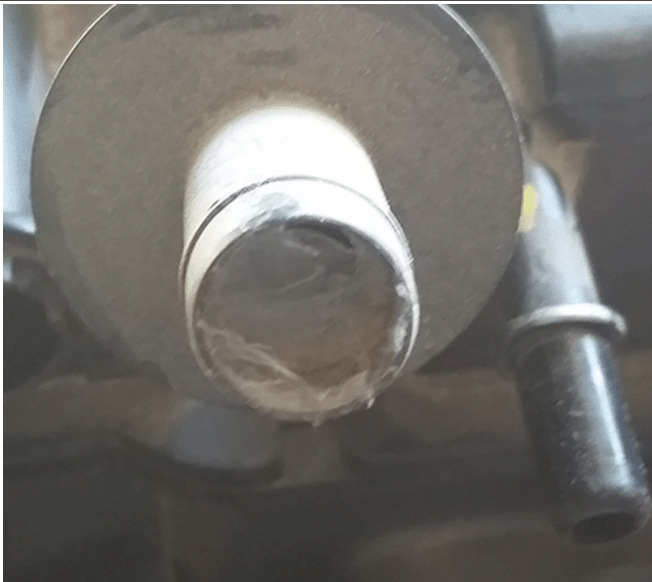
| <b>Cause</b> | <div></div> <p>4646654</p> <p>This may be due to a restriction in the fresh air inlet port of the evaporator canister.</p> |

| <b>Correction</b> | Inspect and replace the canister if a restriction is found. |

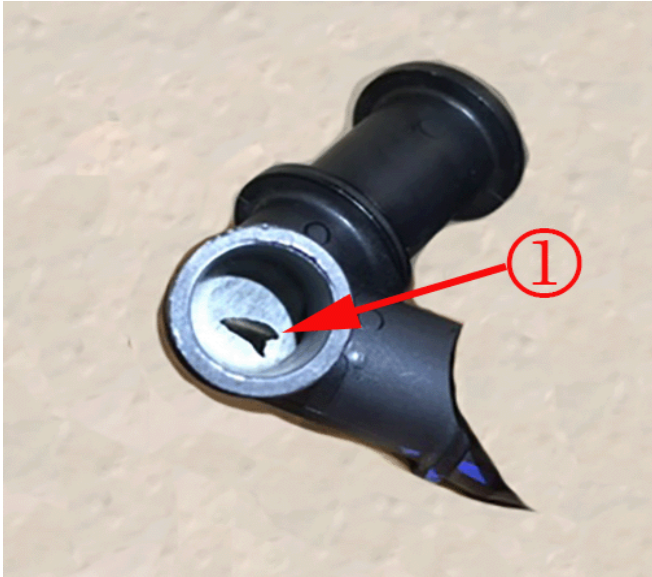
4646659

If you encounter a vehicle with the above concern, remove the evaporator canister vent cap and inspect the evaporator canister for spider nesting in the fresh air inlet port. Replace the evaporator canister. Refer to *Evaporative Emission Canister Replacement* in SI.
