## SERVICE BULLETIN

| EC16-003d | NTB16-027d | May 25, 2018 |

### 2013 – 2018 SENTRA; MIL ON WITH DTC P0101

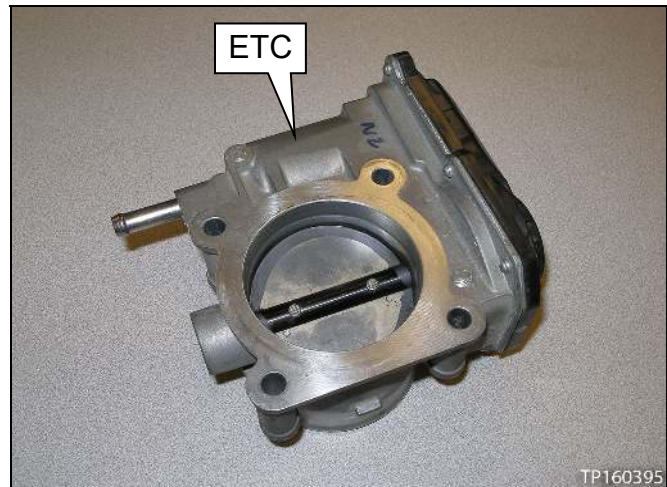
Figure 2a

1. Remove the electronic throttle control actuator (ETC).
  - Refer to the ESM, section **EM-Engine Mechanical**, for ETC removal.
2. On the engine-side of the ETC, clean off deposits on the chamber and throttle valve.

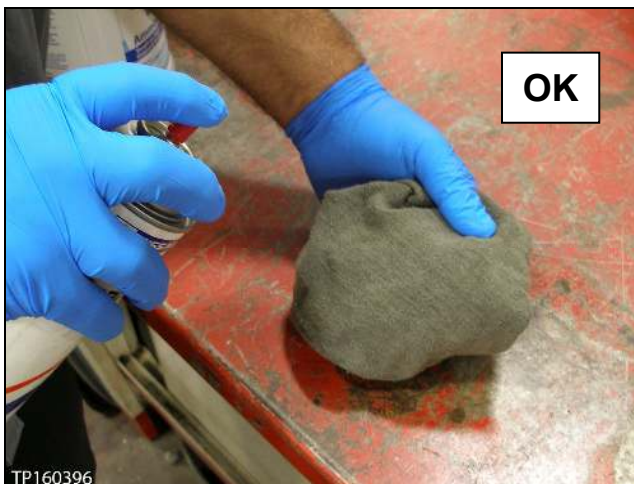
Figure 3a

3. Spray “carburetor” cleaner on a clean cloth towel.
  - Do not use a paper towel.
  - For warranty repairs, use only Nissan Genuine Low VOC Non-Chlorinated Carburetor Cleaner.
  - For non-warranty repairs, Nissan Genuine Low VOC Non-Chlorinated Carburetor Cleaner is recommended, but an equivalent “carburetor” cleaner may be used.

**CAUTION:** Do not spray directly on the ETC chamber. Damage may occur to the electronics of the ETC.

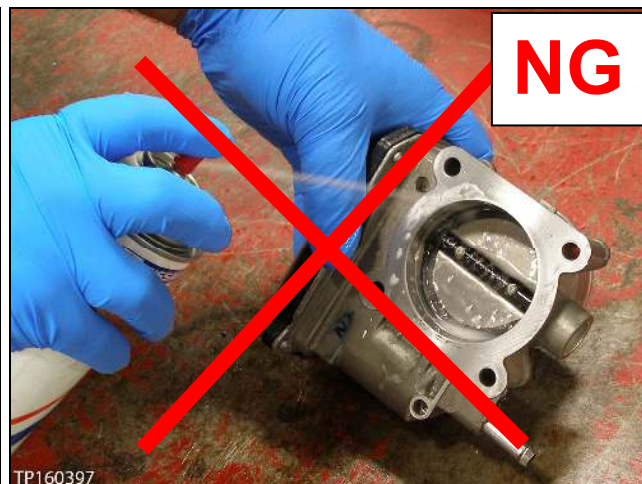
Figure 4a

4. Clean the throttle valve and chamber with the soaked cloth towel.
