| <b>HYUNDAI</b><br><b>Technical Service Bulletin</b> | GROUP<br><b>FUEL SYSTEM</b> | NUMBER<br><b>18-FL-003</b> |
| | DATE<br><b>JUNE, 2018</b> | MODEL<br><b>VELOSTER (FS)</b> |
| <b>SUBJECT:</b> AIR DRAIN CASE REPLACEMENT | | |

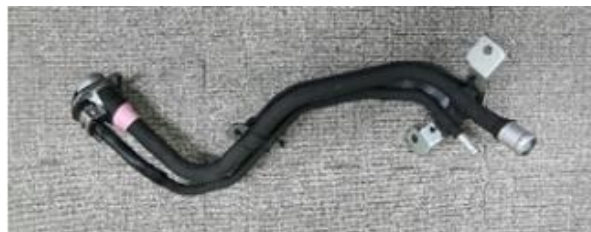
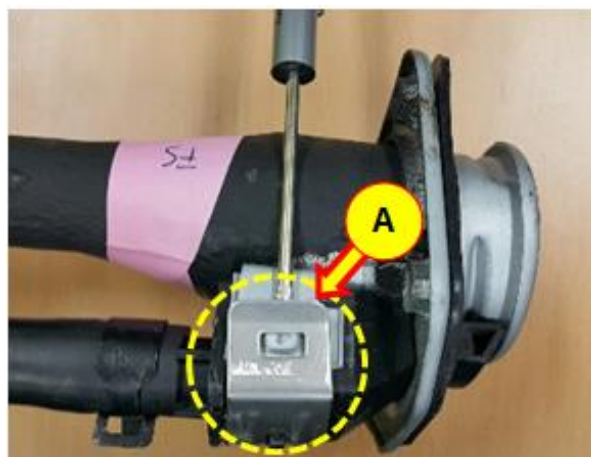
1. Connect the GDS to the vehicle and perform DTC scan to confirm if any of the pertinent DTC P0455/P0456/P0449/P0451 are stored in the Engine Control Module. Print the DTC screen from the GDS and retain with the repair order for documentation purposes and then erase all DTC(s).
2. Remove the fuel filler neck assembly referring to the applicable vehicle shop manual.  
\*Engine control/fuel system > Fuel delivery system > Filler-neck assembly”
3. Remove the retaining clip (A) from the air drain case using a flat head screwdriver.
4. Pull the hose (B) in the direction of the arrow to remove the air drain case from the filler neck.
5. Release the clamp using pliers and remove the air drain case (C).
6. Install the air drain case with a new part as listed in the parts information.
7. Reinstall all removed parts in reverse order of removal.

8. Connect the GDS and perform the **Evap Leakage Test** to ensure a result of **No Leak Detected**. This will confirm proper installation and that the original DTC P0455 condition has been resolved.
