| <b>HYUNDAI</b> NEW THINKING.<br>NEW POSSIBILITIES.<br><b>Technical Service Bulletin</b> | GROUP<br><b>CAMPAIGN</b> | NUMBER<br><b>17-01-003-1</b> |
| | DATE<br><b>JANUARY 2017</b> | MODEL<br><b>VELOSTER (FS)<br/>SONATA HYBRID<br/>(YF HEV)</b> |
| <b>SUBJECT:</b> | CANISTER INSPECTION AND REPAIR - (SERVICE CAMPAIGN 948) | |

***This TSB revises 17-01-003 to update the part order quantity information***

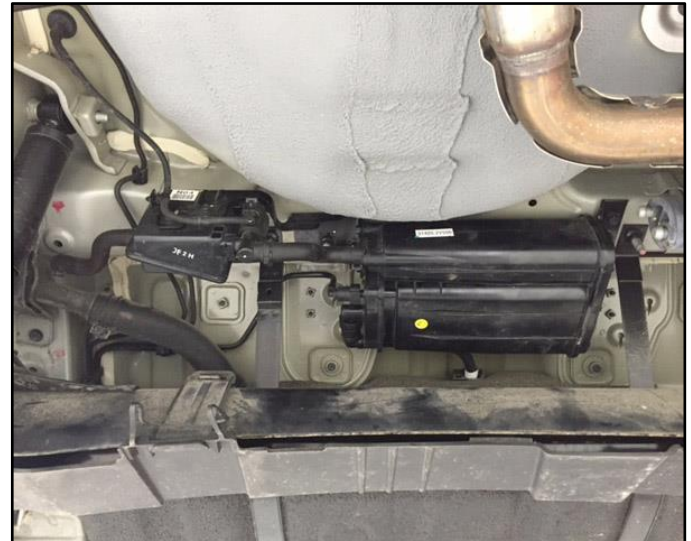
4. Reinstall all removed parts in reverse order of removal.

(Vehicle body side bolts):

**21.6 ~ 32.4 Nm**

**(2.2 ~ 3.3 kgf.m, 15.9 ~ 23.9 lb-ft)**

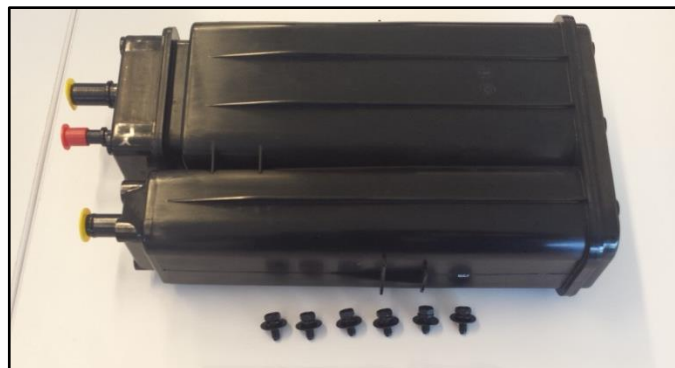
1. Replace the canister with correct Canister Kit and Bolts as shown in the Parts Information section. Install in reverse order of removal.

- Reuse the existing brackets from the vehicle.
- Be sure to transfer the protective metal shield from the old canister to the new canister.

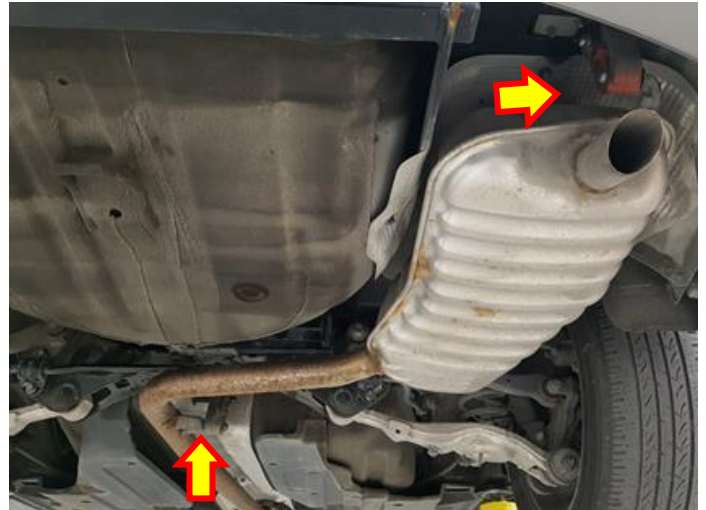
- i. Lift the vehicle on a hoist.
- ii. Disconnect the rear muffler from the 2 hangers as shown. Using a transmission jack, support the rear muffler and slowly lower to gain access to the canister assembly.

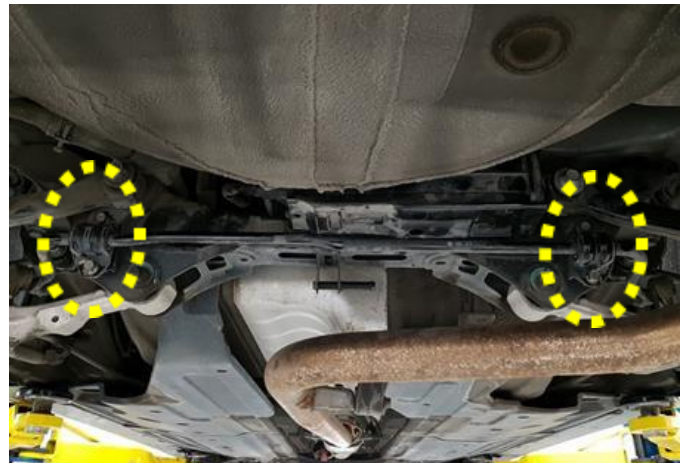
- iii. Remove the 4 bolts from the rear stabilizer bar (sway bar) from the rear cross member.

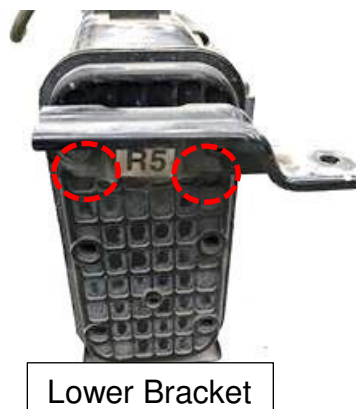
5. With canister and its lower bracket removed from the car, remove the 2 mounting bolts from the canister lower bracket.

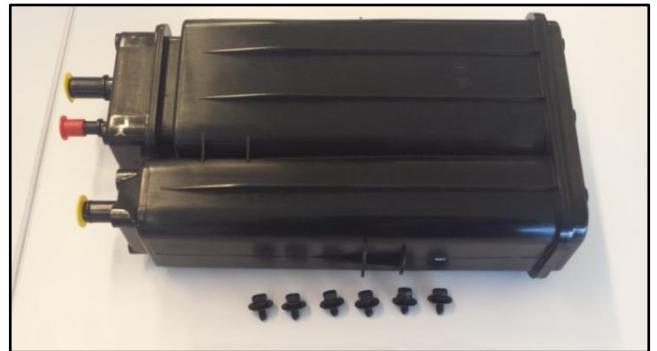
Replace the canister with correct Canister Kit Bolts and Nut as shown in the Parts Information section. Reuse the existing brackets from the vehicle.
