# Technical Service Bulletin

## 20 MIL on (DTC P045600 - EVAP system leak detected NVLD (very small leak))

20 15 48 2035073/10 October 15, 2015. Supersedes Technical Service Bulletin Group 20 number 15-46 dated May 15, 2015 for reasons listed below.

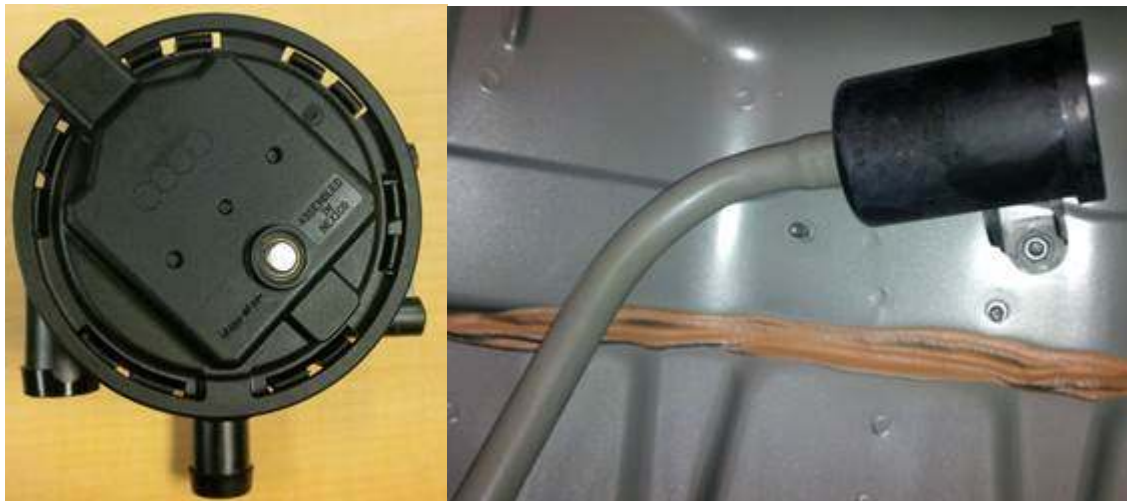
**Figure 1.** NVLD pressure sensor (left) and NVLD filter (right).

1. Ensure that **DTC P045600** (EVAP System Leak Detected NVLD (very small leak)) is stored in the engine control module (ECM), J623 (address word 01). If DTC P045600 is not present, this bulletin does not apply.
2. Replace the NVLD pressure sensor G400 and the NVLD filter with the latest part number available (Figure 1).

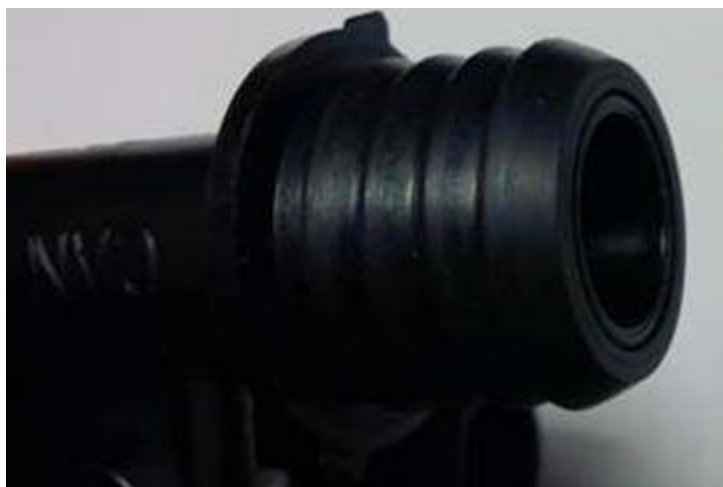
**Figure 2.** Align grommet and sensor outer edges.

- Align grommet and sensor outer edges (Figure 2).

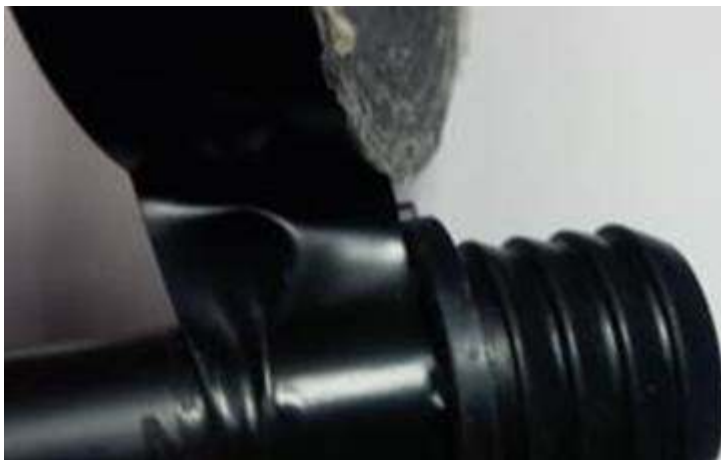
*Figure 3. Wrapping vinyl tape behind the grommet.*

- To aid installation, wrap several (~10) layers of vinyl tape behind the grommet to ensure that it does not slip during installation (Figure 3 and Figure 4).

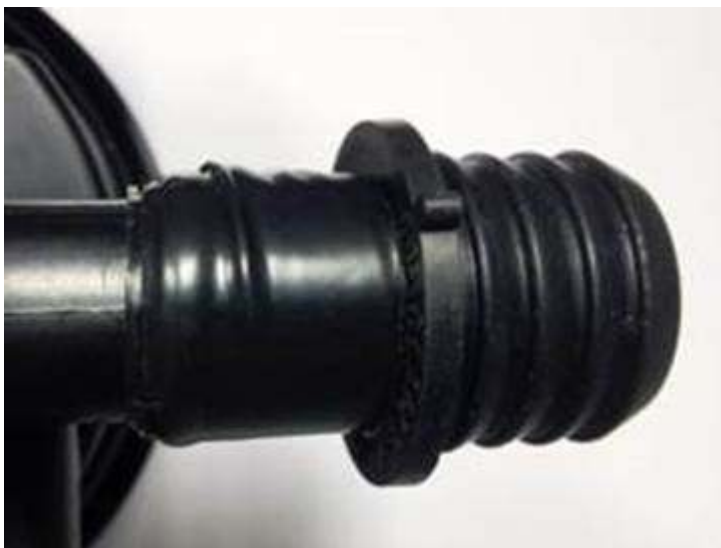
*Figure 4. Vinyl layer supporting grommet.*

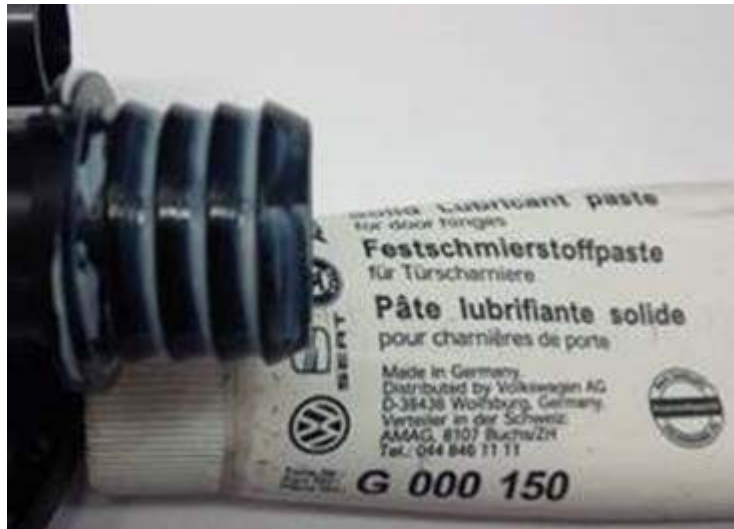
**Figure 5.** Grease film on outer surface of grommet.

- Apply a small amount of grease to create a film on the outer surface of the grommet before installing the sensor (Figure 5).

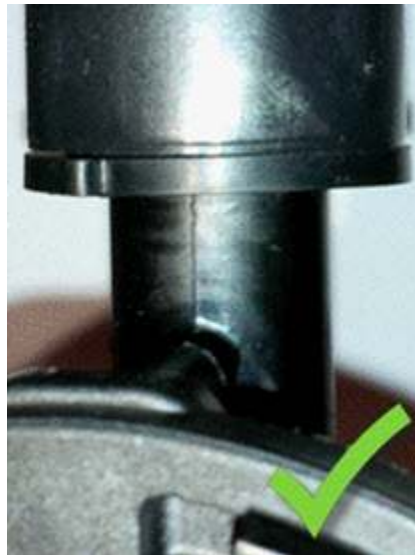
**Figure 6.** Correctly-installed sensor and grommet.

- When the sensor and grommet have been correctly installed, the grommet and canister will be flush (Figure 6). At this point, the vinyl tape can be removed (or it can be left in place).

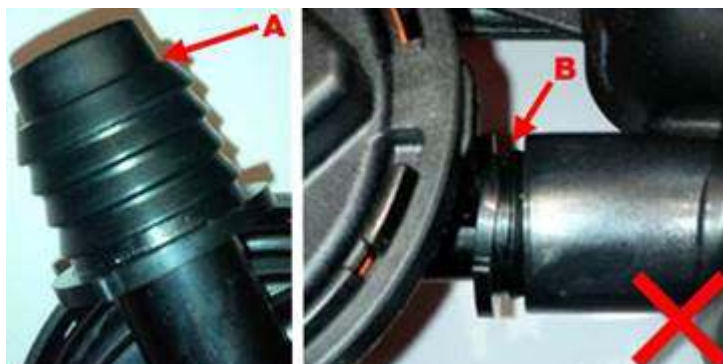
- An incorrectly-installed sensor and grommet (Figure 7) can cause an EVAP leak and repeat failures. Issues can occur when the NVLD switch is pressed too far into the canister, then pulled back out in an attempt to align the NVLD switch with the mounting holes. Do not apply any lubricant between the sensor and the grommet.

**Figure 7.** Plastic port extending past the grommet (A) causing installation issues (B).
