# Technical Service Bulletin

## 20 MIL on (DTC P045600 - EVAP system leak detected NVLD (very small leak))

20 15 52 2035073/11 October 28, 2015. Supersedes Technical Service Bulletin Group 20 number 15-48 dated October 15, 2015 for reasons listed below.

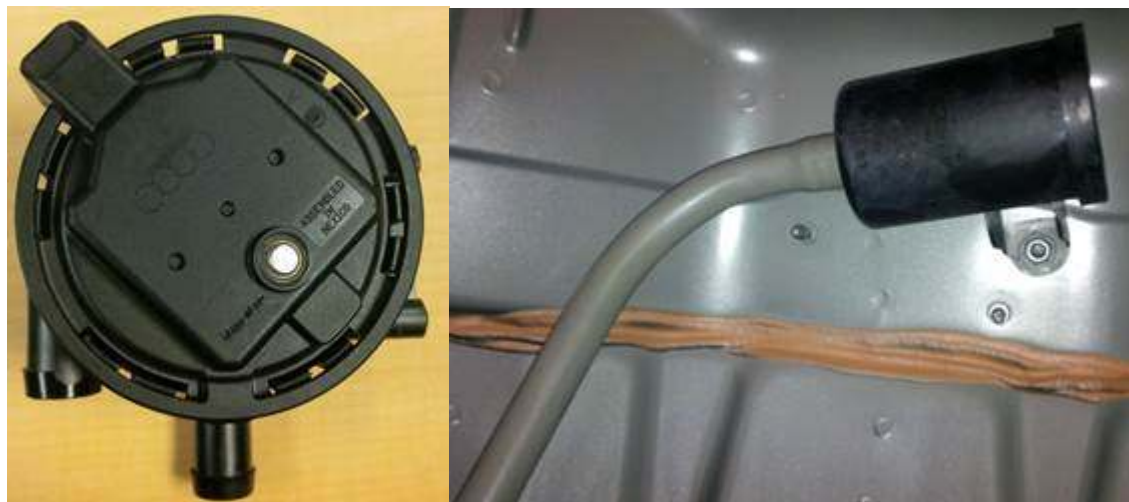
**Figure 1.** NVLD pressure sensor (left) and NVLD filter (right).

1. Ensure that **DTC P045600** (EVAP System Leak Detected NVLD (very small leak)) is stored in the engine control module (ECM), J623 (address word 01). If DTC P045600 is not present, this bulletin does not apply.
2. Replace the NVLD pressure sensor G400 and the NVLD filter with the latest part number available (Figure 1).

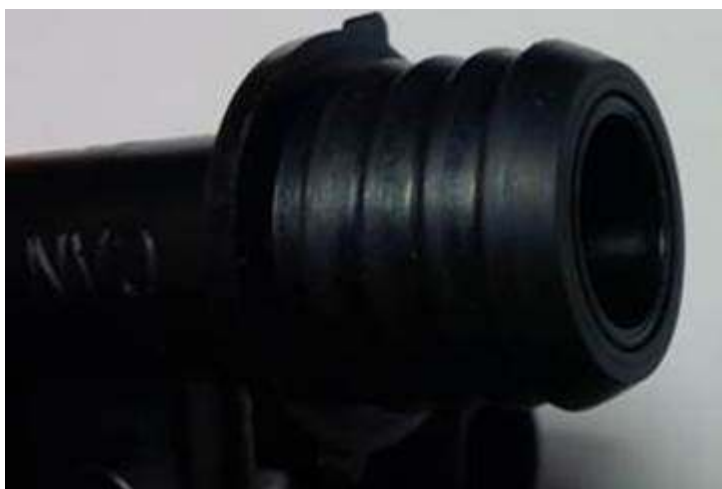
**Figure 2.** Align grommet and sensor outer edges.

- Align grommet and sensor outer edges (Figure 2).

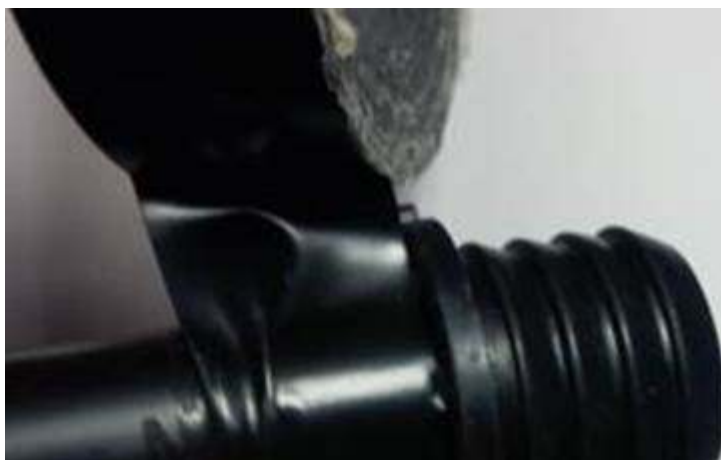
**Figure 3.** Wrapping vinyl tape behind the grommet.

- To aid installation, wrap several (~10) layers of vinyl tape behind the grommet to ensure that it does not slip during installation (Figure 3 and Figure 4).

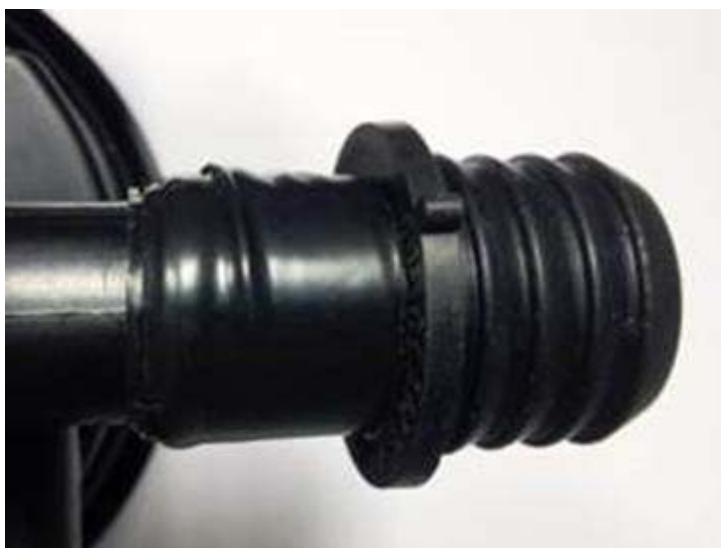
**Figure 4.** Vinyl layer supporting grommet.

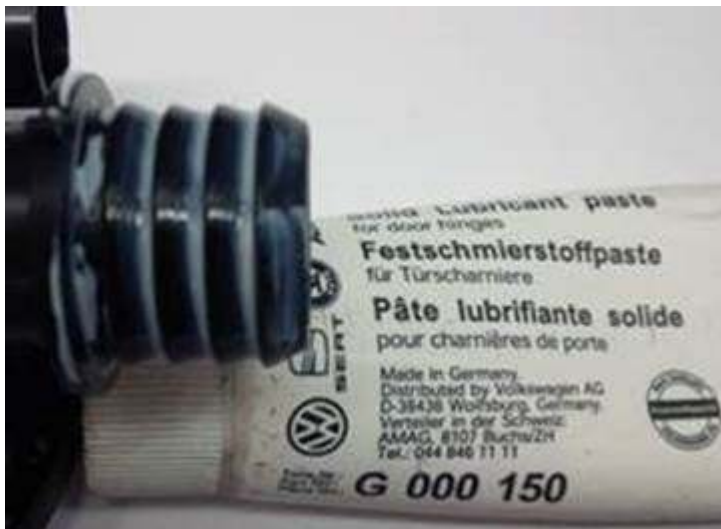
**Figure 5.** Grease film on outer surface of grommet.

- Apply a small amount of grease to create a film on the outer surface of the grommet before installing the sensor (Figure 5).

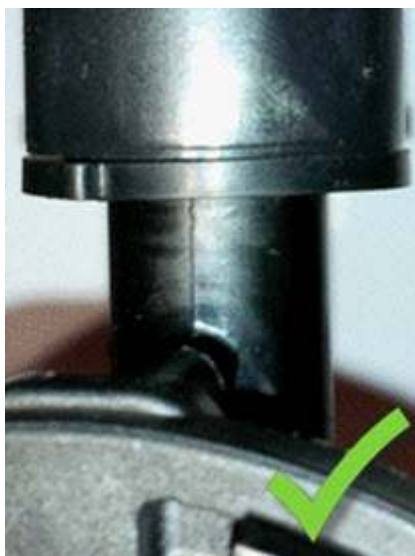
**Figure 6.** Correctly-installed sensor and grommet.

- When the sensor and grommet have been correctly installed, the grommet and canister will be flush (Figure 6). At this point, the vinyl tape can be removed (or it can be left in place).

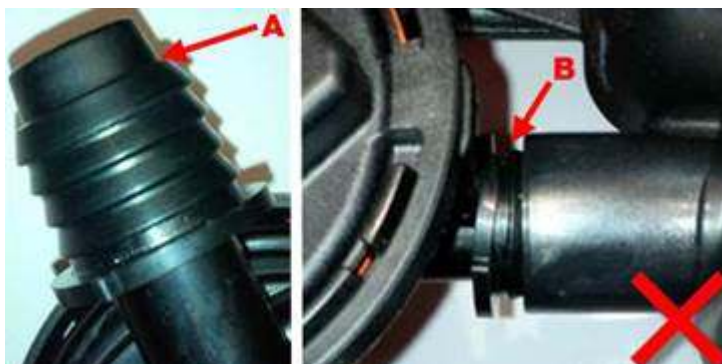
- An incorrectly-installed sensor and grommet (Figure 7) can cause an EVAP leak and repeat failures. Issues can occur when the NVLD switch is pressed too far into the canister, then pulled back out in an attempt to align the NVLD switch with the mounting holes.  
Do not apply any lubricant between the sensor and the grommet.

**Figure 7.** Plastic port extending past the grommet (A) causing installation issues (B).
