# Technical Service Bulletin

## 20 MIL on (DTC P045600 - EVAP system leak detected NVLD (very small leak))

20 15 54 2035073/12 October 29, 2015. Supersedes Technical Service Bulletin Group 20 number 15-52 dated October 28, 2015 for reasons listed below.

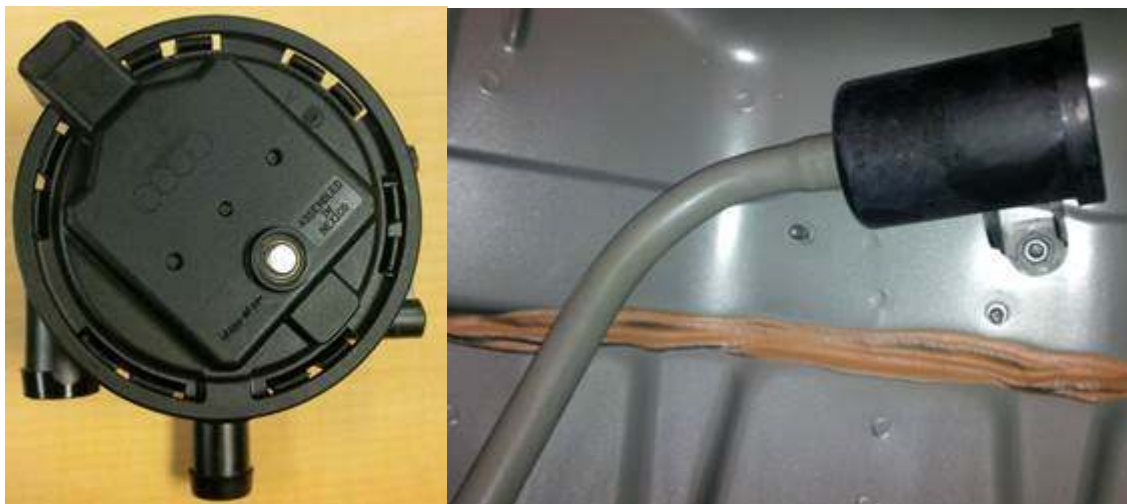
The NVLD pressure switch may erroneously detect a very small leak.

**Figure 1.** NVLD pressure sensor (left) and NVLD filter (right).

1. Ensure that **DTC P045600** (EVAP System Leak Detected NVLD (very small leak)) is stored in the engine control module (ECM), J623 (address word 01). If DTC P045600 is not present, this bulletin does not apply.
2. Replace the NVLD pressure sensor G400 and the NVLD filter with the latest part number available (Figure 1).

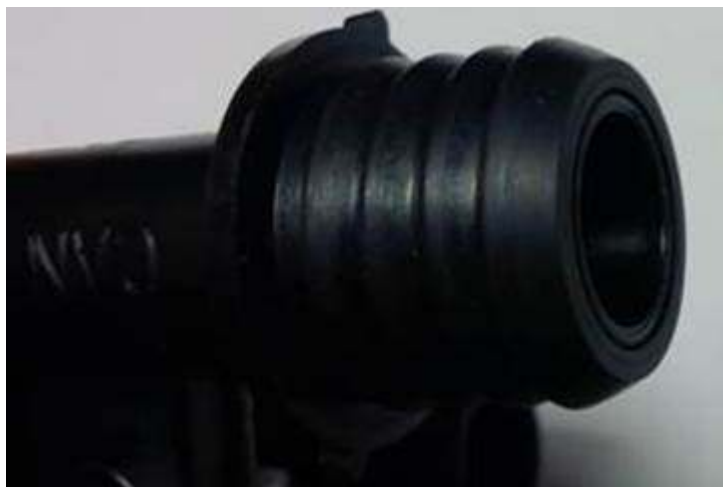
**Figure 2.** Align grommet and sensor outer edges.

Read the following information for correct installation of the NVLD switch grommet. The following information applies only if the sensor is directly installed into the charcoal canister.

- Align grommet and sensor outer edges (Figure 2).

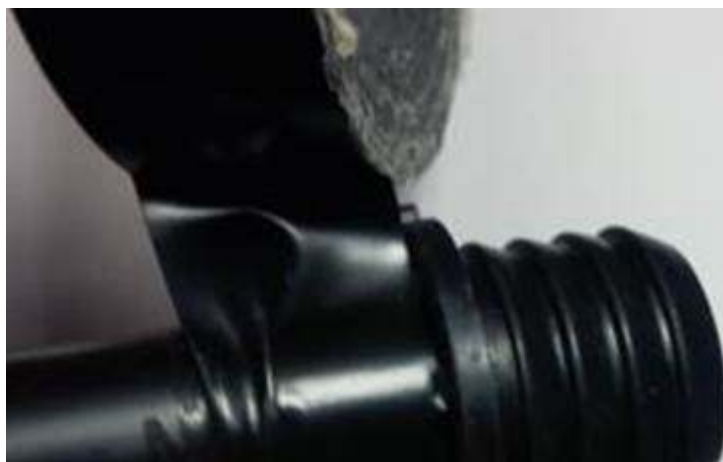
*Figure 3. Wrapping vinyl tape behind the grommet.*

- To aid installation, wrap several (~10) layers of vinyl tape behind the grommet to ensure that it does not slip during installation (Figure 3 and Figure 4).

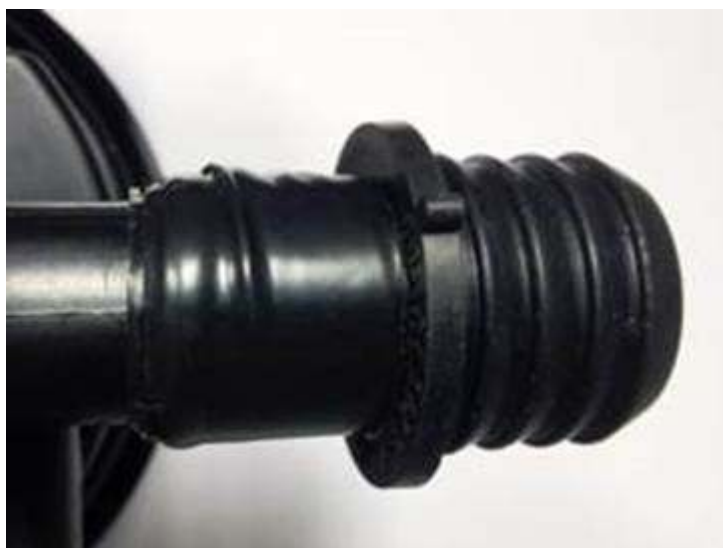
*Figure 4. Vinyl layer supporting grommet.*

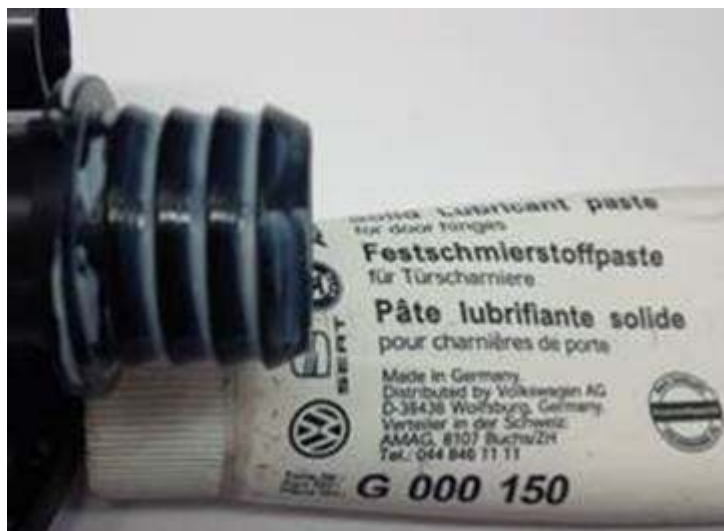
*Figure 5. Grease film on outer surface of grommet.*

- Apply a small amount of grease to create a film on the outer surface of the grommet before installing the sensor (Figure 5).

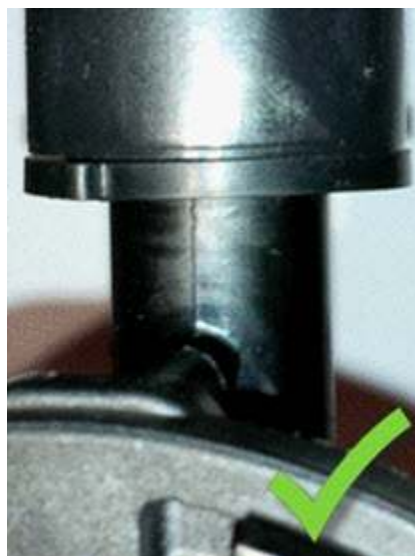
*Figure 6. Correctly-installed sensor and grommet.*

- When the sensor and grommet have been correctly installed, the grommet and canister will be flush (Figure 6). At this point, the vinyl tape can be removed (or it can be left in place).

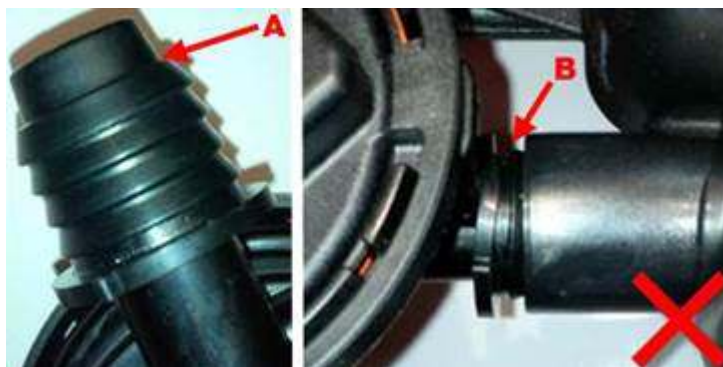
- An incorrectly-installed sensor and grommet (Figure 7) can cause an EVAP leak and repeat failures. Issues can occur when the NVLD switch is pressed too far into the canister, then pulled back out in an attempt to align the NVLD switch with the mounting holes. Do not apply any lubricant between the sensor and the grommet.

**Figure 7.** Plastic port extending past the grommet (A) causing installation issues (B).
