# Preliminary Information

PIP5468 Check Engine Light On with DTCs P0101, P0299, P11CC, P11DC, P2002 and / or P20EE set.

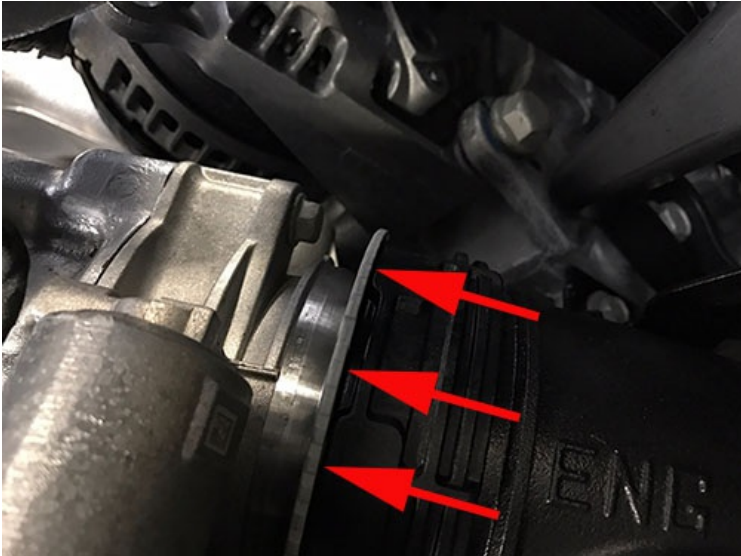
| Brand: | Model: | Model Years: | VIN: | | Engine: | Transmissions: |
|---|---|---|---|---|---|---|
| Cause | These DTCs may be the result of loose connections of the charged air cooler ductwork. | | | | | |

Picture of a non-secured connection between the charged air cooler pipe and the throttle body.

If any combination of DTCs P0101, P0299, P11CC, P11DC, P2002 or P20EE are set; check for loose charged air cooler ductwork at the turbocharger outlet pipe, the charged air cooler inlet pipe, the charged air cooler outlet pipe and the connection at the throttle body. Please note that a static visual inspection may not reveal that the connection is not adequate and that it is most likely to occur during engine roll or brake torque.
