| | <b>GROUP</b><br><b>FUE</b> | <b>MODEL</b><br><b>2014-2018MY</b><br><b>Soul (PS)</b><br><b>2012-2017MY</b><br><b>Rio (UB)</b><br><b>2014-2017MY</b><br><b>Forte (YD, YDm)</b> |
| | <b>NUMBER</b><br><b>038</b> | <b>DATE</b><br><b>April 2018</b> |
| <b>TECHNICAL SERVICE BULLETIN</b> | | |
| <b>SUBJECT:</b> <b>CANISTER CLOSE VALVE INSPECTION AND</b><br><b>AIR DRAIN CASE REPLACEMENT</b> | | |

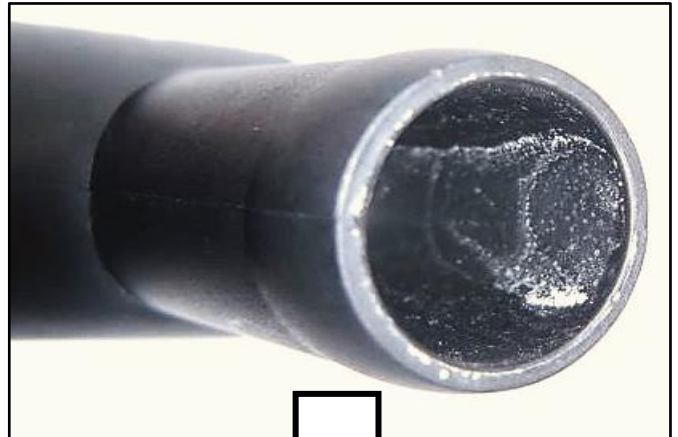
1. Remove the Canister Close Valve (CCV) by referring to the “Engine Control / Fuel System → Engine Control System → Canister Close Valve (CCV) → Repair procedures” chapter in the applicable shop manual.
2. Check both of the Canister Close Valve (CCV) port ends for signs of water contamination.

- 3a. If there is **no** sign of water contamination, re-assemble the CCV in the reverse order of removal. Follow the DTC troubleshooting information found on KGIS and submit any additional repair as a normal warranty claim.
