**SSPD8 - Check Engine Light ON with DTC P0126:00**

**WARRANTY EXTENSION**

**REPAIR PROCEDURE & PARTS AND WARRANTY INFORMATION**  
**WARRANTY EXTENSION SSPD8**

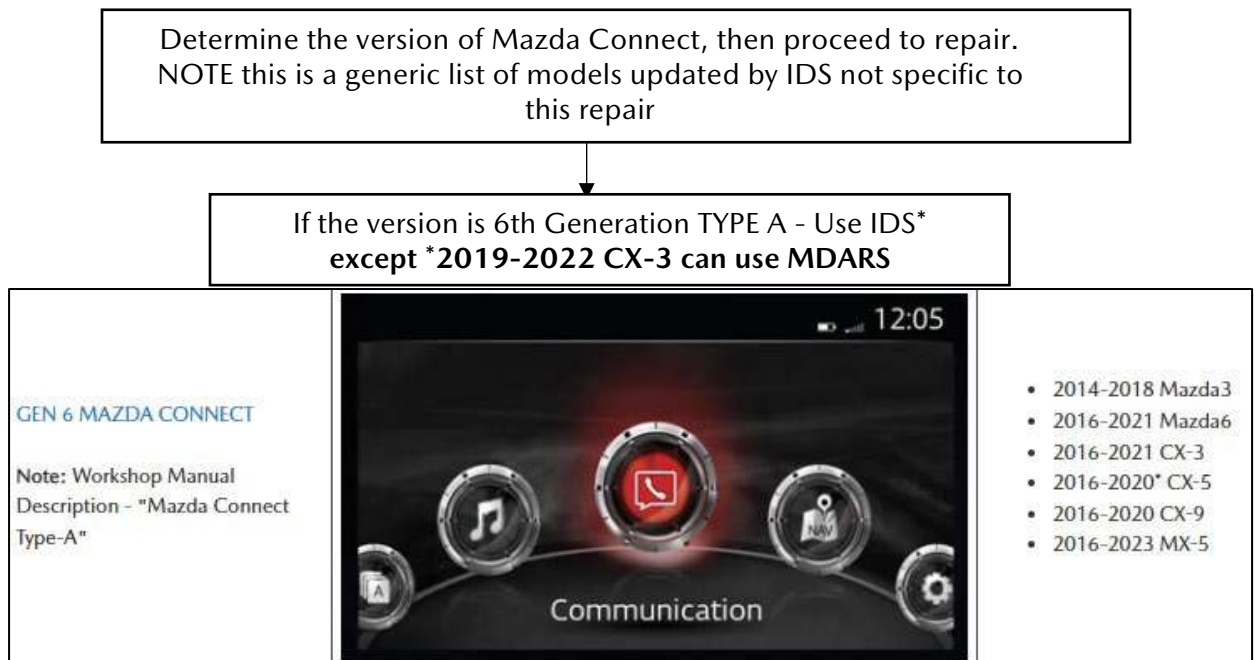
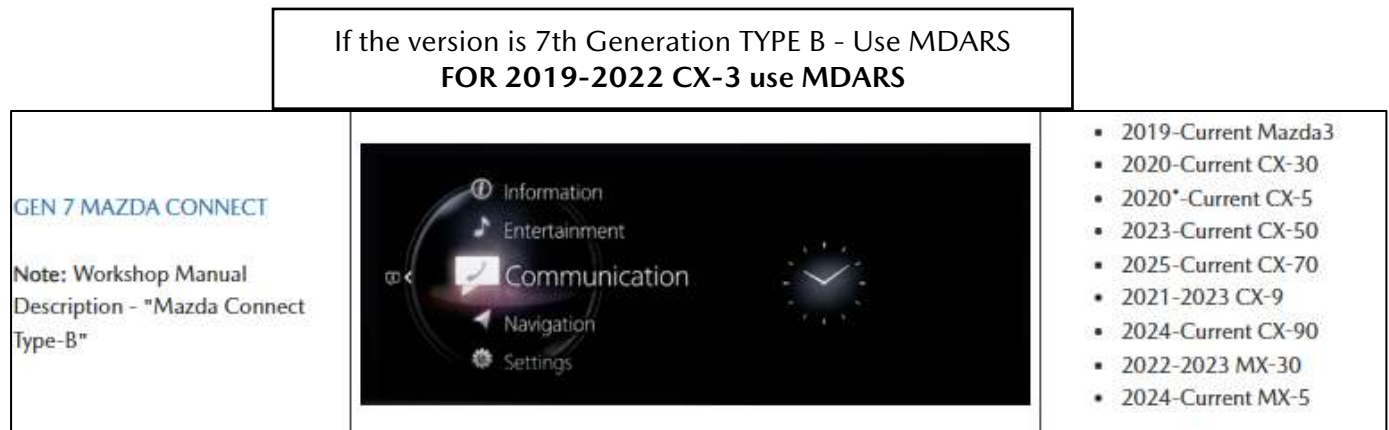
Section A: Flow Chart: NOTE: This Flow Chart needs to be followed strictly.

**REPAIR PROCEDURE – FLOW CHART** - The thermostat repair information has been removed.  
PLEASE FOLLOW THE FLOW CHART BELOW BEFORE PERFORMING THE REPAIR.

The dummy plug and PCM update repair procedure are required as of December 8, 2025. The TSB has been updated to repair with the dummy plug and PCM update here: [Technical Service Bulletin \(TSB\) No. 01-003/25](#).
