Engine vibrations perceived at low rpm -  
Camshaft adjustment fault codes stored

| Topic number | LI05.20-P-080257 |
| Function group | 05.20 - Camshaft, camshaft adjustment |
| Validity | M254 engine in all model series |

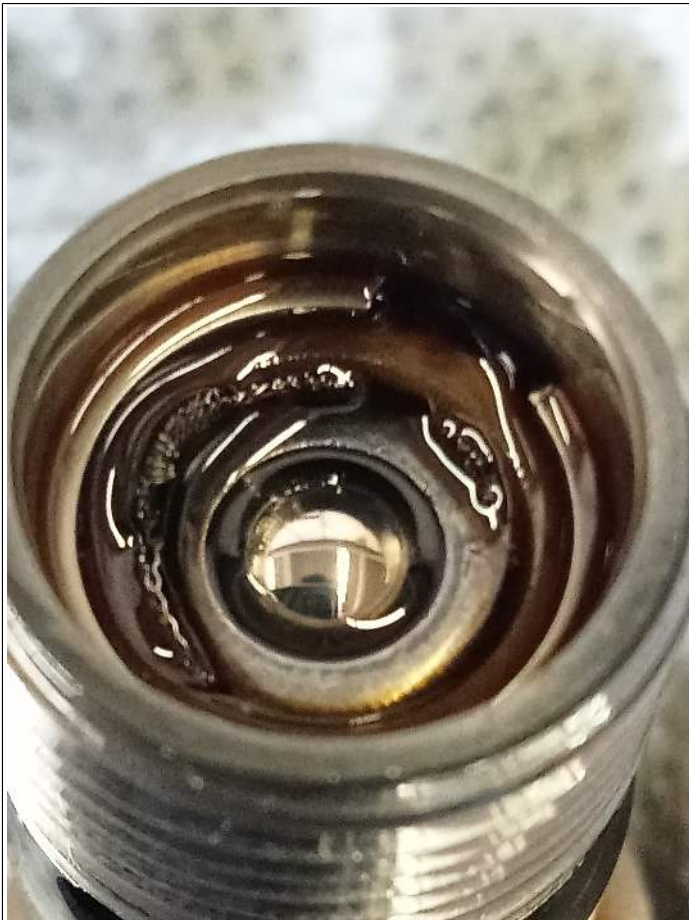
Fehlendes Sieb des Zentralventils.jpg

The screen has almost completely broken out

If the filter screen breaks loose, parts of it may settle in the camshaft adjuster or in the camshaft. If there are parts in the camshaft, they can pass through the oil supply bore to the last camshaft bearing (i.e., the first camshaft bearing behind the adjuster) and cause damage there.

2. In cases where the screen is completely missing and metal particles are found in the oil filter, the camshaft bearings must be checked. If any damage is visible there, proceed as follows:

- Both central valves
- The camshaft adjuster of the damaged central valve

- The camshaft bearing housing (camshafts are already included here)
- Oil change with oil filter

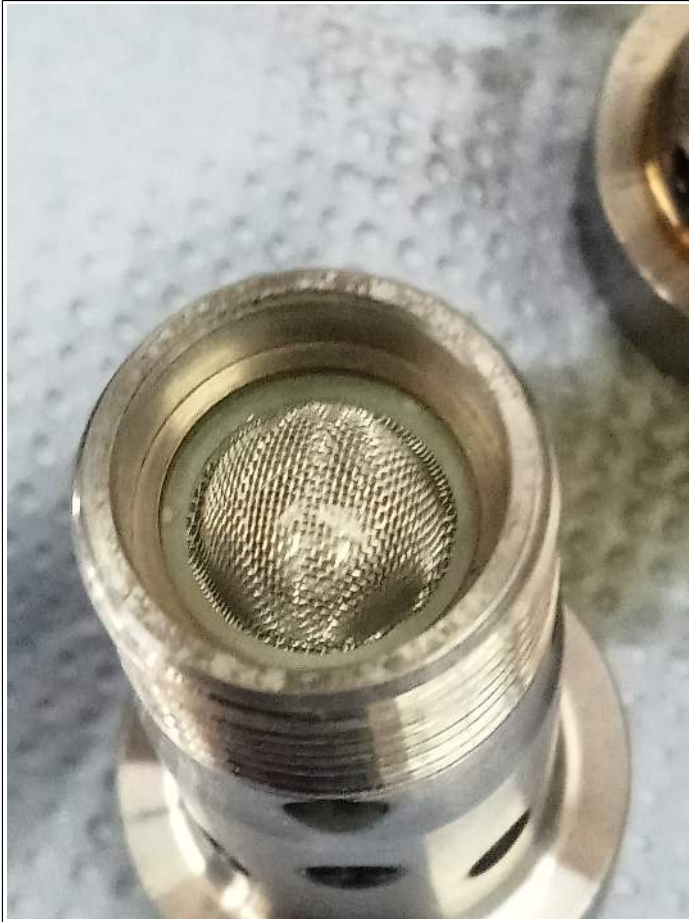
Neues Zentralventil.jpg

New central valve with optimized holding ring
