# TECHNICAL SERVICE BULLETIN

## Loss Of Engine Coolant And/Or Cooling Fan Noise

**26-2060**

| 2026 Transit | 3.5L Duratec |

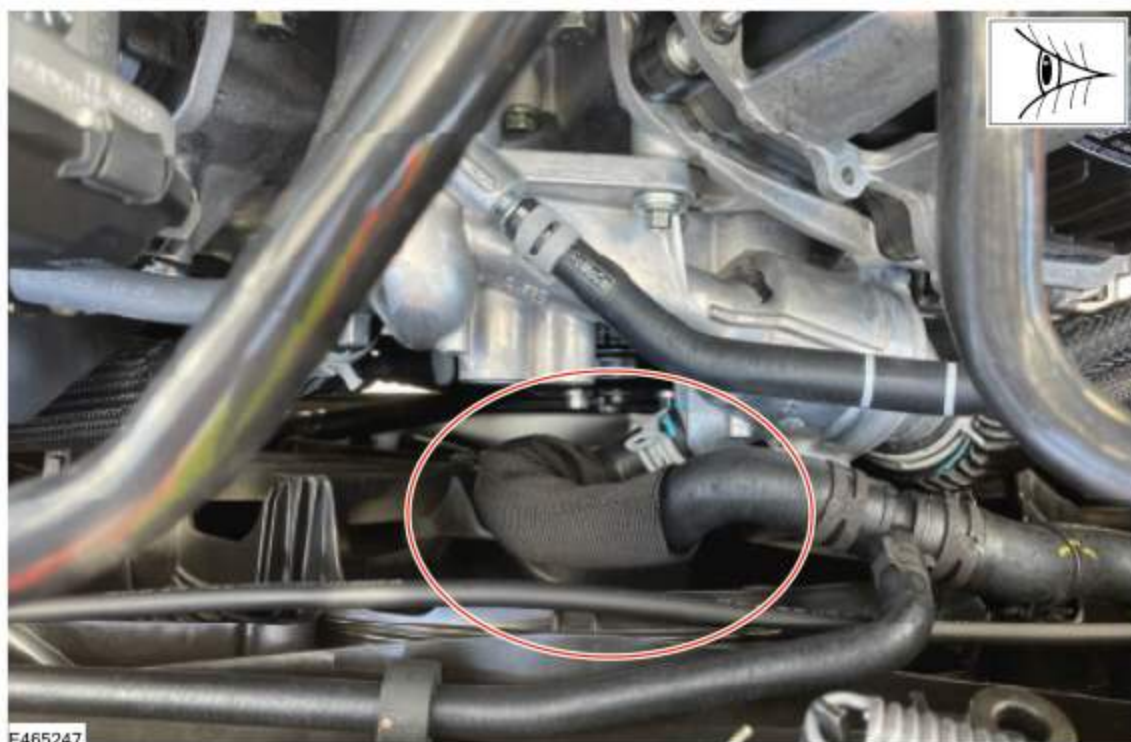
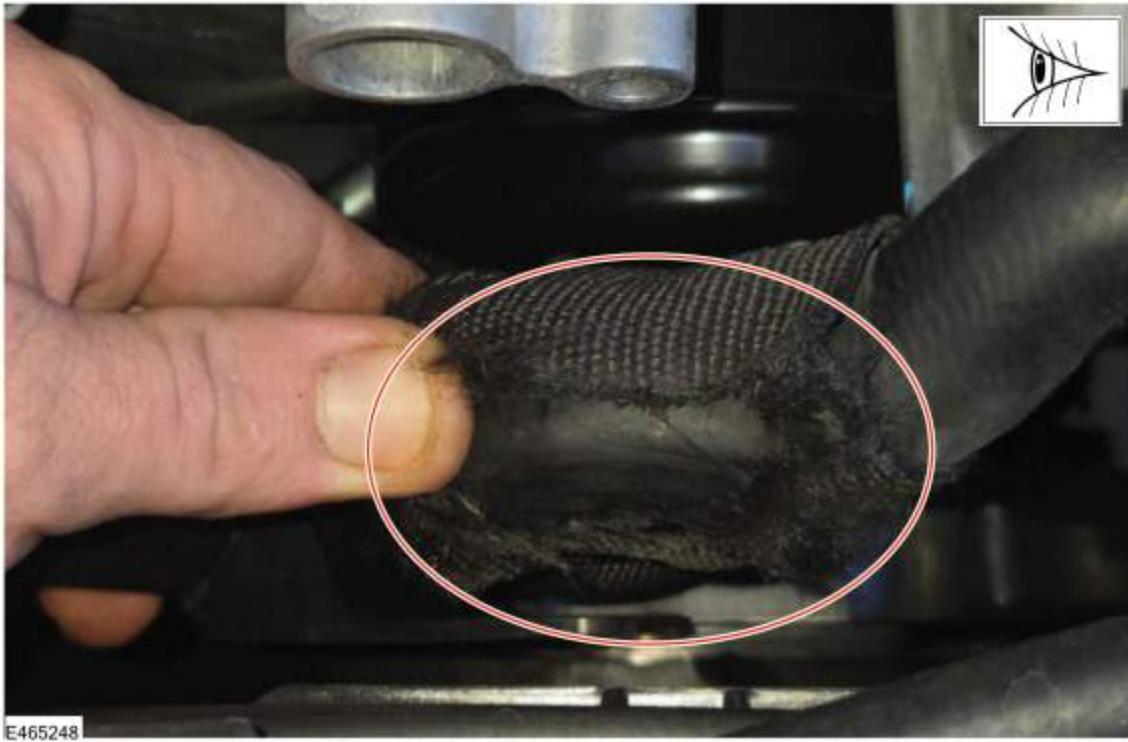
1. Visually inspect the coolant heater hose assembly near the cooling fan assembly for leaks and damage (Figures 1-2). Is damage or coolant leakage present?

**Issue:** Some of the vehicles listed in the Model statement above may exhibit a loss of engine coolant at the heater hose assembly near the engine cooling fan. The vehicle may also have DTCs P1299 and/or P1285 stored in the PCM. This may be due to an incorrectly indexed hose connection at the thermostat housing causing contact with the cooling fan.

**Action:** For vehicles that meet all of the criteria in the Issue and Model statements, follow the Service Procedure to replace and correctly index the coolant heater hose assembly and if necessary, inspect and replace the cooling fan motor and shroud assembly.

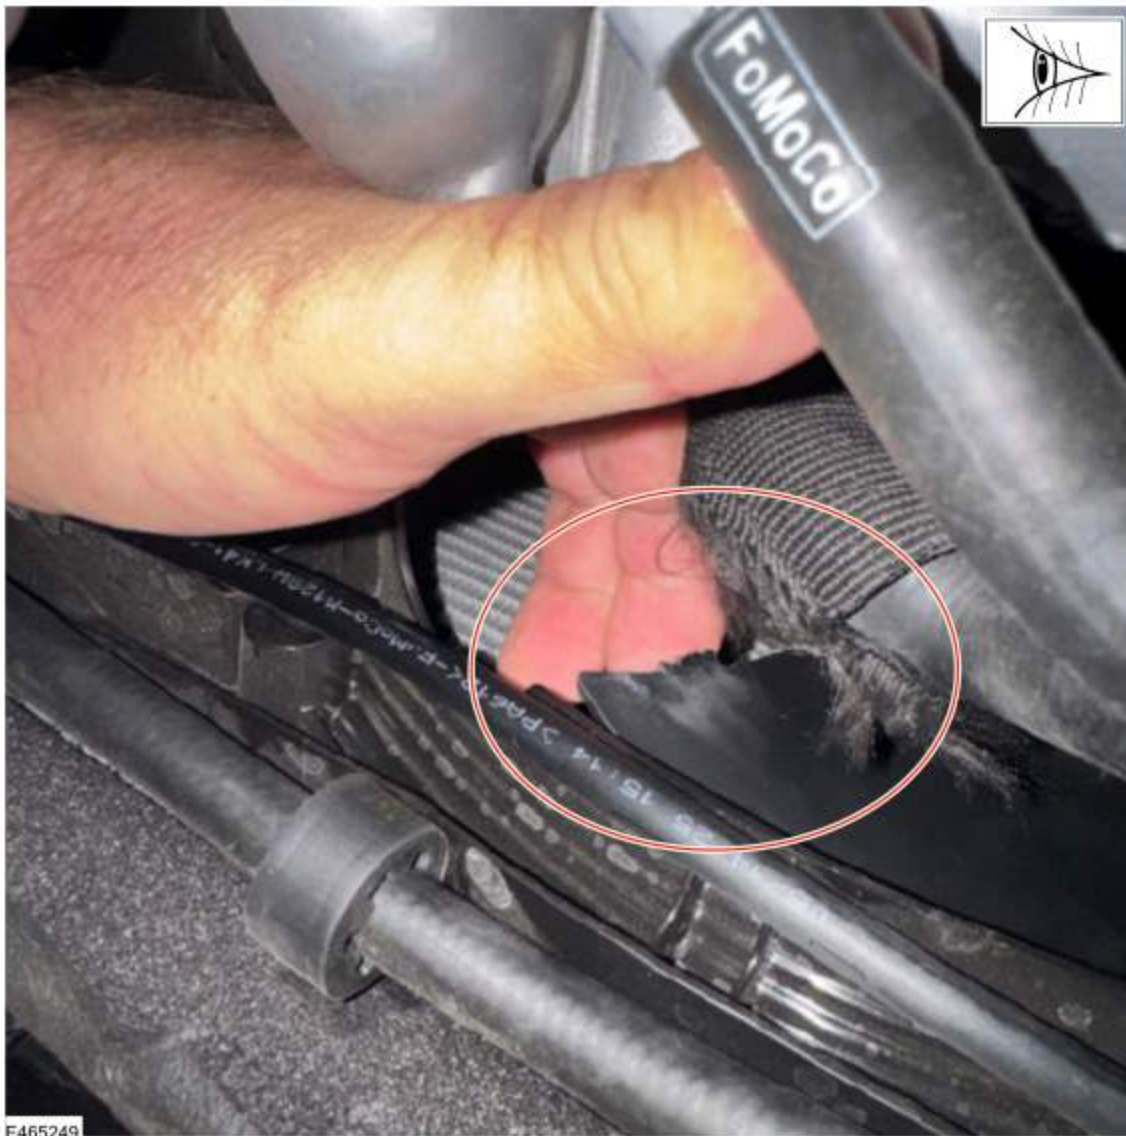
Figure 3

2. Inspect the cooling fan blades for damage due to contact with the heater hose (Figure 3). Is any damage present?

1. Yes - proceed to Step 3.
  2. No - proceed to Step 4.
  3. Replace the cooling fan motor and shroud assembly. Refer to the WSM, Section 303-03 Engine Cooling > Removal and Installation > Cooling Fan Motor and Shroud.
  4. Drain the cooling system. Refer to the WSM, Section 303-03 Engine Cooling > General Procedures > Engine Cooling System Draining, Vacuum Filling and Bleeding.
  5. Remove and discard the heater hose (Figure 4).
- Figure 4 - Heater hose 3.5L Duratec shown, 3.5L EcoBoost similar
