| <b>Topic</b> | Bentayga V8 Kovomo - DTC P310B00 with Symptom Code 2638 - Check Engine Lamp - Fuel Pressure Regulation |
| <b>Transaction No.</b> | 2058484/15 |

Bentayga V8 Kovomo - DTC P310B00 with Symptom Code 2638 - Check Engine Lamp - Fuel Pressure Regulation

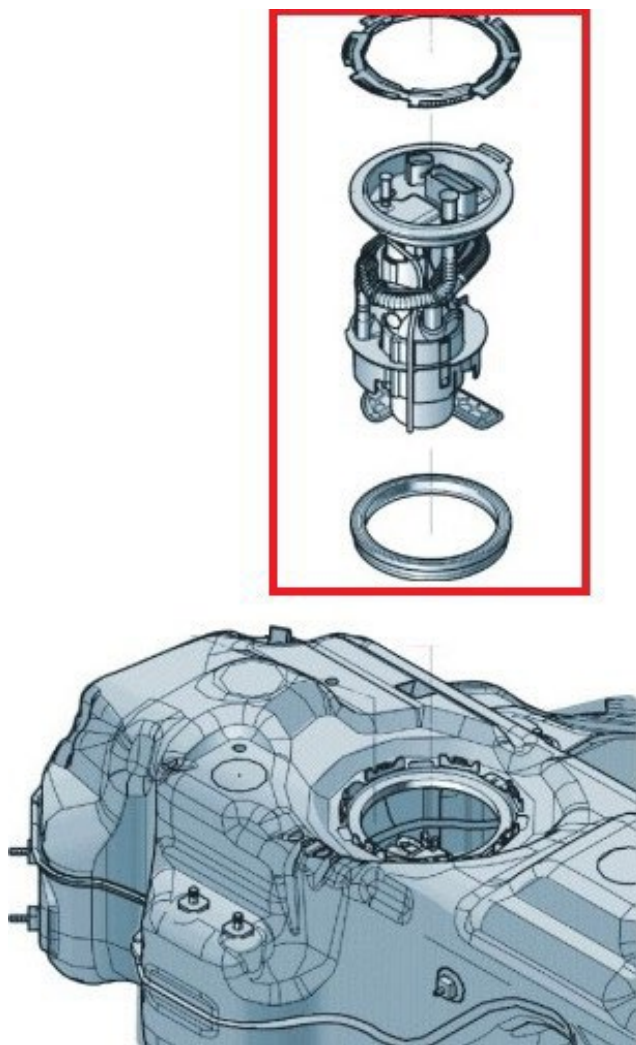
Figure 2

- In the event the fuel pressure actual value is above 450kPa the Fuel Delivery Module within the fuel tank (Figure 2) should be replaced

- In the event the fuel pressure actual value is above 475kPa (2023MY) the Fuel Delivery Module within the fuel tank (Figure 2) should be replaced

The fuel tank flange seal and securing ring should also be replaced

- Refer to Repair Group 20 Fuel supply, gas operation / 4.0L V8 TSI / Fuel pump, fuel level sensors, and jet pump (RH) - To remove and fit

- Refer to Repair Group 20 Fuel supply, gas operation / 4.0L V8 TSI / Fuel pump, fuel level sensors, and jet pump (RH) - To remove and fit.

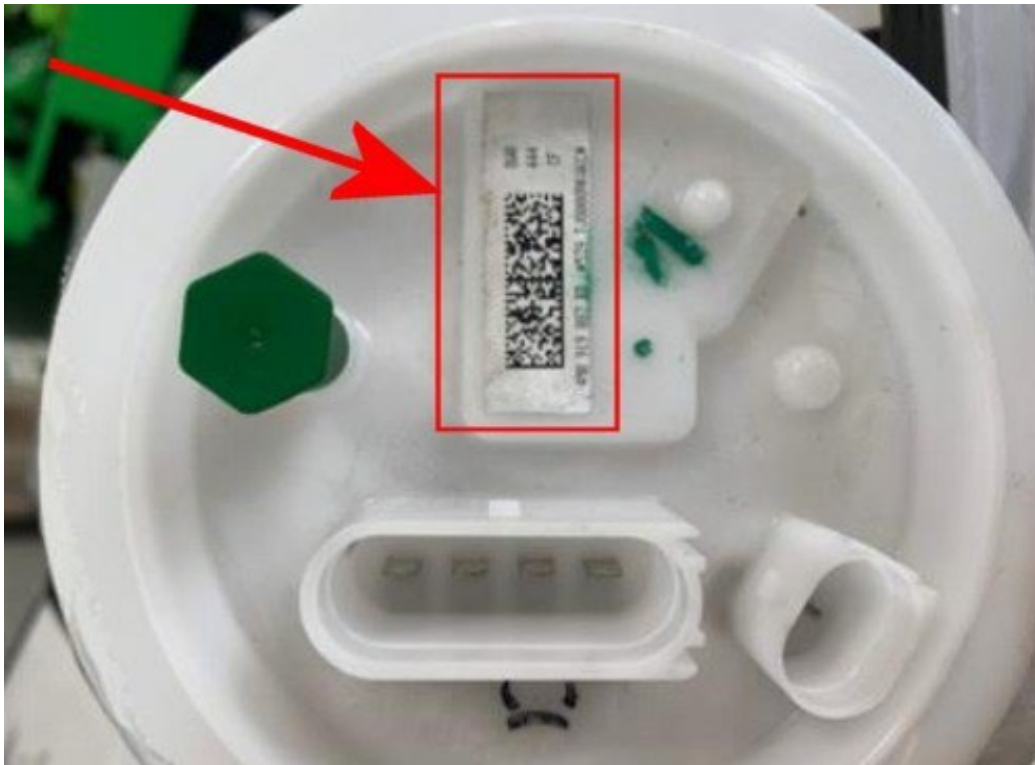
**IMPORTANT:** Once the fuel delivery module has been replaced, the operative should attach a clear photograph of the manufacture information label as shown in Figure 3
