Engine vibrations perceived at low rpm -  
Camshaft adjustment fault codes stored

| Topic number | LI05.20-P-080329 |
| Function group | 05.20 - Camshaft, camshaft adjustment |
| Validity | M254 engine in all model series |

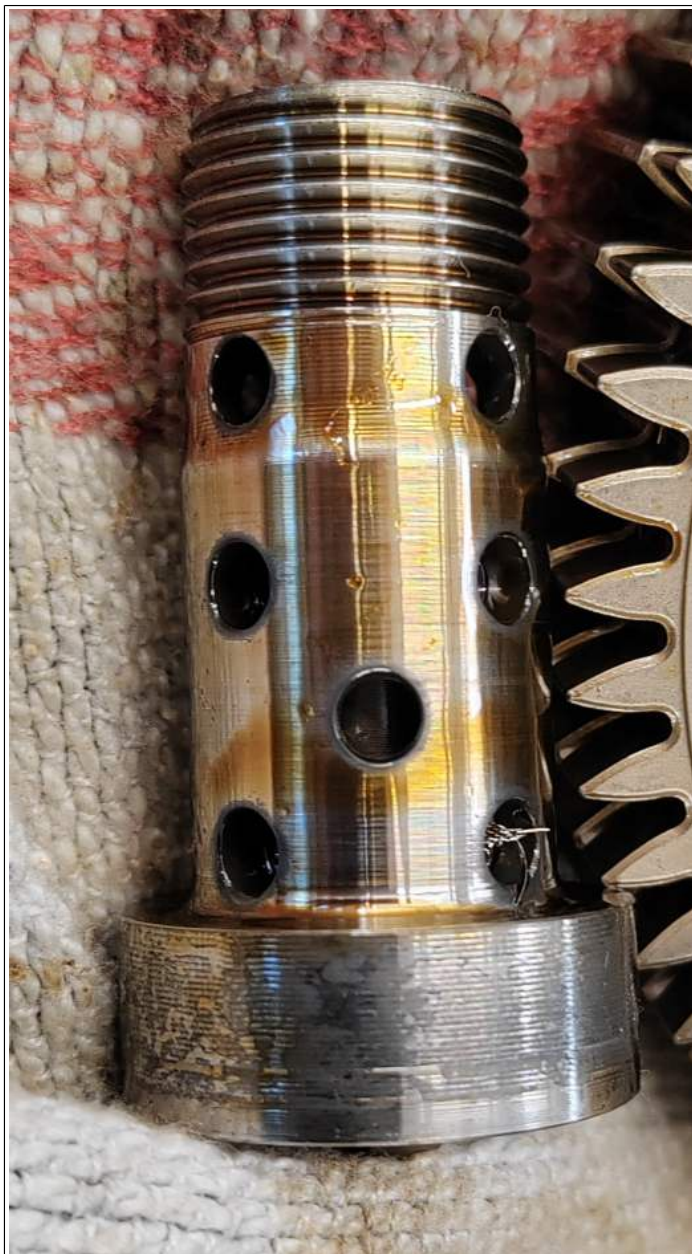
| Attachments | |
|---|---|
| Gebrochenes Sieb im Zentralventil.jpg | Here, the filter screen is protruding from one of the holes |

Continuously fluctuating oil pressure in the central valve may lead to damage to the filter screen on the central valve. This can result in damage to the filter screen or the filter screen breaking loose.

1. In cases in which only the screen of the central valve is damaged and no metal particles are found in the oil filter, the following parts must be replaced:

- Always both central valves
- The camshaft adjuster of the damaged central valve

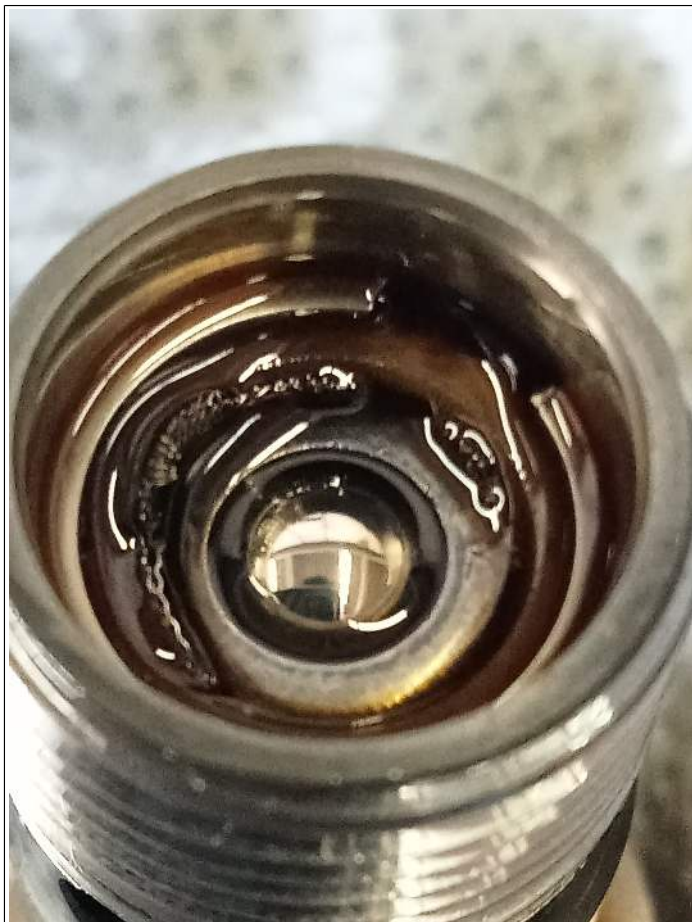
Fehlendes Sieb des Zentralventils.jpg

The screen has almost completely broken out

If the filter screen breaks loose, parts of it may settle in the camshaft adjuster or in the camshaft. If there are parts in the camshaft, they can pass through the oil supply bore to the last camshaft bearing (i.e., the first camshaft bearing behind the adjuster) which could cause damage there.

2. In cases where the sieve is completely/partially missing and metal particles are found in the oil filter, the camshaft bearings must be checked. If any damage is visible there, proceed as follows:

- Both central valves
- The camshaft adjuster of the damaged central valve
- The camshaft bearing housing (camshafts are already included here)
- Oil change with oil filter

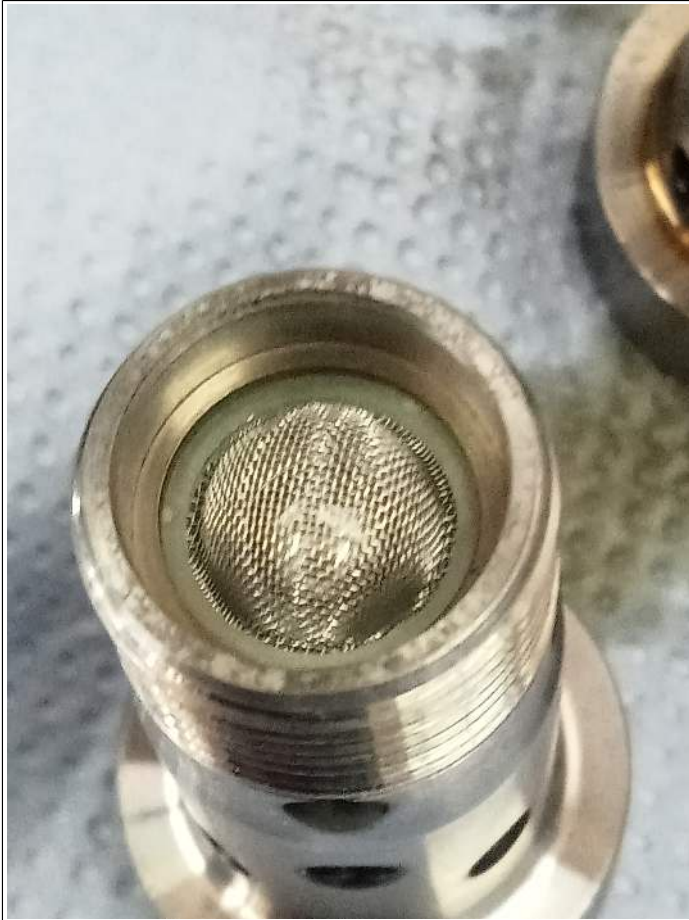
Neues Zentralventil.jpg

New central valve with optimized holding ring

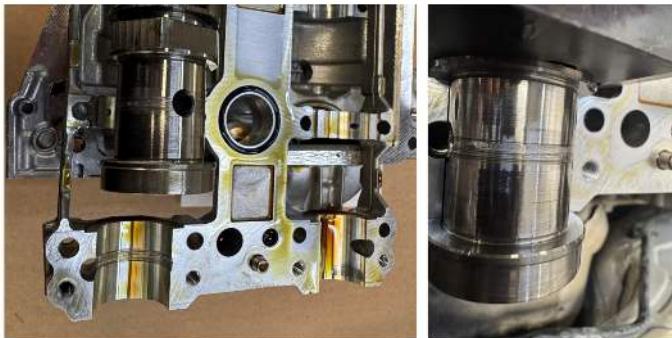
Camshaft bearing damage.jpg

Camshaft and bearing damage
