Yellow warning message in the "Cooling system fault, operating energy input reduced, service required" display in connection with the fault entry "B3A0077" in the powertrain control unit N127 (PTCU)

| Topic number | LI83.30-P-079196 |
| Validity | Model series 294, 295, 296, 297 |

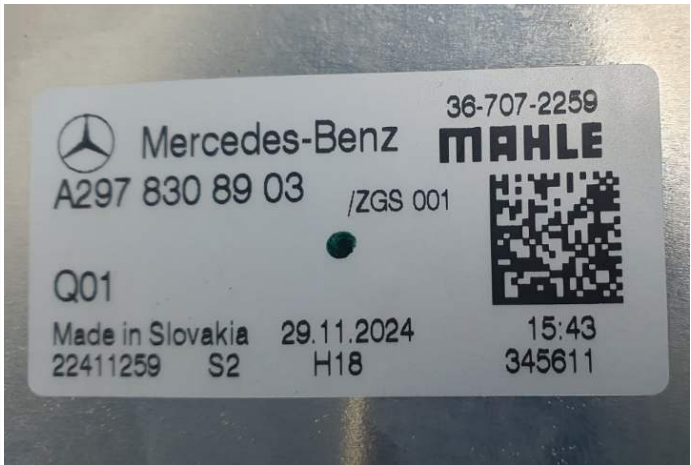
| Attachments | |
|---|---|
| <a href="#">Label ZB Chiller.PNG</a> | Example of chiller assembly label |

Do not replace Y140/1 if the installed component has part number A 297 830 8903 and a production date after February 1, 2025!  
Please create TIPS case, attach the current quick test and attach picture of the evaporator assembly component part label and a picture of the production date of the EXV Y140/1 (see example attached).

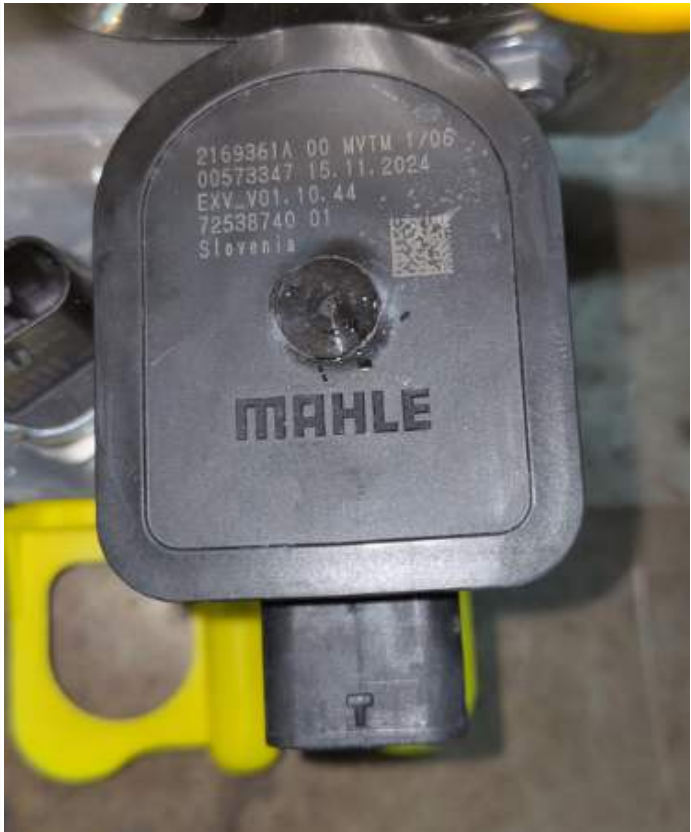
| Attachments | |
|---|---|
| <a href="#">Label EXV.PNG</a> | Example of expansion valve Y140/1 label |
