**Date:** 11.03.2026      **Affected Models:** Emira 4-Cylinder Vehicles      **Affected Regions:** All Markets      **Affected Volume:** N/A      **Number:** 131-26007

Diagnosing medium temperature engine coolant thermostat operation to prevent unnecessary thermostat replacement.

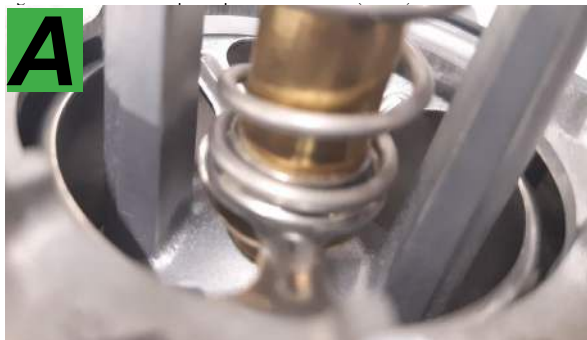
Inspect for the cold/closed position of the medium temperature thermostat piston.

- ✓ The piston should be recessed into the thermostat housing as shown in image A, which is the CORRECT closed position for a cold thermostat.

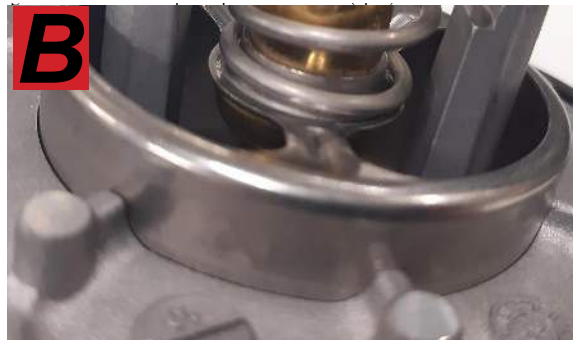
- ✗ If the piston is not recessed or protrudes out of the thermostat housing as shown in image B, then it is in the partially or fully open/hot position which is INCORRECT for a cold thermostat.

- 1.If the thermostat **MOVES FREELY** when heated and cooled, then refit the original thermostat with a new gasket and refill the engine with new antifreeze/coolant.
- 2.If the thermostat **DOES NOT** move freely when heated and cooled, then fit a **NEW** thermostat and gasket and refill the engine with new antifreeze/coolant. Carefully package the thermostat and contact Emira Support using LCMS to arrange collection.

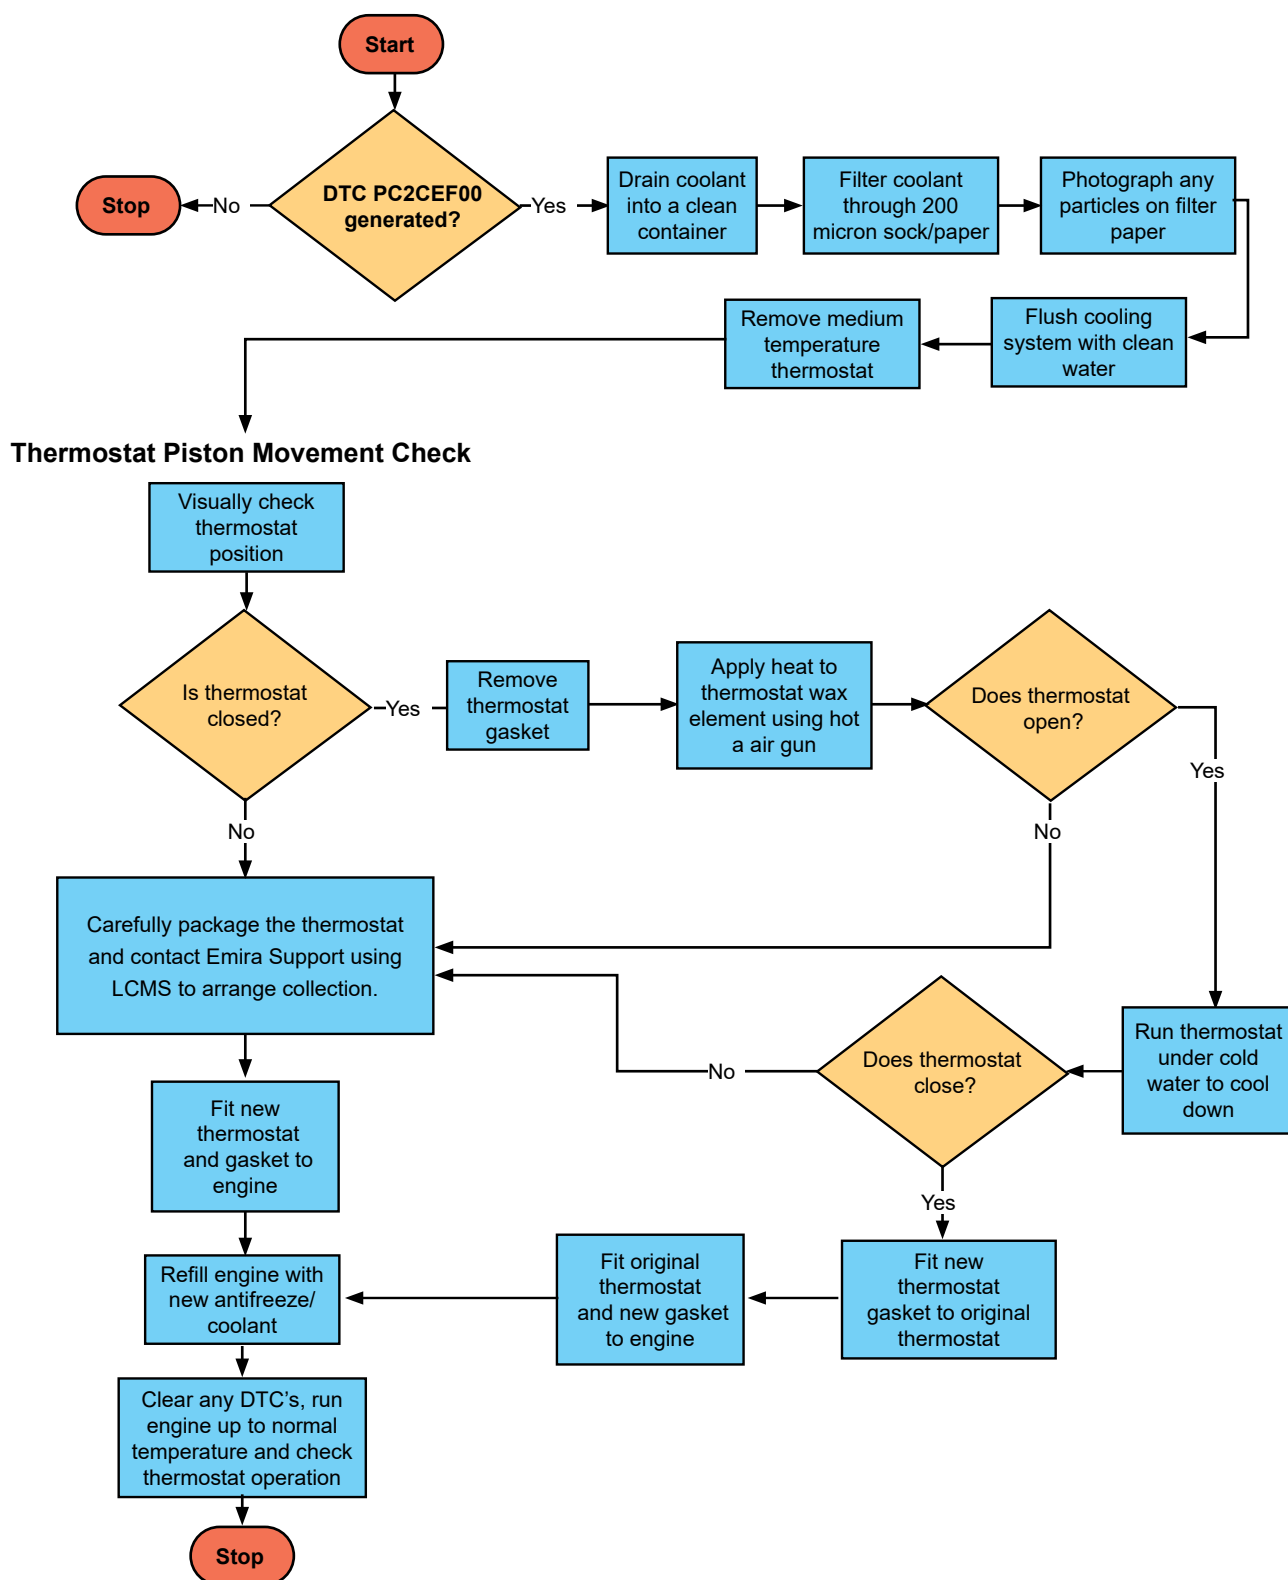
A process flow chart showing all the steps of the thermostat checking procedure is shown on page 4 of this bulletin.
