Preliminary Information

PIT5677C SES MIL / No Start / No Crank / Runs Rough / Reduced Engine Power / VSS / DTCs (Inspect Engine Harness)

| Brand: | Model: | Model Years: | VIN: | | Engine: | Transmissions: |
|---|---|---|---|---|---|---|
| Chevrolet | Silverado 1500 (New Model) | 2019 - 2020 | All | All | 2.7L L3B | All |
| GMC | Sierra 1500 (New Model) | 2019 - 2020 | All | All | 2.7L L3B | All |

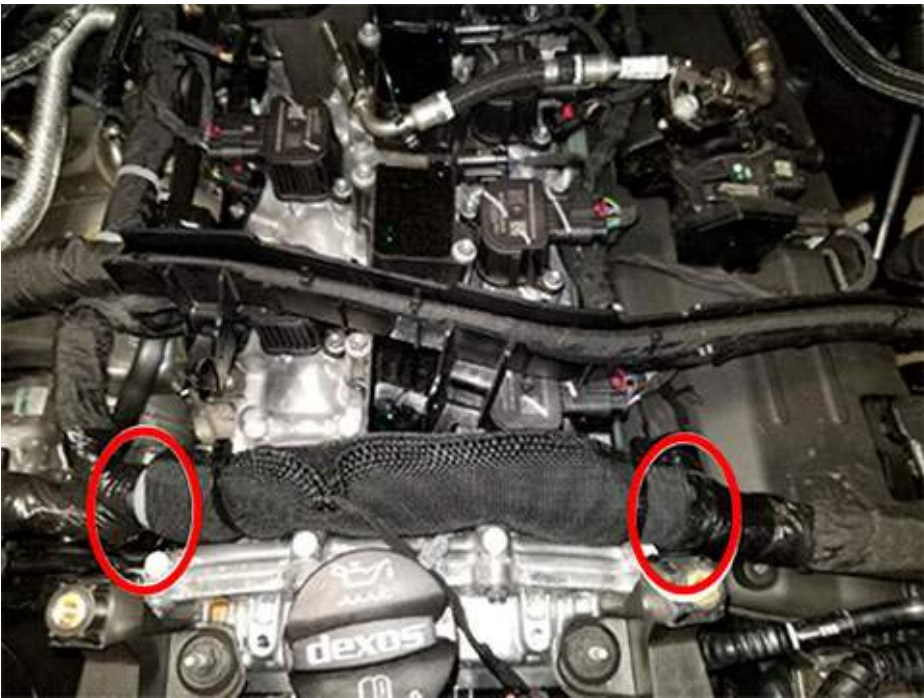
Inspect the engine harness as it crosses over top of the Camshaft Carrier Cover.

Harness damage can occur at any point across the Camshaft Carrier Cover.  
Typical inspection locations shown below.

**Correction:**

If engine wiring harness contact is isolated during inspection, use a seam ripper type tool to carefully inspect for internal wiring damage.

If found, repair the damaged wiring following the SI wire to wire repair procedures.

Once repaired, protect the engine wiring harness at all points listed in this PI using Woven Polyester (PET) Electrical/Anti-Abrasive Tape.

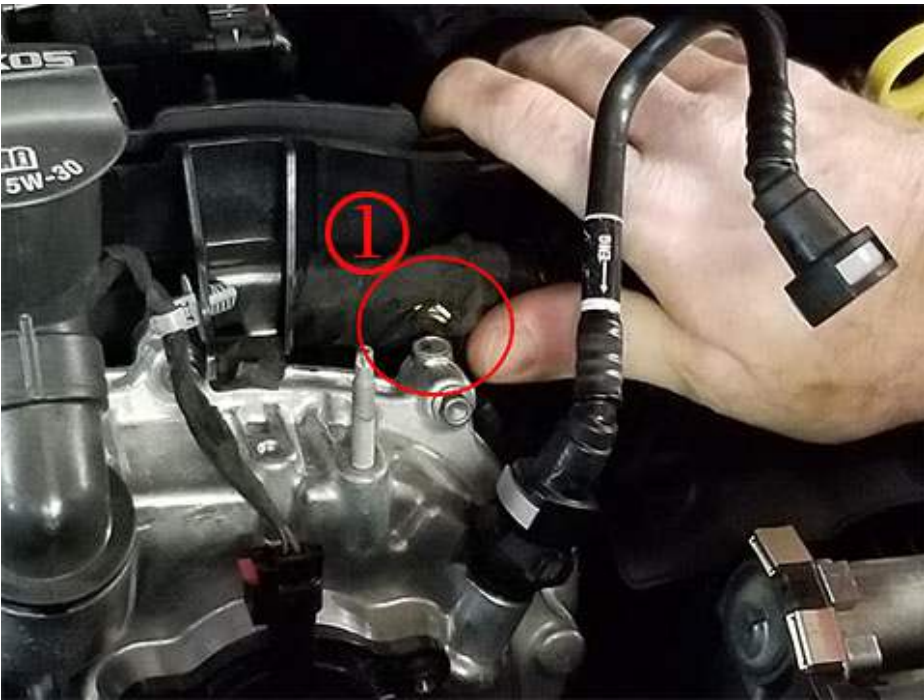
Example of engine wiring harness damage at Camshaft Carrier Cover shown below.

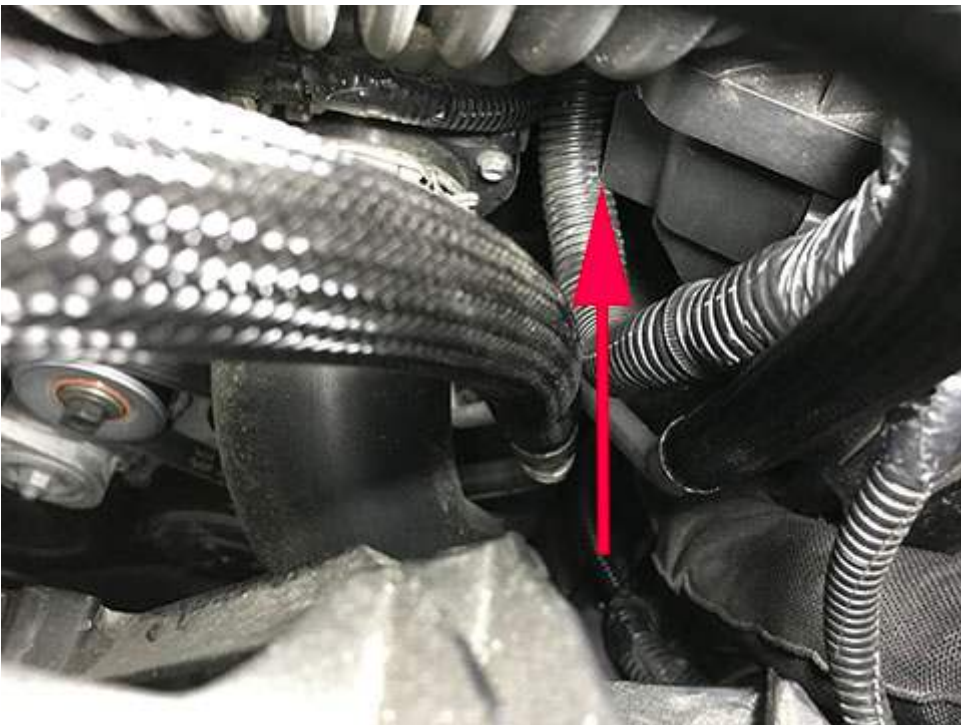
Inspect the engine harness at the Lower Air Cleaner Housing as shown below.

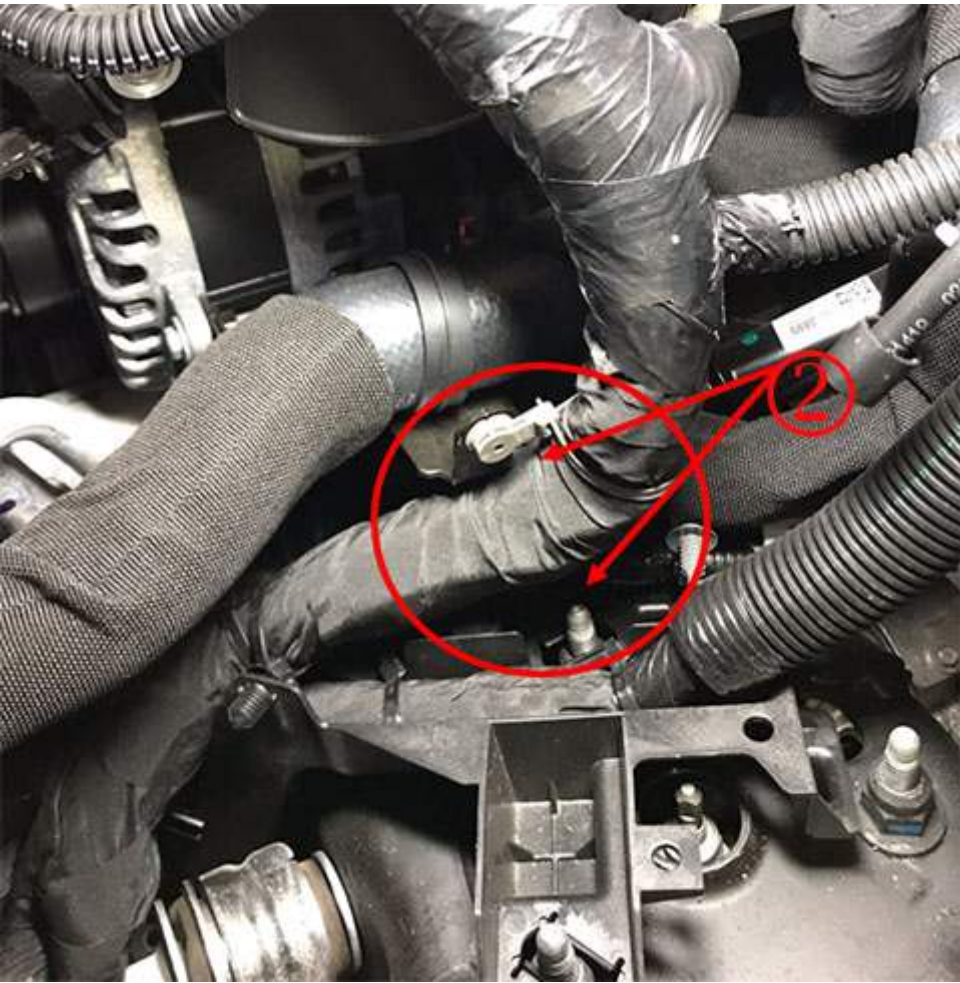
Inspect the engine harness at the Inlet Radiator Hose Bracket and Left Front Coil Spring stud as shown below.

**Note:** Under normal driving conditions, the engine will rock back and forth in its mounts.

This may result in harness contact with this bracket that may not be present during engine off inspections.

Careful visual inspections are necessary to isolate areas of contact.

It may be necessary to disconnect several engine harness connections to reposition the harness for inspections.

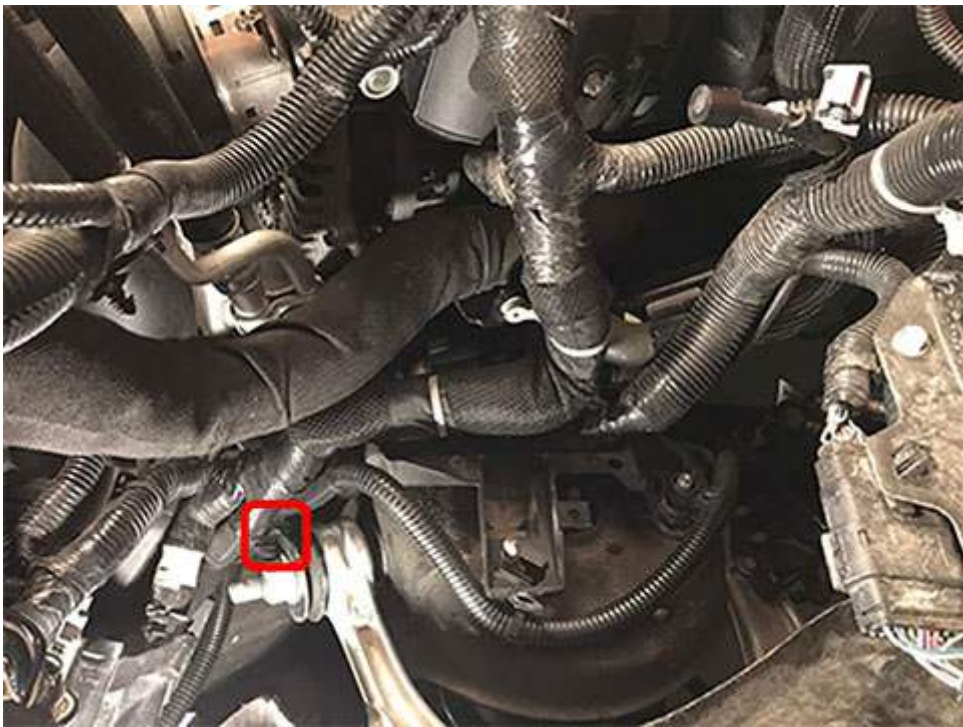
Inspect the engine harness at the Left Front Upper Control Arm Bushing as shown below.
