# Technical Service Bulletin

## 37 Vehicle electronics malfunction message, DTC B116229 is stored in the steering wheel or vehicle electronics module

37 20 95 2047609/4 April 10, 2020. Supersedes Technical Service Bulletin Group 34 number 20-44 dated March 5, 2020 for reasons listed below.

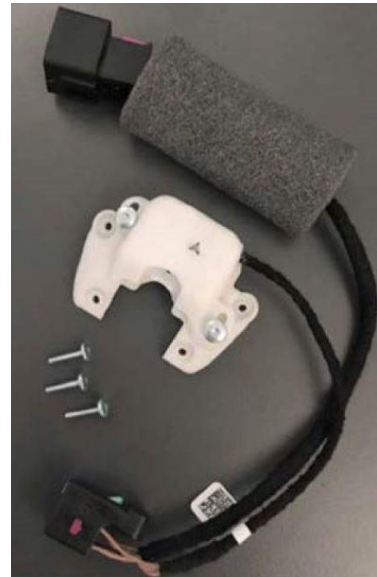
**Figure 1.** New micro switch module.

If the customer has the above condition and the DTC B116229 is stored in the steering wheel electronics module, J527 (address word 0016) or the vehicle central electrical system module J519 (address word 0009), then install the new externally mounted micro switch module and selector lever handle sleeve per the instructions below (Figure 1).
