# SERVICE BULLETIN

DA15-032C

NTB15-099C

## SERVICE INFORMATION FOR DTCs C1A12 AND C1A16

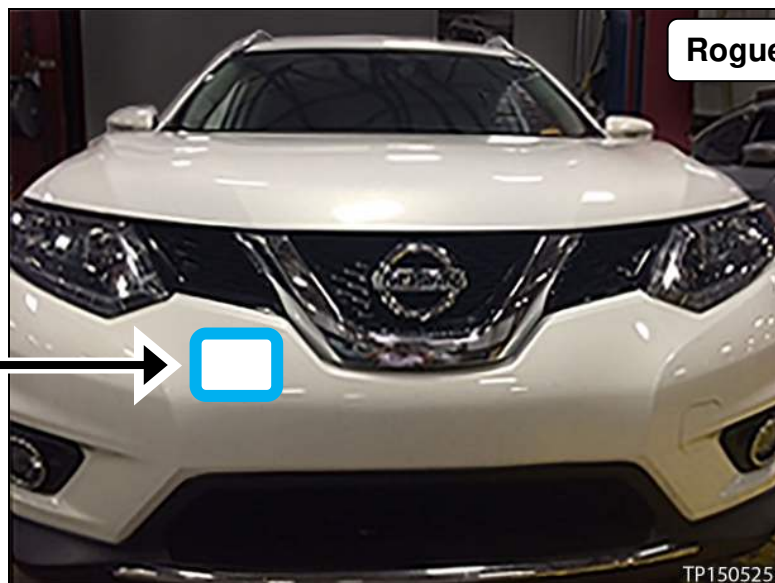
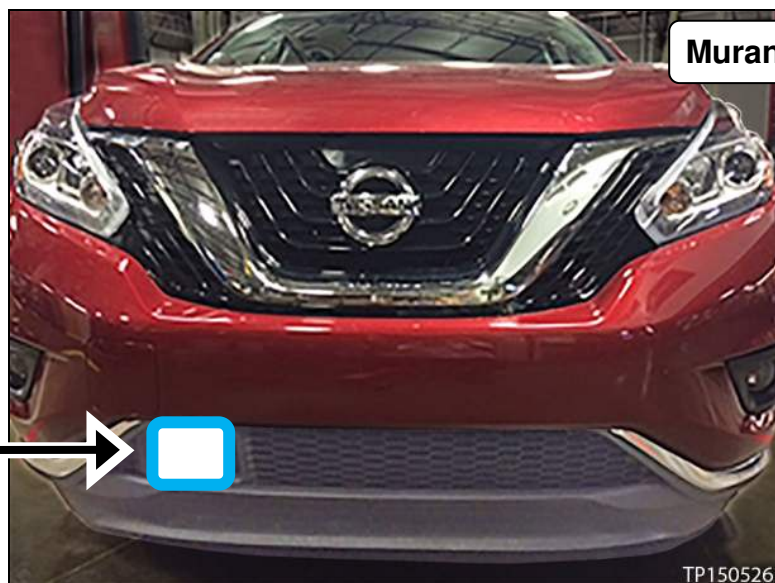
Location of  
ICC/distance  
sensor, behind  
or below  
bumper fascia

- Check the ICC/distance sensor lens or the bumper fascia in front of the sensor (see pages 2, 3, and 4). Remove any obstructions, including any clear bra or film, and clean off any stains (mud, dirt, road debris, dirty rain water, etc.), and then verify proper system operation.

- Inspect the bumper fascia in the area in front of the ICC/distance sensor (see pages 2, 3, and 4).
  - Check for stains and/or physical damage (for example, mud/dirt, road debris, dirty rain water, scrapes, punctures, misshapen surface).
  - If there is physical damage but not severe, clean the area in front of the ICC/distance sensor, perform an ICC/distance sensor alignment using CONSULT-III plus (C-III plus), and then verify proper system operation.
  - If an ICC/distance sensor alignment is not successful, inspect the ICC/distance sensor bracket for damage (see page 5).
    - If damaged, replace the ICC/distance sensor bracket, and then perform an ICC/distance sensor alignment again.

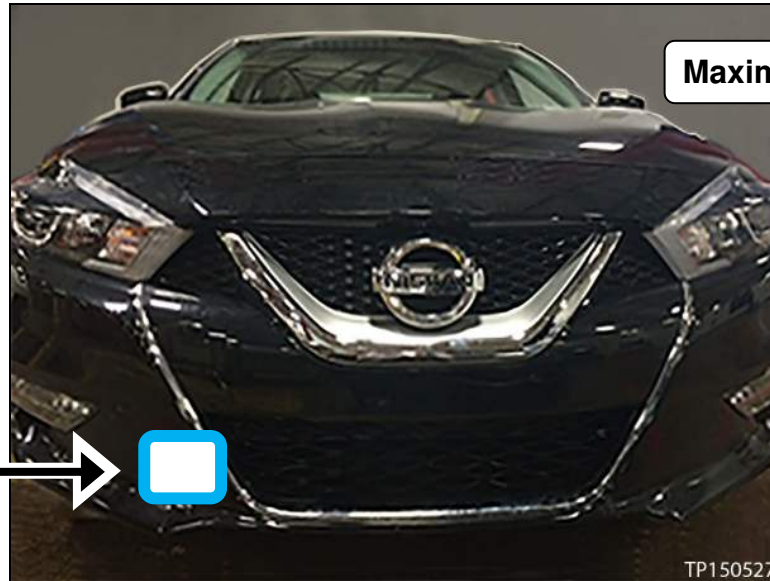
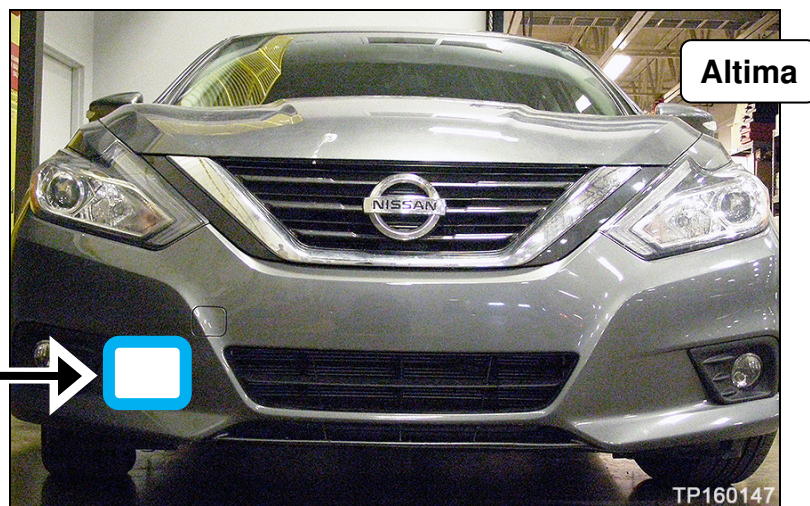
Location of  
ICC/distance  
sensor, behind  
or below  
bumper fascia

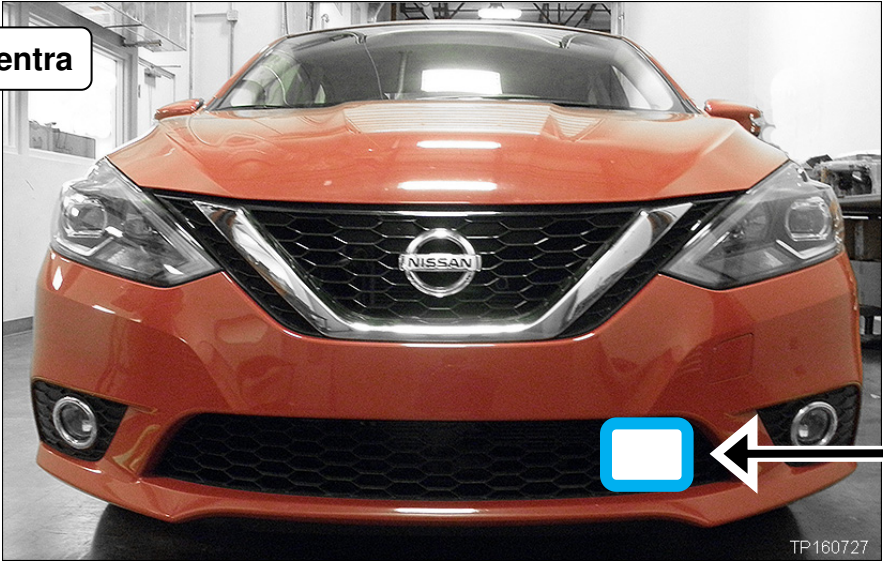
Sentra

Location of  
ICC/distance  
sensor, behind  
or below  
bumper fascia
