## SERVICE BULLETIN

AT15-005e

### PATHFINDER, QUEST, MURANO, MAXIMA, ALTIMA V6; CVT JUDDER AND DTC P17F0 OR P17F1 STORED

#### APPLIED TRANSMISSION: CVT

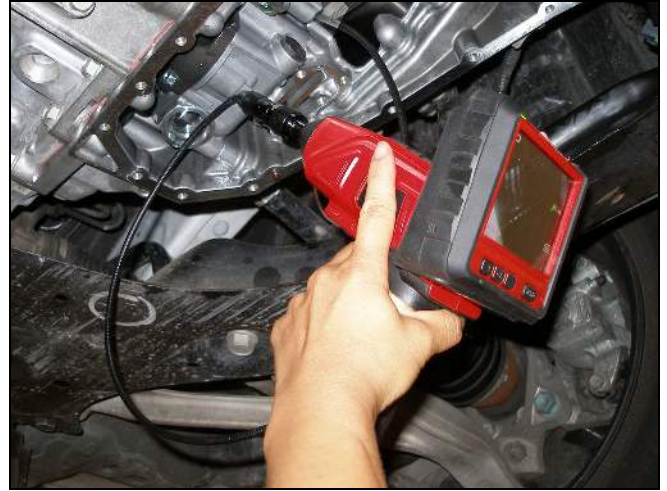
Figure 11

4c. Slowly and carefully turn the left front tire one full turn in the forward rotation to view all of the chain.

- Holding the borescope with one hand allows for turning the tire with the other hand (see Figure 11).

**CAUTION:** If the tire is rotated in the rearward rotation, the camera lens may get caught between the chain and pulley.

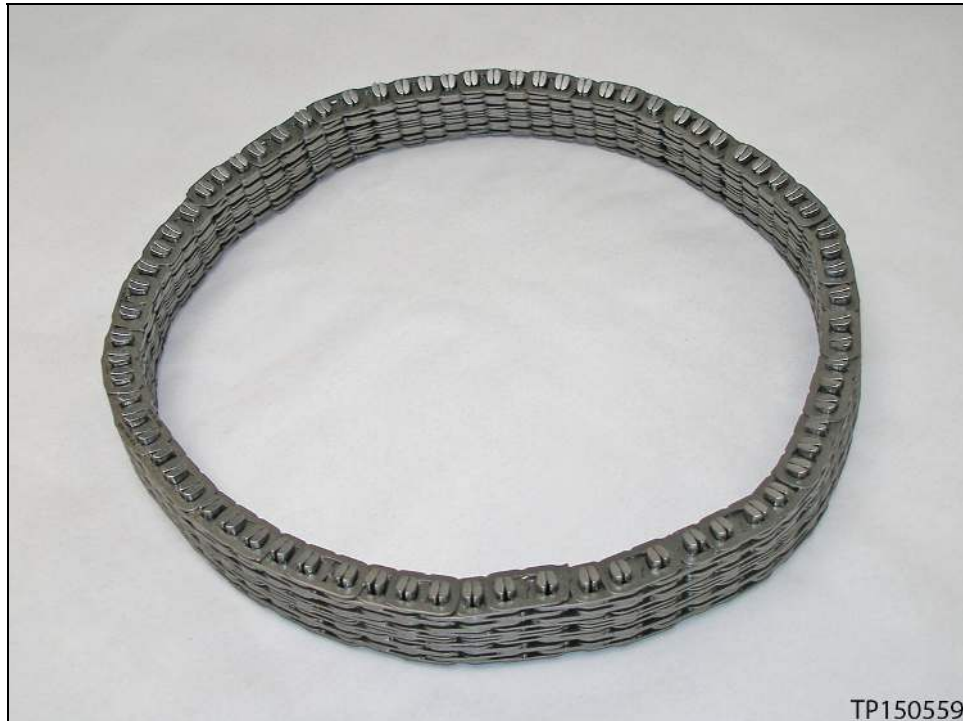
Figure 14: CVT chain

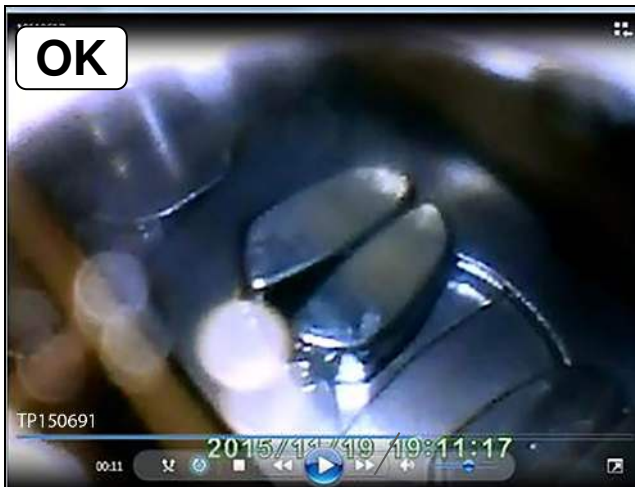
Pictures in Figure 16 and 17 were taken with borescope J-51951.

**NOTE:** Reference the pictures on page 13-15 for comparison.

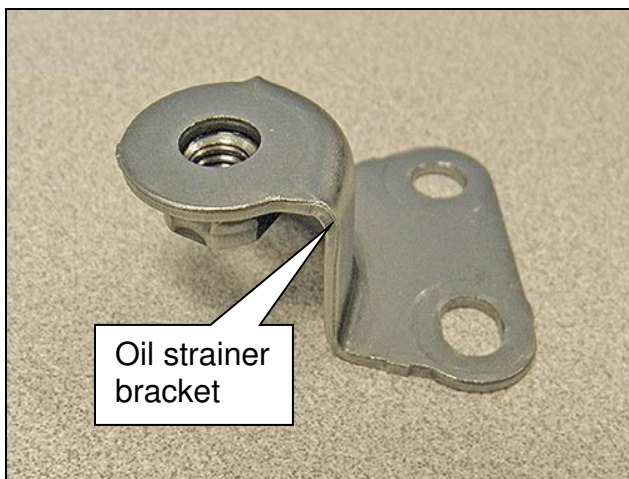
Figure 25

1. Discard the oil strainer bracket (Figure 25).
2. Install a new lip seal. Do NOT reuse the old lip seal (Figure 26).

**NOTE:** Apply a small amount of petroleum jelly to the lip seal to keep it in place on the CVT.

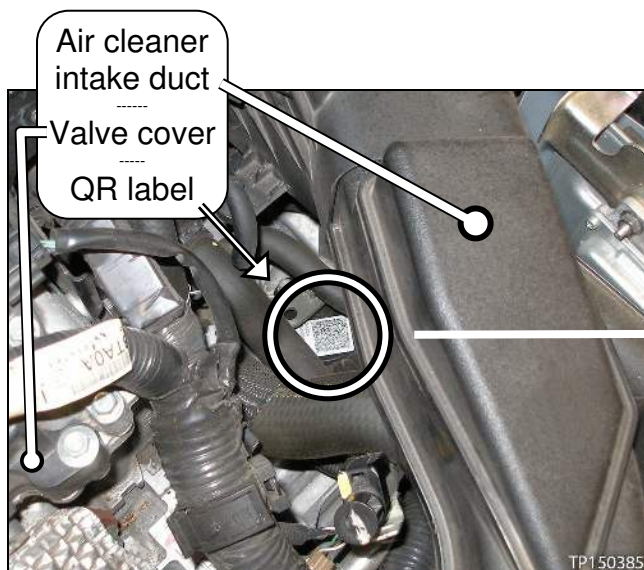
- Refer to **TM – Transaxle & Transmission / BASIC INSPECTION**, and perform **ADDITIONAL SERVICE WHEN REPLACING TRANSAXLE ASSEMBLY**.
  - Check for fluid leakage.
  - Attach the QR label with the new calibration data onto the transmission range switch (inhibitor switch).
    - See Figure 34 and 35 below.
    - A QR Label and CD-R are included with the replacement valve body.
