# SERVICE BULLETIN

AT18-009C

## MIL ON WITH DTC P0776, P1715 AND MAY HAVE HESITATION AND/OR LACK OF POWER

**APPLIED VEHICLES:** 2017-2018 Sentra Turbo (B17)

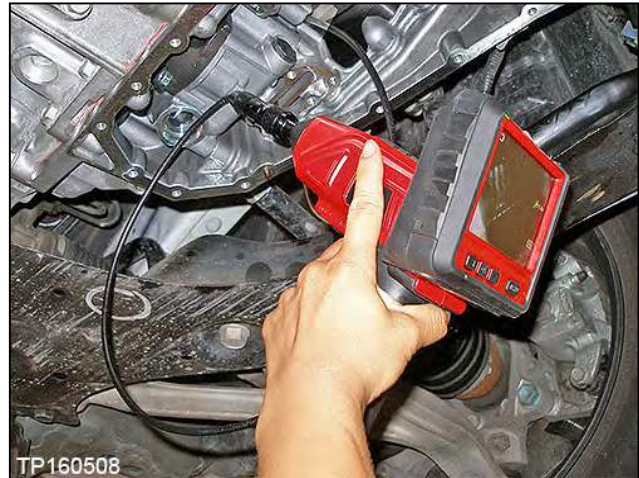
Figure 5

- b. Slowly and carefully turn the front left tire one full turn in the forward rotation to view all of the belt.

- Holding the borescope with one hand allows for turning the tire with the other hand (see Figure 5).

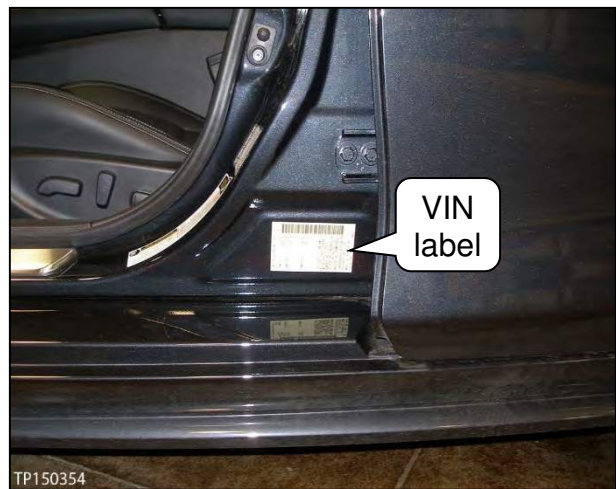
Figure 7

- f. If CVT replacement is required based on the inspection results from 6b and 6d, use borescope J-51951 to record a continuous video, 15 seconds or less, of the most severe evidence of belt slip and the VIN on the F.M.V.S.S. certification label (VIN label). See Figure 7.

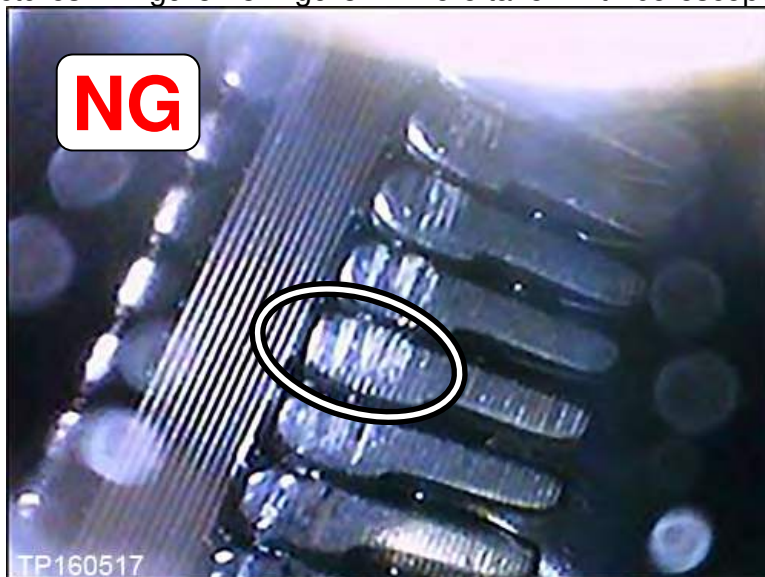
Pictures in Figure 15-Figure 17 were taken with borescope J-51951.

Figure 15: Example of NG belt

- **YES:** Continue to step 6f.
- **NO:** Proceed to step 10 on page 13 and replace valve body.

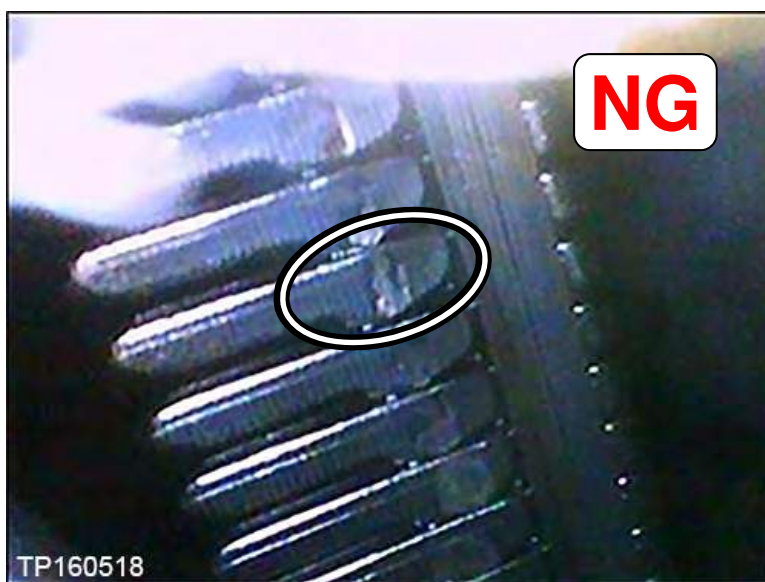
Figure 16: Example of NG belt

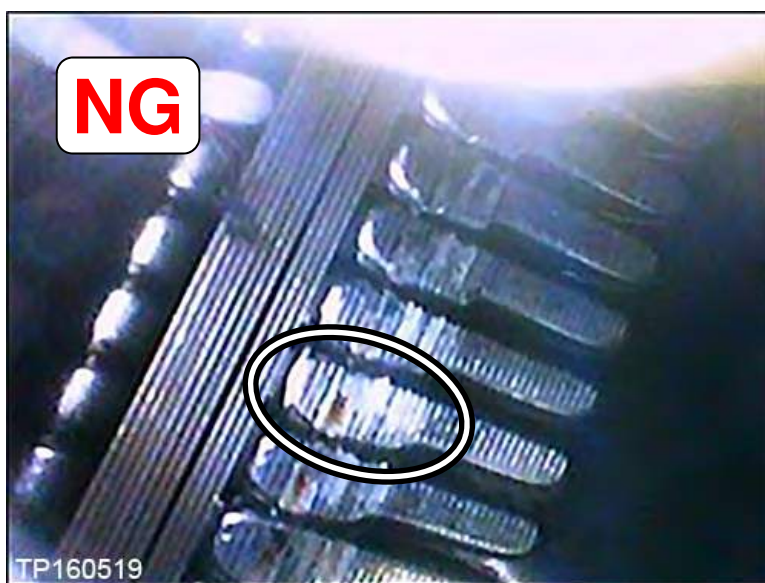
Figure 17: Example of NG belt

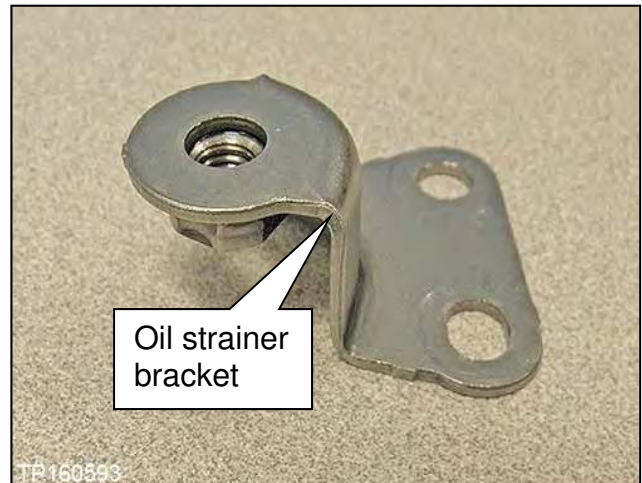
Figure 18

**NOTE:** If an oil strainer bracket was removed, discard it. An oil strainer bracket (Figure 18) will not be used with the new oil strainer.
