# Technical Service Bulletin

## 69 Airbag light on, DTC B101C29 and/or B101D29 is stored in the airbag control module - Repair Authorization

69 21 70 2064545/1 September 14, 2021.

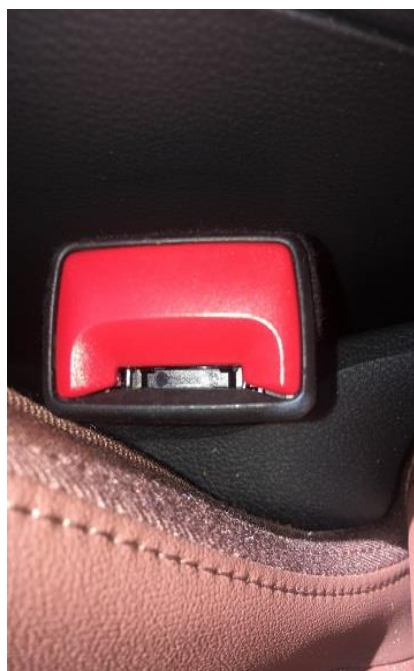
1. Verify the customer concern.
2. Before performing any repairs, please take detailed photos of the following:
  - Belt buckle with latching mechanism (Figure 1).

**Figure 1.** Belt buckle with latching mechanism.

3. Perform root cause analysis.
4. Inspect the seat belt buckle for foreign objects and/or sticky fluids, the belt buckle wiring for damage and the belt buckle connectors for any concerns (e.g. damaged wiring, backed out or widened pins, corrosion, etc.).
5. Take detailed photos of any concerns found during analysis.
6. Upload photos to Doc-It and reference this TSB in the claim comments.

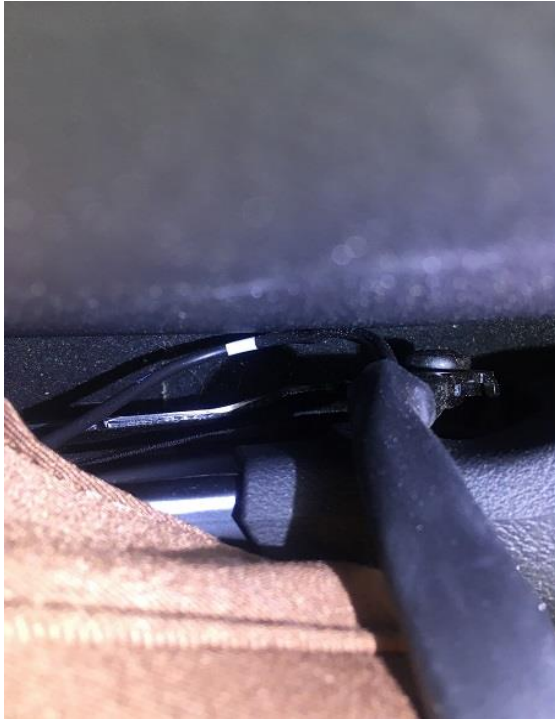
- Belt buckle wiring from buckle to seat frame (Figure 2).

**Figure 2.** Belt buckle wiring from buckle to seat frame.

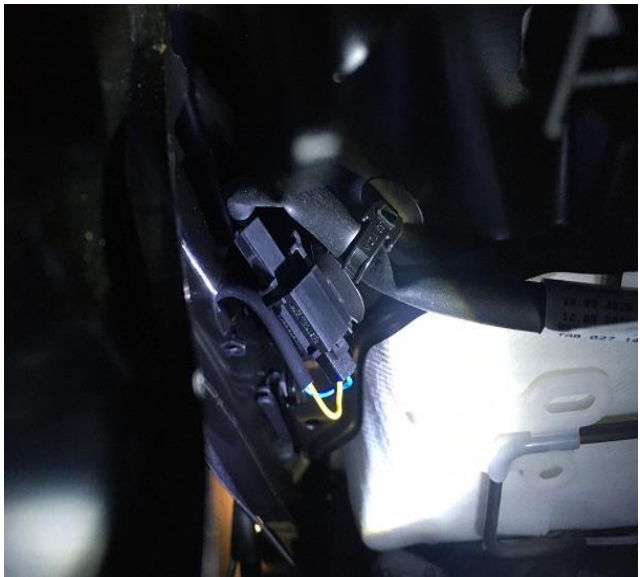
- Belt buckle wiring and connector on seat frame (Figure 3).

**Figure 3.** Belt buckle wiring and connector on seat frame.

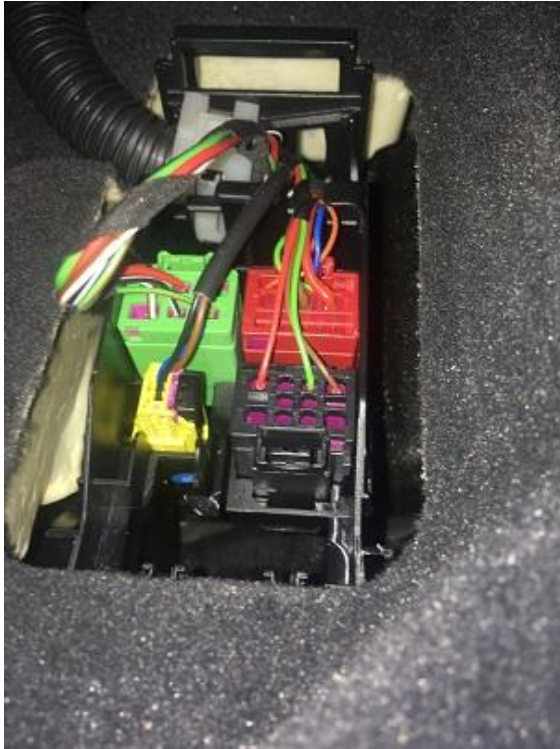
- Belt buckle wiring and connector in seat coupling point underneath seat (Figure 4).

**Figure 4.** Belt buckle wiring and connector in coupling station.
