| <b>HYUNDAI</b><br><b>Technical Service Bulletin</b> | GROUP<br><b>CAMPAIGN</b> | NUMBER<br><b>21-01-066H</b> |
| <b>SUBJECT:</b> THETA GDI ENGINE DTC P1326 - ENGINE INSPECTION / REPLACEMENT (SERVICE CAMPAIGN T3G) | | |

**Description:** Applicable vehicles with 2.0L T-GDI and 2.4L GDI engines may experience the Check Engine warning lamp illuminated with DTC P1326 and/or engine may exhibit Abnormal Noise or No Crank/No Start condition. Follow the procedure to inspect the vehicle and replace the engine or update the engine ECU software based on the inspection results.

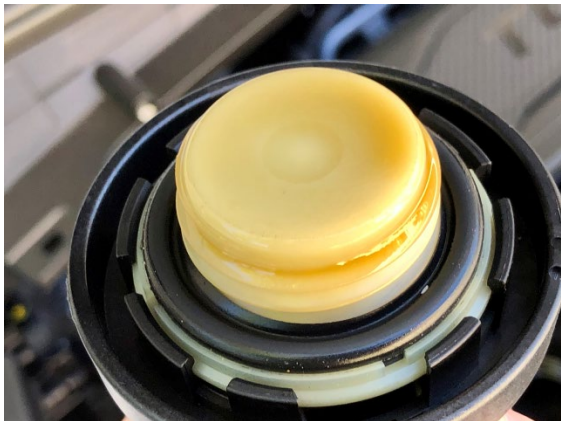
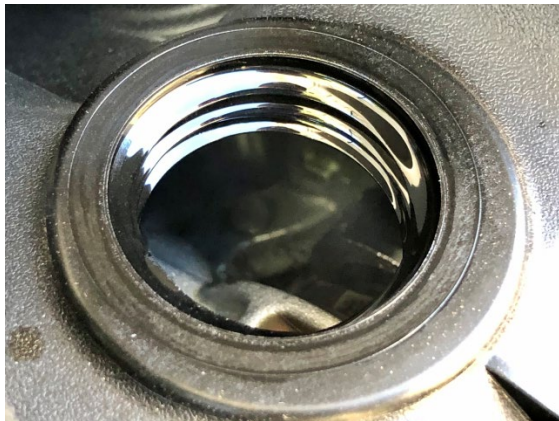
1. Scan for DTC P1326 using the GDS.
  - If DTC P1326 (or any other code) is present, take screenshot of Freeze Frame data for PA using GDS screen capture if any DTCs are present and proceed to Step 2.
2. Take pictures of the dipstick, engine oil filler cap, and inside the valve cover oil filler opening.
  - Using STUI on the GDS, take and submit pictures of the following with the VIN in the background of the photo (RO or last 6 digits written on paper). **VIN must be legible.**

| Oil filler cap: Clear view of cap underside | Oil filler opening: Clear view inside opening. |

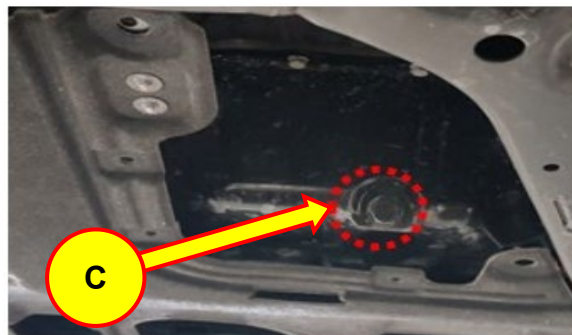
2. Lift up the vehicle and remove the oil drain plug (C).

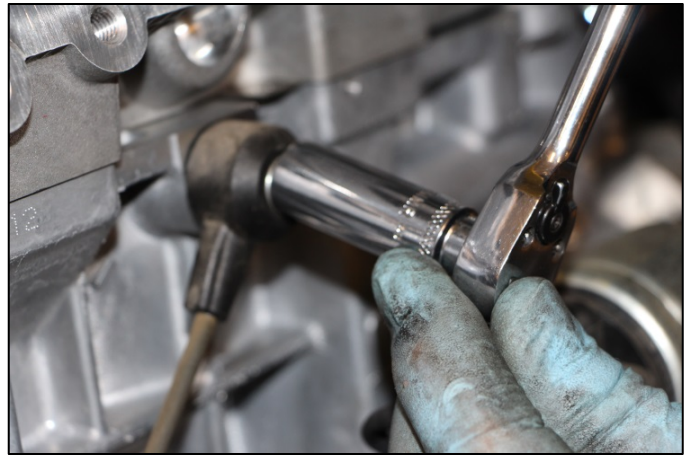
5. Remove and reinstall the engine knock sensor from the old engine to the new engine.

**Knock Sensor Fastener Tightening torque:**  
21Nm (15.5lb-ft)

Ensure the knock sensor is torqued to specification using a torque wrench.

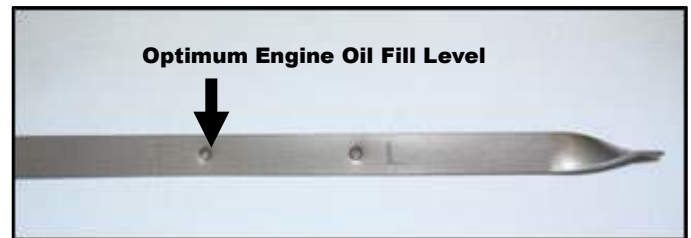
- ❖ Check for any leaks during this time.
- ❖ After the engine has warmed up to normal operating temperature, turn the engine off, wait a few minutes, and then **adjust the engine oil level to near the “F” mark as shown.**
