# Service Campaign T3G & Warranty Extensions TXXC/TXXI - ENGINE BEARING INSPECTION / ENGINE REPLACEMENT- Dealer Best Practice

Revised publication April 15, 2022

Certain vehicles with 2.0L T-GDI and 2.4L GDI engines may experience the Check Engine warning lamp illuminated with DTC P1326 and/or engine may exhibit abnormal noise or no crank/no start condition related to connecting rod bearing wear or damage. This Dealer Best Practice outlines the service procedure to inspect the vehicle and replace the engine or update the engine ECU software based on the inspection results, as well as related warranty coverage for the conditions outlined above.

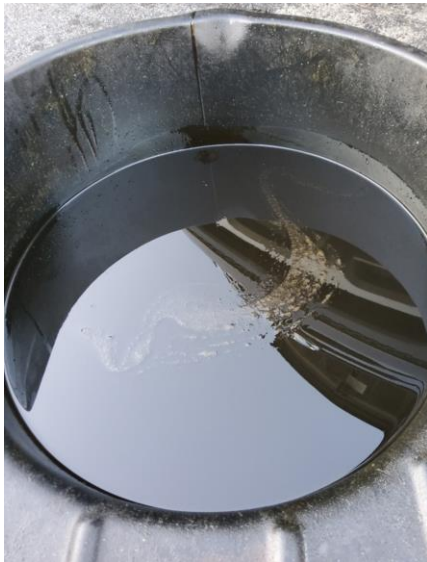
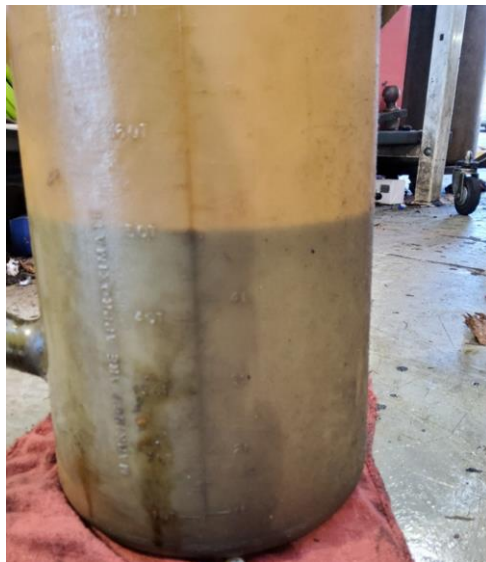
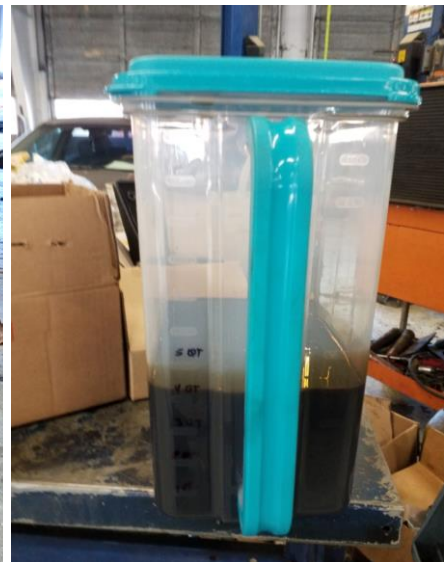
**Bad Oil Drain Photo (see below)**

### Example 1

### Example 2

### Example 3

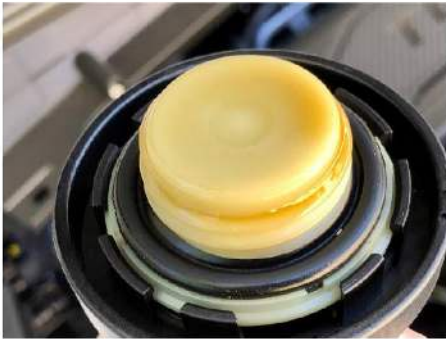
Oil filler cap: Clear view of cap underside

When submitting a picture of the oil cap, please include it with a picture of the repair order showing the last 6 digits of the VIN as seen below

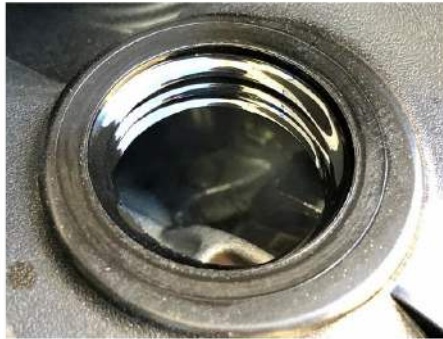
Oil filler opening: Clear view inside opening.
