| <b>HYUNDAI</b><br><b>Technical Service Bulletin</b> | GROUP<br><b>CAMPAIGN</b> | NUMBER<br><b>22-01-023H-1</b> |
| <b>SUBJECT:</b> DTC P1326 - ENGINE BEARING INSPECTION /<br>ENGINE REPLACEMENT (SERVICE CAMPAIGN T6G) | | |

**Description:** Certain vehicles listed below may experience the Check Engine warning lamp illuminated with DTC P1326 and/or an engine concern/noise related to connecting rod bearing wear or damage. Follow the procedure to inspect the vehicle and replace the engine and/or update the engine ECU software (if new ROM is available) based on the inspection results.

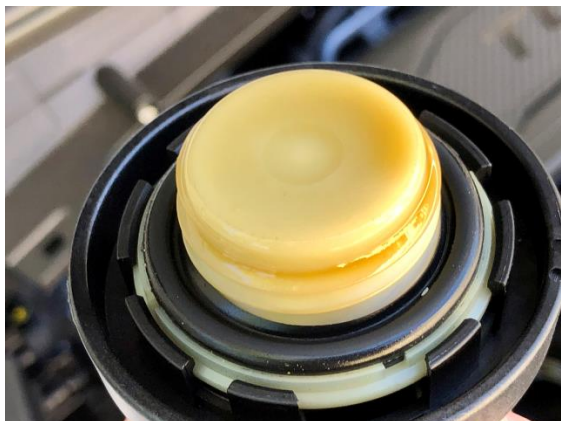
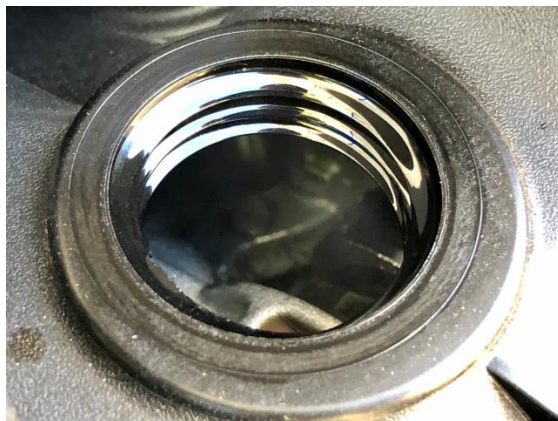
| <b>Oil filler cap:</b> Clear view of cap underside | <b>Oil filler opening:</b> Clear view inside opening. |

1. Scan for DTC P1326 using the GDS.
  - ❖ If DTC P1326 (or any other code) is present, take screenshot of Freeze Frame data for PA using GDS screen capture if any DTCs are present and proceed to Step 2.
2. Take pictures of the dipstick, engine oil filler cap, and inside the valve cover oil filler opening.
  - Using STUI on the GDS, take and submit pictures of the following with the VIN in the background of the photo (RO or last 6 digits written on paper). **VIN must be legible.**

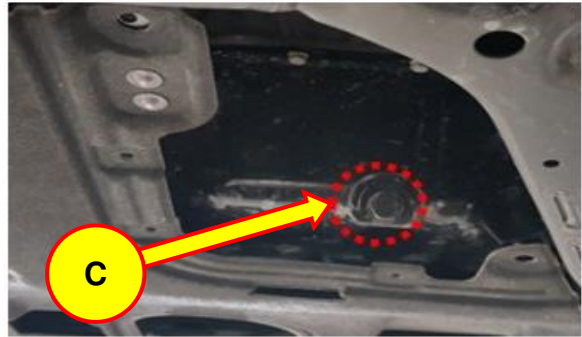
2. Lift up the vehicle and remove the oil drain plug (C).

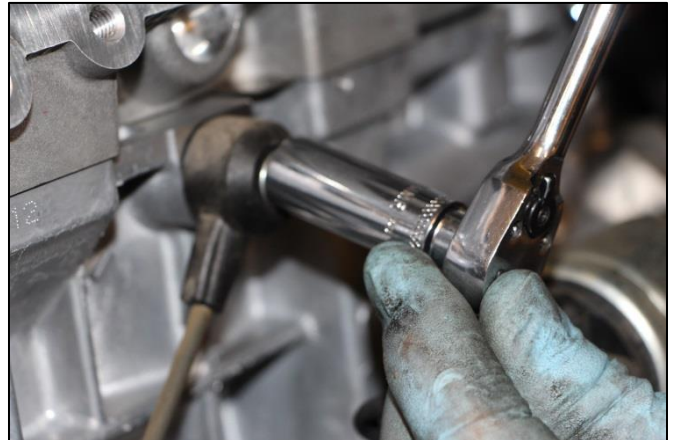
3. Remove and reinstall the engine knock sensor (if not newly supplied) from the old engine to the new engine.

**Knock Sensor Fastener Tightening torque:**  
21Nm (15.5lb-ft)

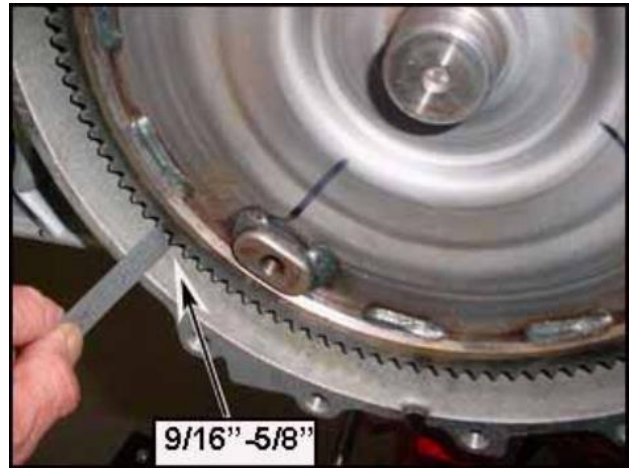
(For Automatic Transmissions equipped w/ torque converters only) If the torque converter has moved from the fully inserted position, carefully push inward and rotate the torque converter until the converter is recessed approximately 5/16" - 9/16" (8 -14 mm) into the transaxle case when reinstalling the automatic transaxle.

Check the depth of the torque converter to confirm it's fully installed in the transmission otherwise the oil pump may be damaged resulting in transmission failure.

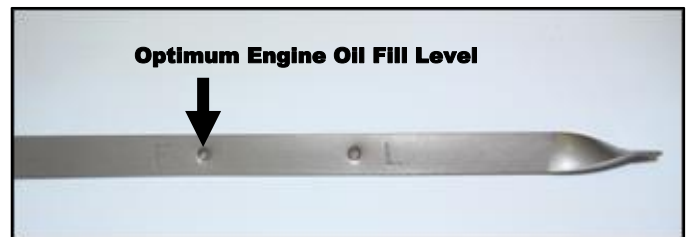
- Check for any leaks during this time.
  - After the engine has warmed up to normal operating temperature, turn the engine off, wait a few minutes, and then **adjust the engine oil level to near the "F" mark as shown.**
