# HYUNDAI

## Technical Service Bulletin

| GROUP<br><b>CAMPAIGN</b> | NUMBER<br><b>22-01-033H</b> |

**SUBJECT:** THETA GDI ENGINE DTC P1326 - ENGINE BEARING  
INSPECTION / REPLACEMENT (SERVICE CAMPAIGN T3G)

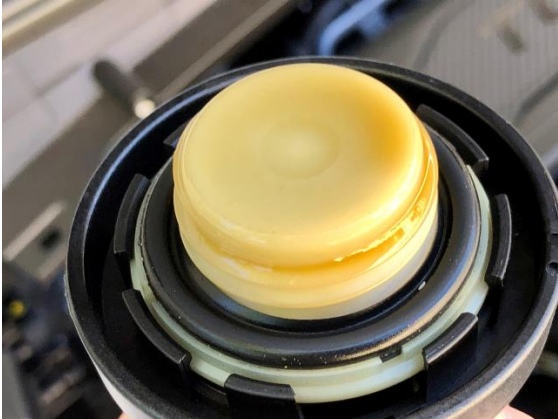
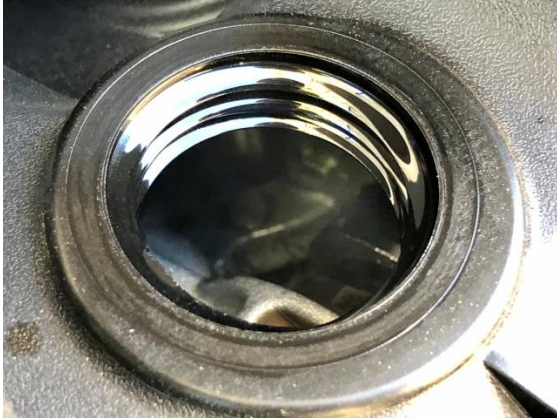
| Oil filler cap: Clear view of cap underside | Oil filler opening: Clear view inside opening. |

1. Check ROM ID to take a screenshot and scan for DTC P1326 using the GDS.
  - If DTC P1326 (or any other code) is present, take screenshot of Freeze Frame data for PA using GDS screen capture if any DTCs are present and proceed to Step 2.
2. Take pictures of the dipstick, engine oil filler cap, and inside the valve cover oil filler opening.
  - Using STUI on the GDS, take and submit pictures of the following with the VIN in the background of the photo (RO or last 6 digits written on paper). **VIN must be legible.**

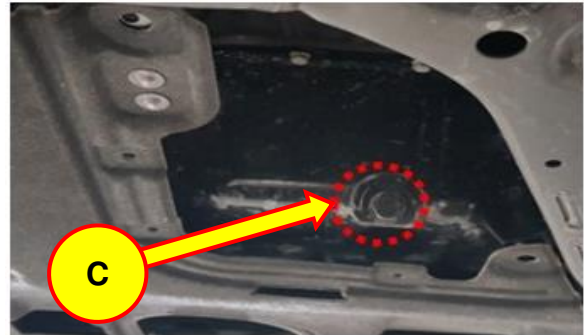
2. Lift up the vehicle and remove the oil drain plug (C).

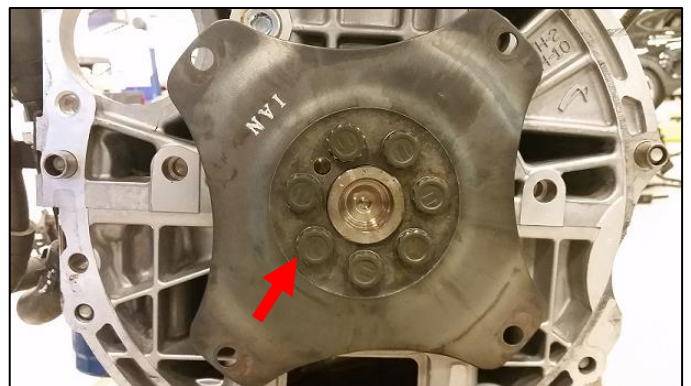
7. Inspect inside the drive plate mounting holes at the crankshaft flange to determine whether it is **drill-through** type or **pocket** type.

- ❖ If crankshaft is **drill-through type**, then follow the **NOTICE** below to **apply thread-locking sealant** to all the threads of the drive plate bolts before tightening.
- ❖ **Drive Plate Tightening torque:**  
111.7 ~ 127.5 Nm (86.8 ~ 94.1 lb-ft)

If the crankshaft has drill-through type drive plate mounting holes, then thread-locking sealant must be used to prevent any oil seepage through the (7) drive plate bolts.

- Apply on all threads a low/medium strength thread-locking adhesive that seals fasteners and are tolerant to engine oil.

[Suggested Products] ThreeBond 2403, LOCTITE 200, LOCTITE 204, LOCTITE 243 (or equivalent)

- Be sure to lightly brush all the bolt threads free of debris/residue and clean off any oil prior to applying the thread-locking sealant for installation.

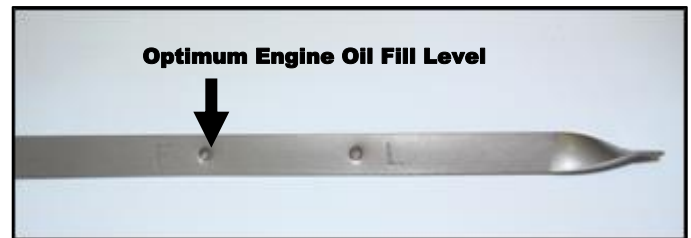
- ❖ Check for any leaks during this time.
- ❖ After the engine has warmed up to normal operating temperature, turn the engine off, wait a few minutes, and then **adjust the engine oil level to near the “F” mark as shown.**
