**August 30, 2022**

## MIL Comes On with DTC P2422

### AFFECTED VEHICLES

| Year | Model | Trim | VIN Range |
|---|---|---|---|
| 2017– 22 | Ridgeline | ALL | ALL |

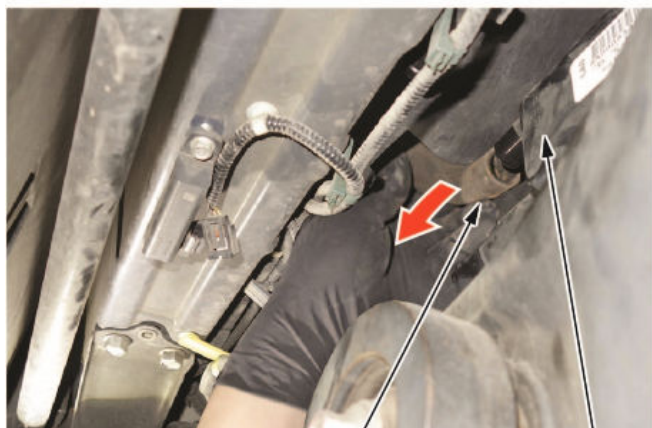
Disconnect the rubber drain tube. EVAP CANISTER

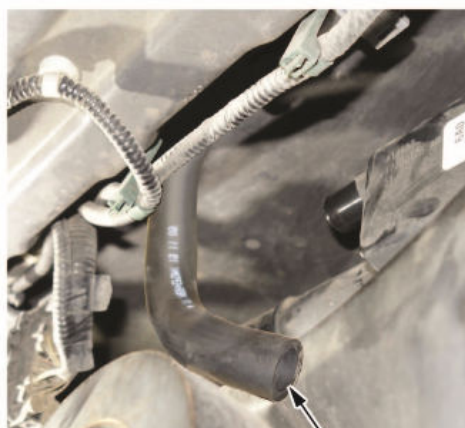
Inspect for dirt or dust.

- For 2WD vehicles, if the drain tube has any dust or dirt inside it, go to REPAIR PROCEDURE A.
- For AWD vehicles, if the drain tube has any dust or dirt inside it, go to REPAIR PROCEDURE B.
