September 22, 2022

Version 3

## MIL Is ON with DTC P0455

Supersedes 21-007, dated September 2, 2022, to revise information highlighted in yellow.

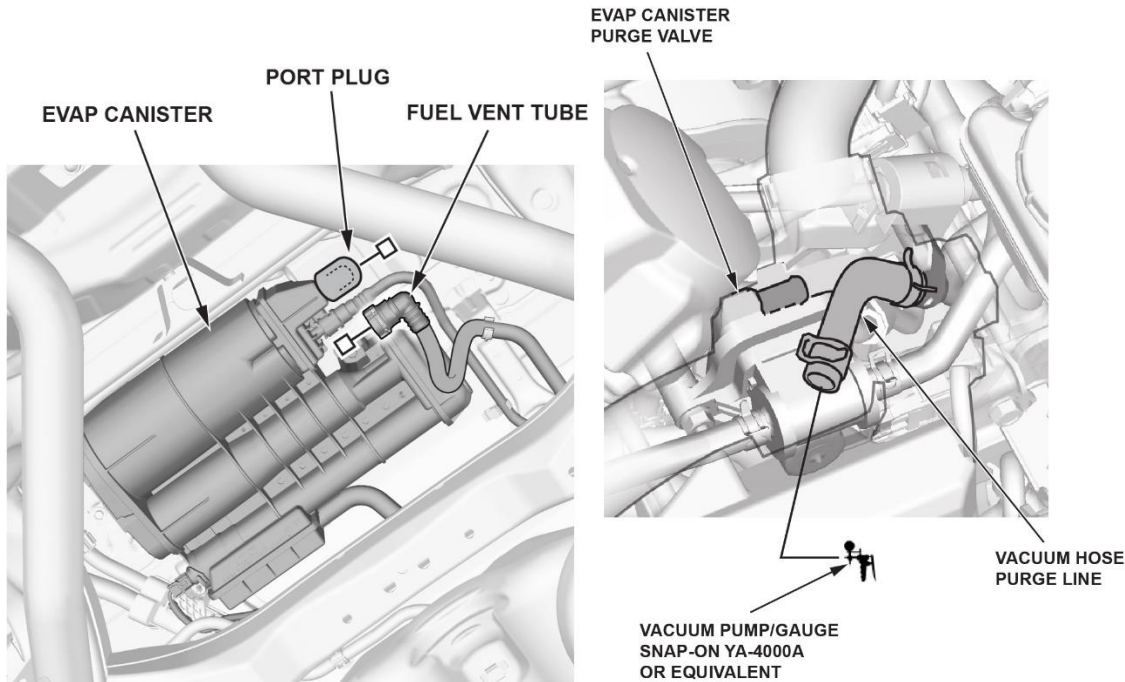
11. Check for a poor connection or damage on the fuel fill pipe and the fuel tank vapor recirculation tube.

- If the connections are ok and there are no damages, the system is normal. Reconnect the fuel vent tube and the vacuum hose purge line. Go to REPAIR PROCEDURE.
- If there are any damages or loose connections, this bulletin does not apply. Continue with normal system troubleshooting.

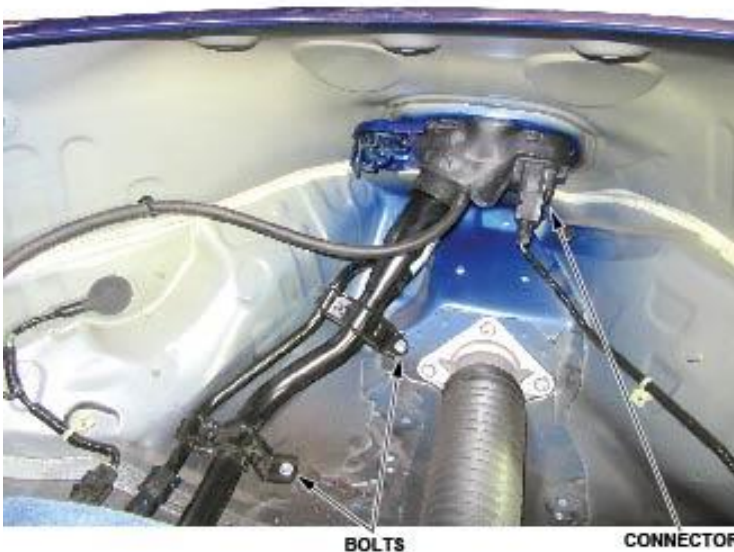
6. Unclip the fuel filler adapter assembly from around the filler door hinge.

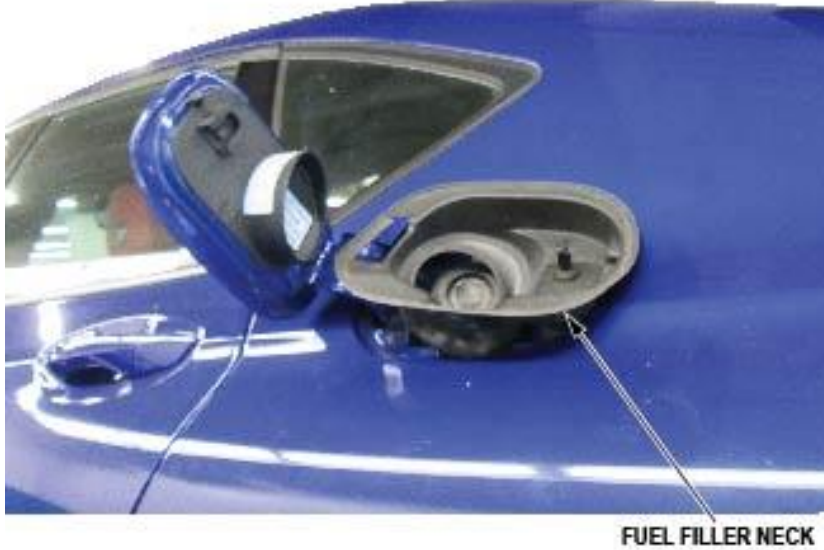
7. Pull away the filler neck adapter assembly (no need to fully remove).
8. Remove the fuel filler pipe assembly by releasing the retainer tabs on the clips that release them from the locking tabs.
