## Climate control system improper operation with fault codes B10A207, B105C07, B109F07 and/or B113600 in ACC control unit

| Topic number | LI83.10-N-071291 |
| Validity | Model 907 |

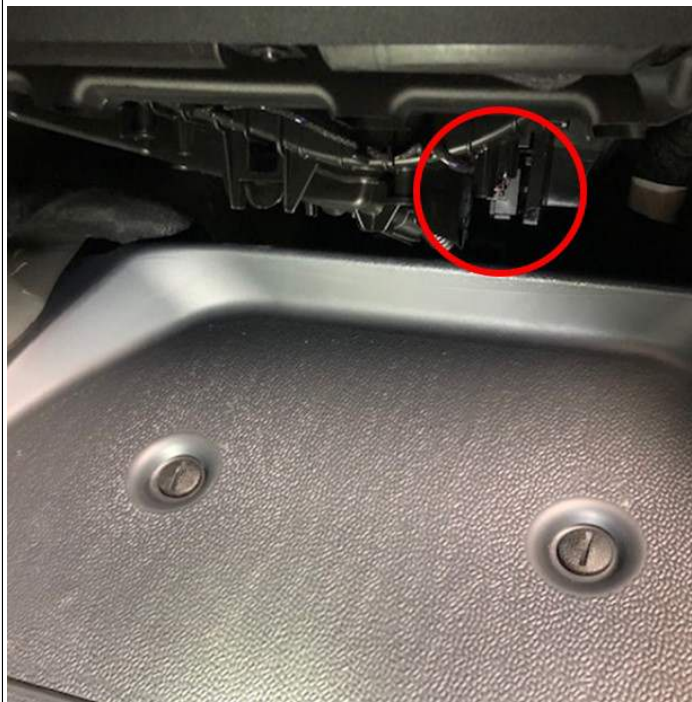
| Attachments | |
|---|---|
| <a href="#">remedy 2 motor location.jpg</a> | Air recirculation flap actuator motor |

- 3.Remove all three front ac stepper motors. While removed, check linkage manually for proper movement (if concern is related to temperature, please make sure temperature is achievable by manually moving the blend linkage)
- 4.Reinstall stepper motors (torque stepper motors to case at 1.8Nm)
- \*\*\* Follow correct torque to prevent binding of stepper motors\*\*\*
- 5.Connect XENTRY diagnosis and perform teach-in then normalization of stepper motors.
- If normalization is unsuccessful, continue to Remedy 2.

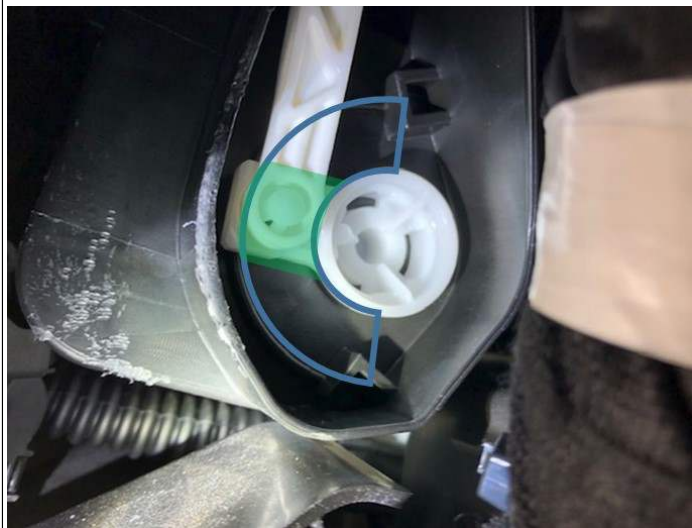
| <a href="#">remedy 2 linkage orientation.jpg</a> | Linkage orientation |
