## Technical product information

| <b>Topic</b> | Coolant leaking from the mechanical coolant pump - Low coolant level warning - Engine overheating - DTC's evident |
| <b>Brand</b> | Bentley |
| <b>Transaction No.</b> | 2065919/6 |

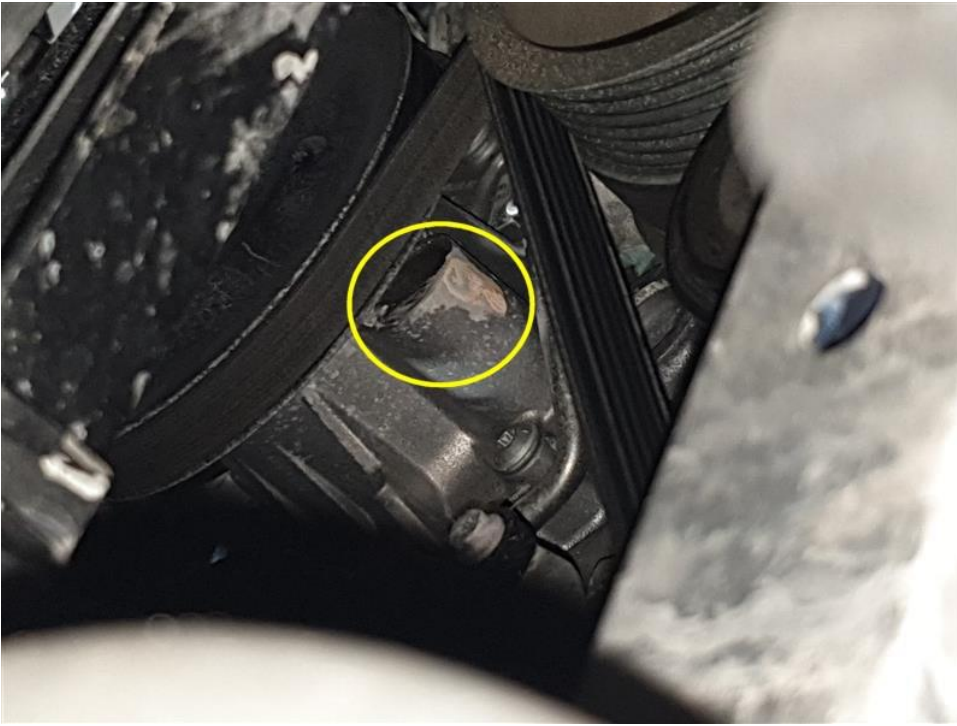
Figure 2

Refer to the video located within the Bentley Hub reference TPI 2065919/- this video shows an example of a coolant pump with no leak although there is a small coolant witness mark evident (Figure 2) in this scenario the coolant witness mark should be cleaned off (using a suitable cleaning agent) to the condition shown in Figure 3

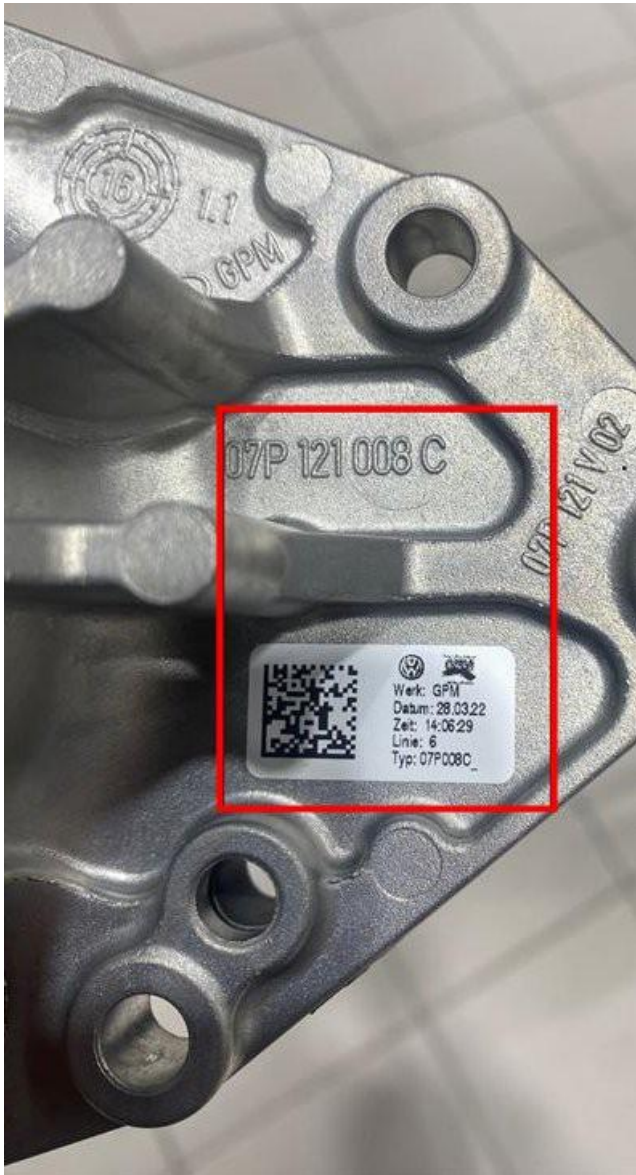
NOTE: The photo shown in Figure 4 is a C level coolant pump (shown removed from the vehicle for photographic purposes) a borescope may have to be used for photos of the coolant pump when fitted

- Use a Mityvac or similar vacuum tool to check and confirm there are no vacuum related issues/leaks present within the system to check and confirm if N492 is sticking open and supplying a constant vacuum
- The operative must raise a technical DISS query or respond via an already open DISS query to request permission to replace the mechanical coolant pump ensuring the following is attached to the DISS query:
- Clear photo of the coolant level
- Clear photo of the original mechanical coolant pump part number **07P 121 008C** (Figure 4)
- Video of the coolant leak whilst carrying out the pressure test
- Current ODIS log

- Once permission has been given via the technical DISS query, replace the following
- Mechanical coolant pump - Rep.Gr 19
- Solenoid for coolant circuit N492 assembly - Rep.Gr 19
