# Service Bulletin

Bulletin No.: 20-NA-130

Subject: Information on Message Illuminated in DIC, DTC B094C (39) Set

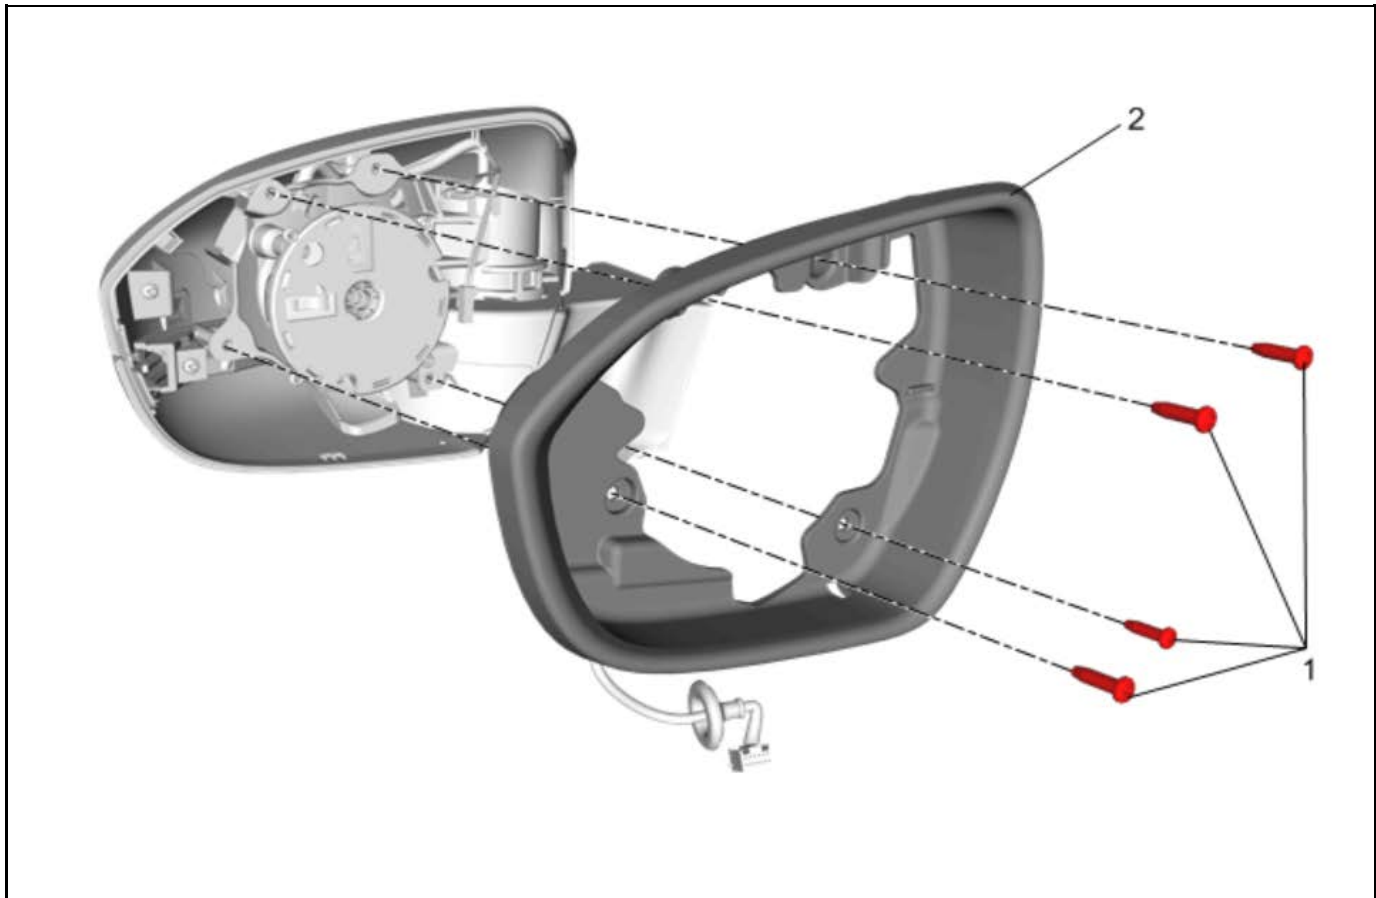
4533897

1. Remove the affected outside rearview mirror housing bezel (2). Refer to Outside Rearview Mirror Housing Bezel Replacement in SI.

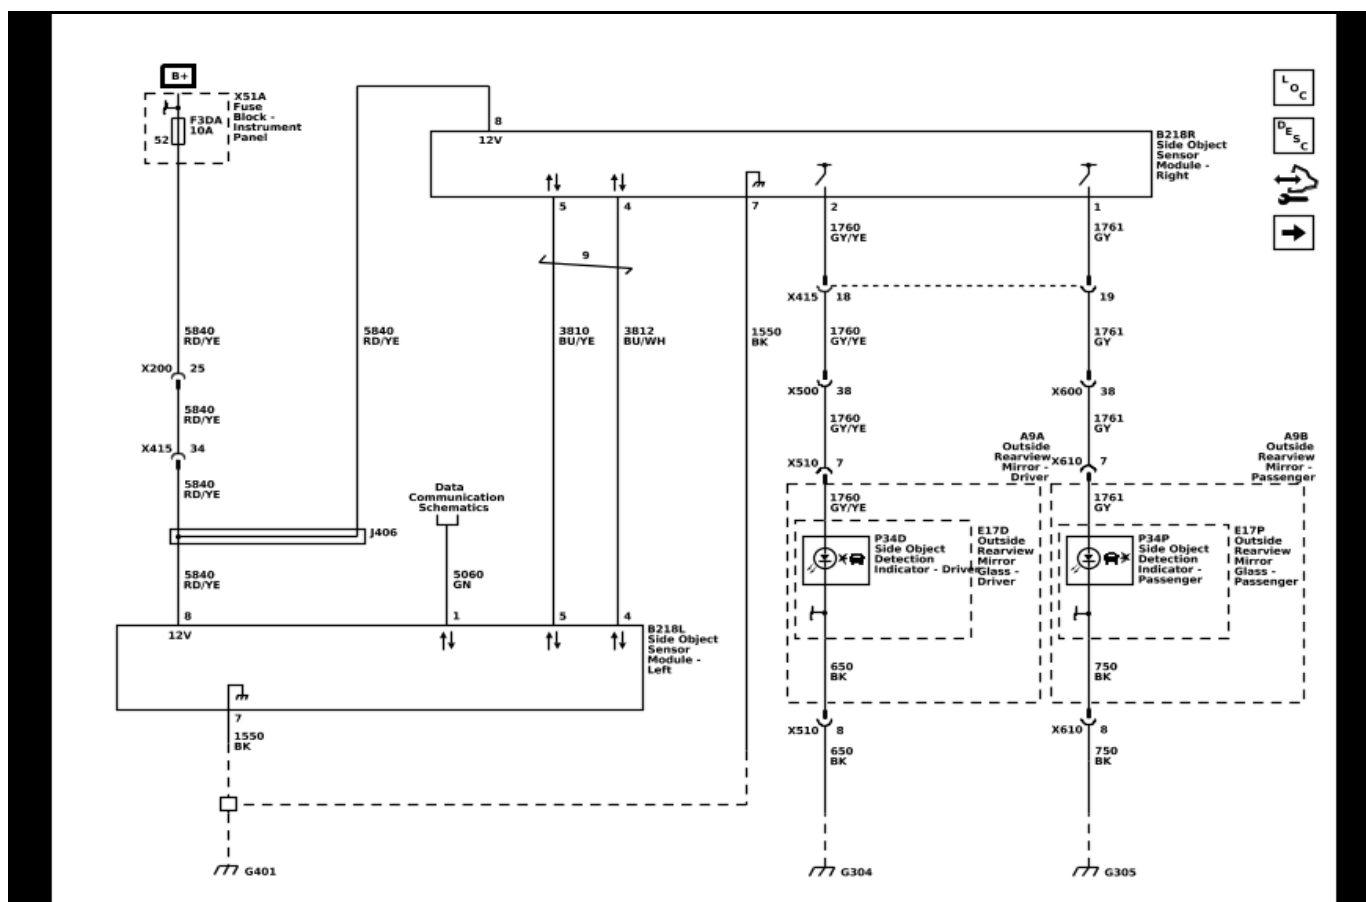
4811651

2. Inspect the LED circuit in the mirror for corrosion. Refer to Rear Cross Traffic Alert (UFG) and Side Object Detection (UKC) (Document ID #4817118) in SI.
  - " If any corrosion IS found, it will be necessary to replace the mirror assembly. Refer to Outside Rearview Mirror Replacement in SI.
  - " If NO corrosion is found, reinstall the mirror and follow the DTC B094C (39) diagnostics referenced in SI.
