# Service Bulletin

Bulletin No.: 22-NA-248

Subject: HVAC Heat Intermittently Inoperative, DTCs B2B05 and/or B2B06 Set

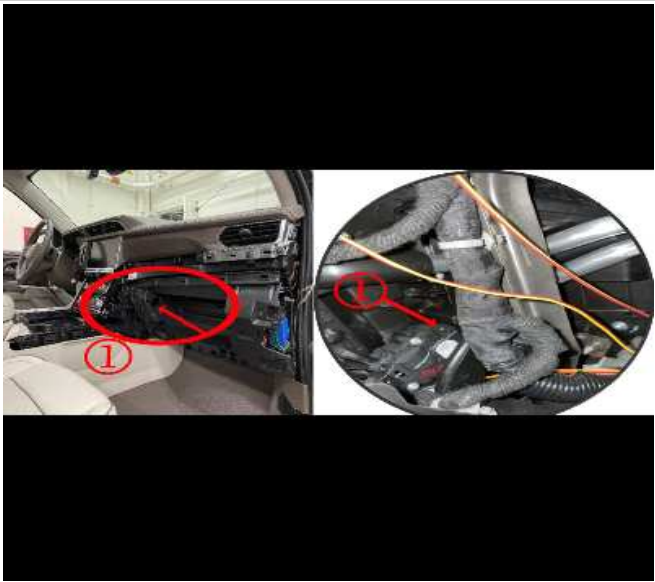
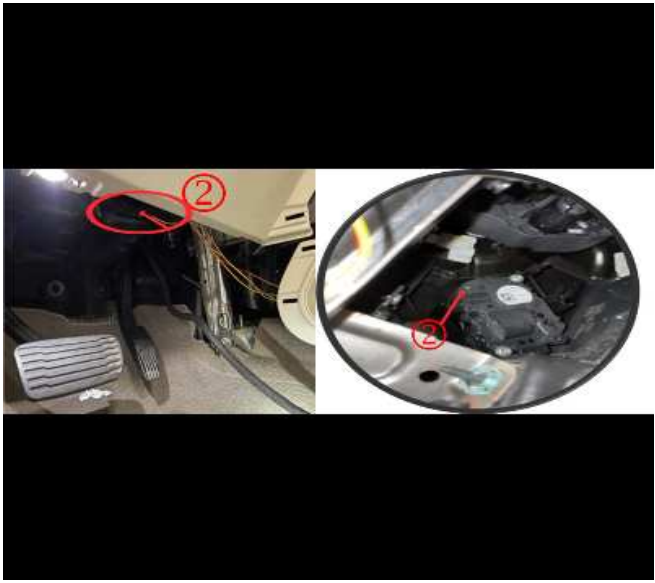
| Condition | Some customers may comment on the HVAC heat intermittently inoperative.<br>Technicians may find one or both of the following DTCs set in the BCM.<br>" B2B05 - HVAC Temp Motor - Front 1 Performance<br>" B2B06 - HVAC Temp Motor - Front 2 Performance |
| Cause | The condition may be caused by a mismatch of B020 firmware and B018 parameters. |

| <p>Correction</p> | <div data-bbox="683 153 1333 730"></div> <div data-bbox="1419 739 1482 758"><p>6213239</p></div> <div data-bbox="683 772 1333 1350"></div> <div data-bbox="1419 1358 1482 1377"><p>6213261</p></div> <p>Visually inspect the right side temperature valve actuator (1) and the left side temperature valve actuator (2) for a yellow dot, as shown in the pictures above, that indicates the parts were manually re-flashed. If the yellow dot is present, replace the temperature valve actuator.</p> |

Refer to Temperature Valve Actuator Replacement in SI.
