PIP5889A Diagnostic Tip: DTC P0299 Set As Current Or In History Models

| Condition: | DTC P0299 set as current or in history |
| Cause: | Possible Charge Air Bypass Valve sticking open intermittently. |

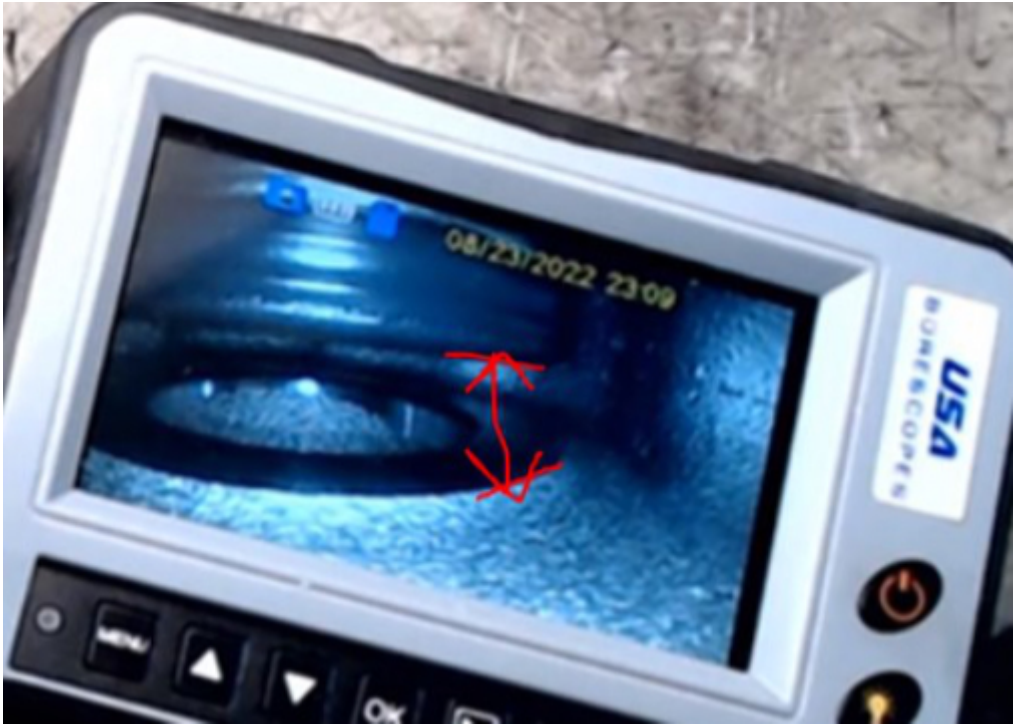
The bore scope picture below is showing the Charge Air Bypass Valve in a stuck open position.

If the Charge Air Bypass Valve is found to be stuck open or is causing an intermittent DTC p0299 replace the Charge Air Bypass Valve using current service parts listed in EPC.

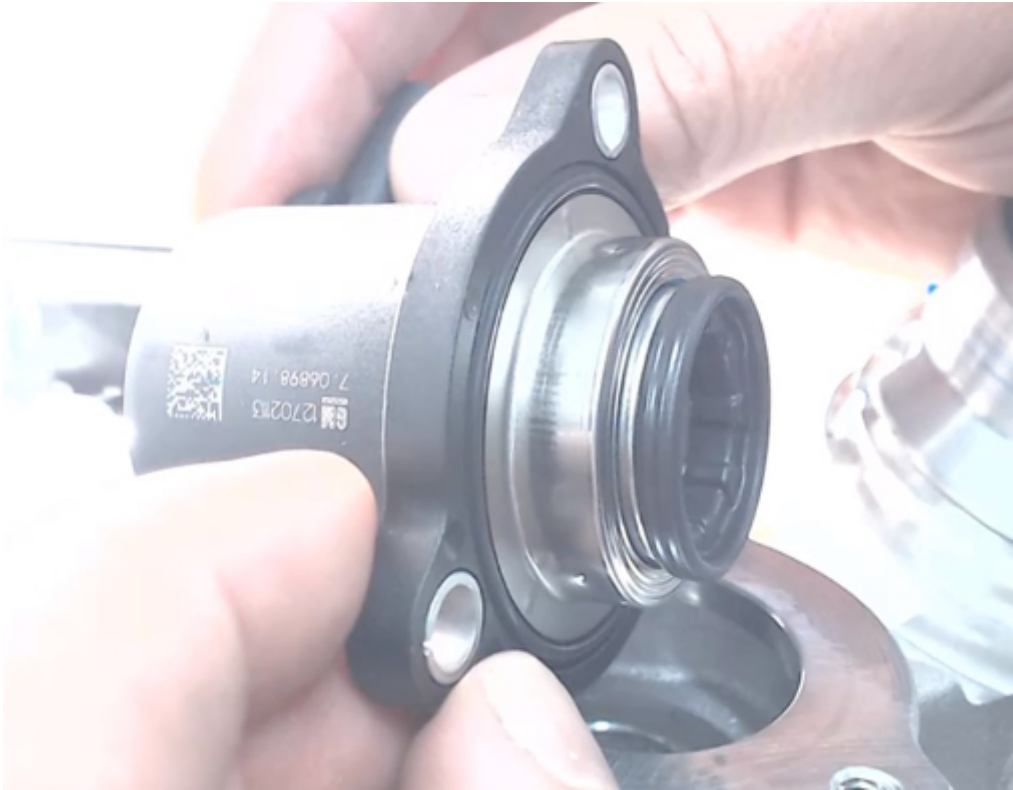
Picture below shows Charge Air Bypass Valve in stuck open position (plunger fully retracted)

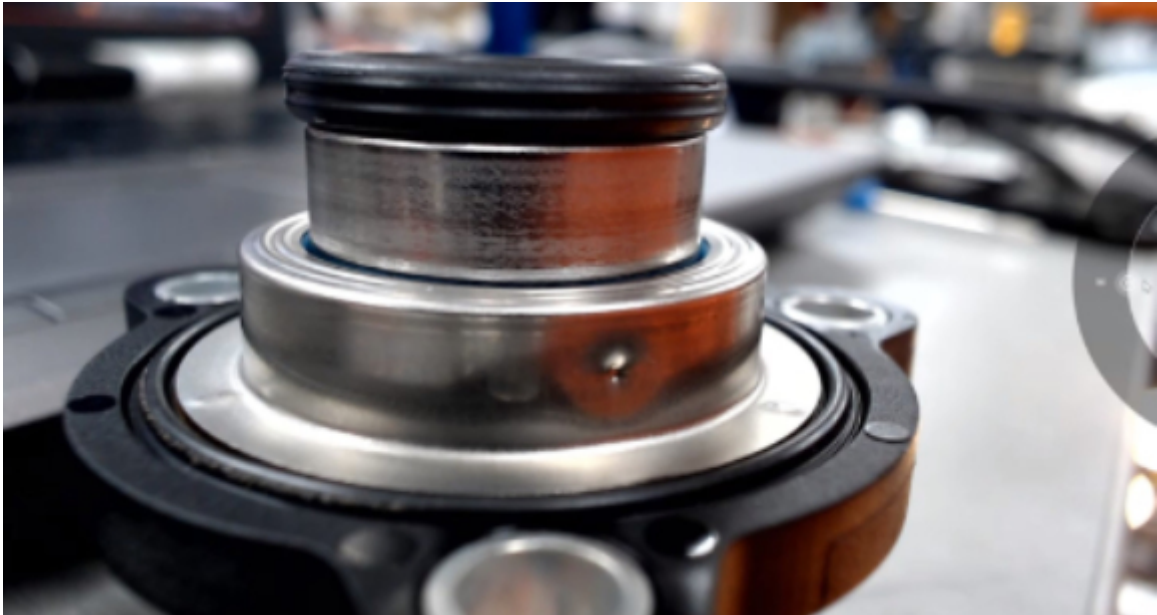
Picture below shows Charge Air Bypass valve fully extended or closed position
