# Technical Service Bulletin

## 69 Airbag warning light on, DTC B1225F1 stored in the airbag control module

69 23 90 2051242/7 June 2, 2023. Supersedes Technical Service Bulletin Group 69 number 22-86 dated May 4, 2022, for reasons listed below.

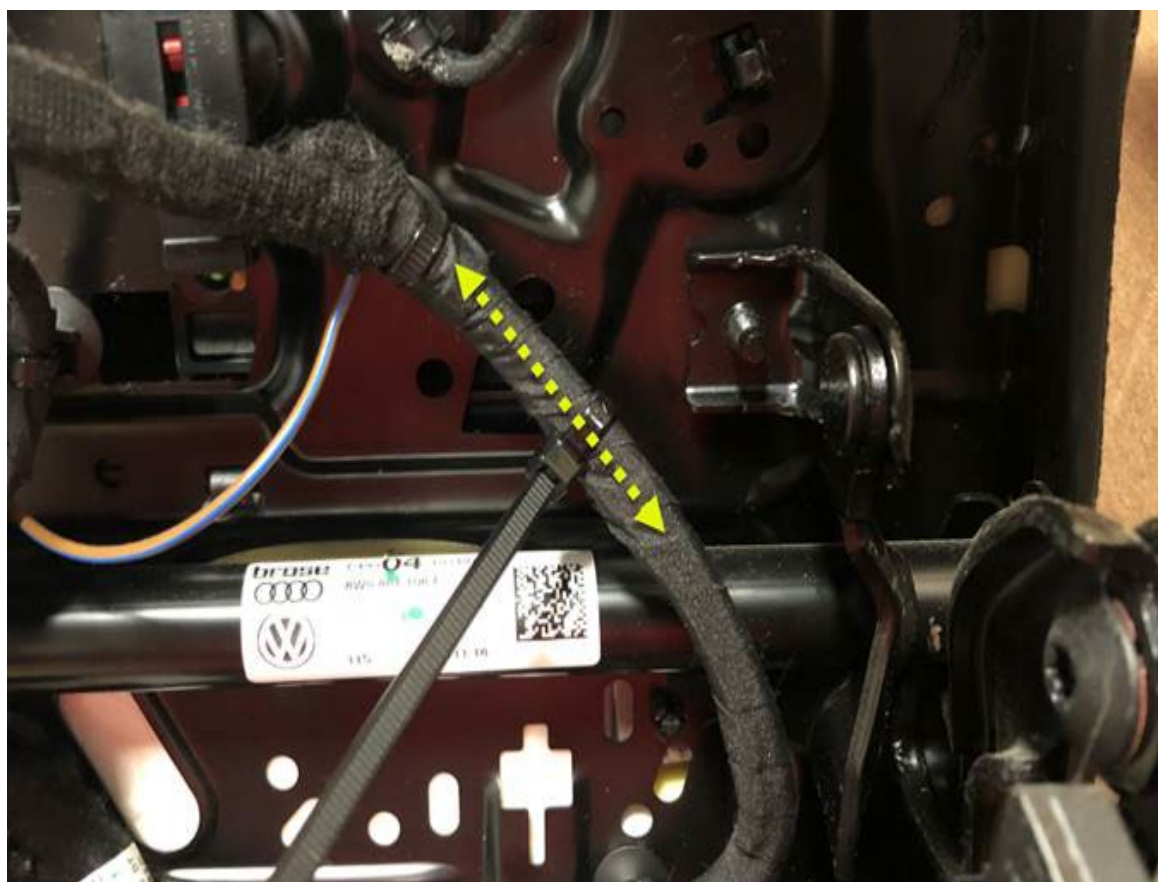
2. You will attach the first cable tie in the yellow marked area on the harness between the cable tie clip and the crossbar tube as shown below (Figure 2).

**Figure 2.** Attach the first cable tie in the yellow area.

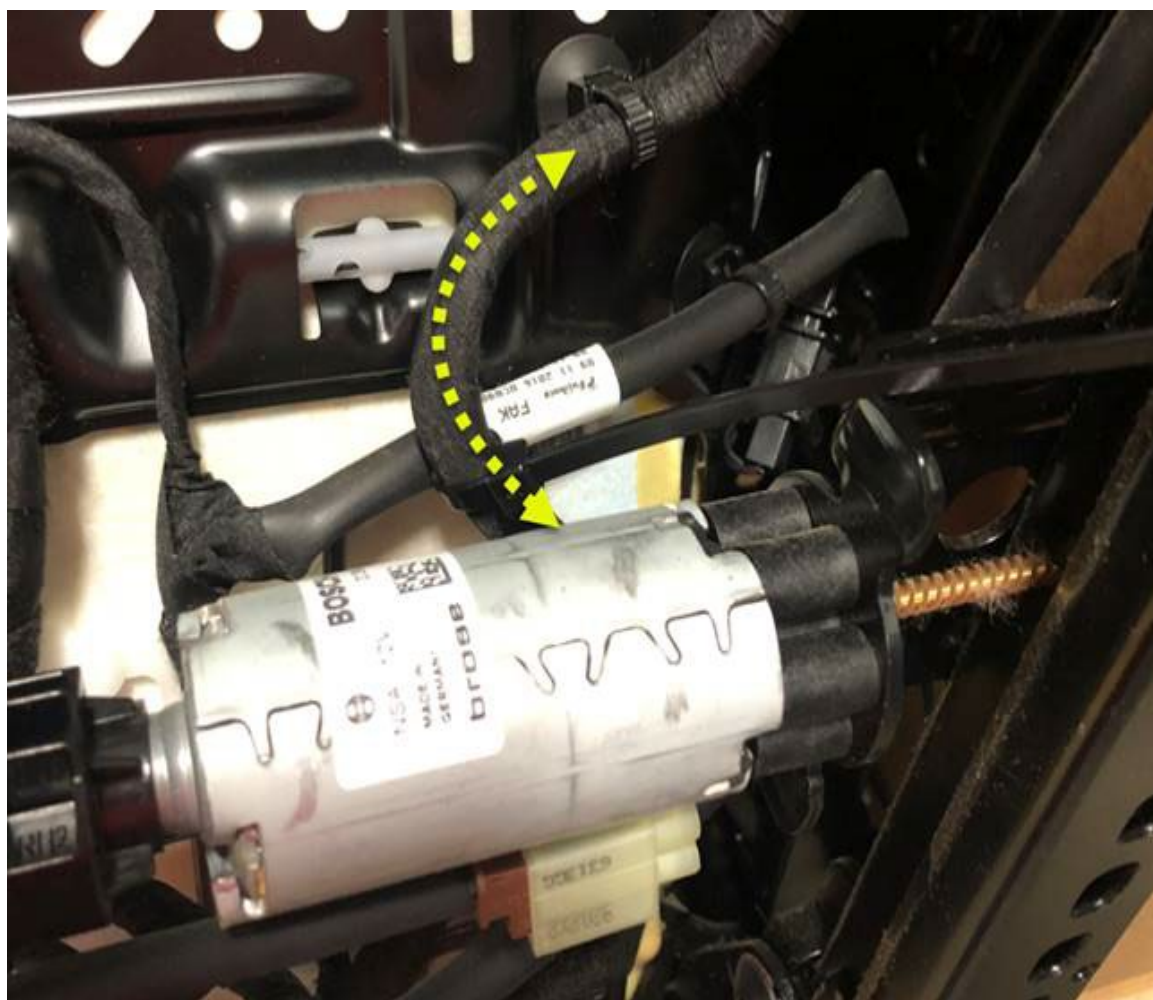
3. The second cable tie position is to the rear of the crossbar tube where the harness drops down from the frame. Place the cable tie in the yellow marked area shown below (Figure 3).

**Figure 3.** Attach the second cable tie to the yellow marked area.

When tightening the cable ties, only tighten them with your hands, do not use any tools to tighten the cable tie as this can damage the harness. Check that the cable ties cannot be rotated on the harness by hand, to ensure that proper tension is achieved. Then cut off the excess length from the tie wrap.
