# Technical Service Bulletin

**01 MIL on, DTC P040100 is stored in the ECM - TDI**

01 23 60 2064398/1 July 7, 2023.

| Model(s) | Year | VIN Range | Vehicle-Specific Equipment |
|---|---|---|---|
| A3 Sportback | 2010 - 2013 | Not Applicable | TDI |

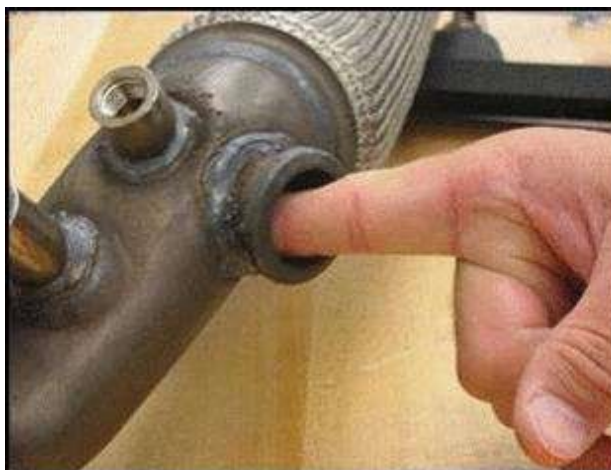
*Figure 1. Checking for carbon.*

1. Remove the EGR filter from the Diesel Particulate Filter (DPF) and swipe the inside of the exhaust pipe at the EGR filter connection point using a clean cloth or your finger.

2. If your finger or the cloth comes out with black soot:
  - Replace the DPF & EGR filter together. **The engine must be running correctly with no faults stored to perform the next steps.**
  - **Read out 01 ECM control module OBD Basic Settings block 67 with engine at idle and at operating temperature. Select activate and monitor field 3 when EGR is in OFF position.**
  - **If the MAF actual value is equal to or greater than 540 mg/h, proceed to smoke testing below (there is likely a leak within the intake system).**

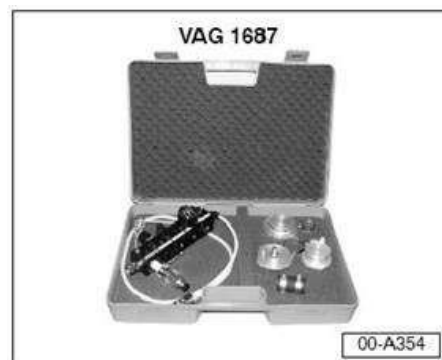
1. The charge air pressure system can be checked using the VAG 1687. Charge air system tester along with the VAG1687/10 adapter as follows:

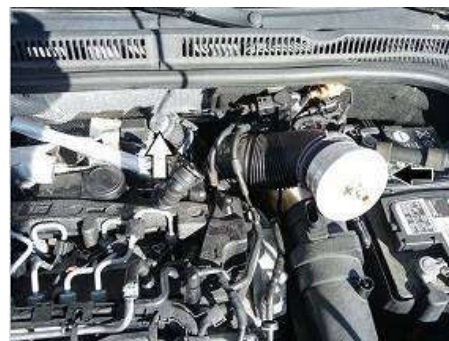
## 3. Special tool VAG 1687/10 pressure adapter, installing.

- Separate intake hose from the Mass Airflow Sensor assembly (MAF).
- Insert VAG 1687/10 pressure adapter in intake hose -black arrow- using existing clamp (as shown).
- Remove crankcase ventilation valve or tube from intake hose at -white arrow-.
- Plug hose with appropriate metal plug and hose clamps supplied with VAG 1687 special tool kit at -white arrow-.

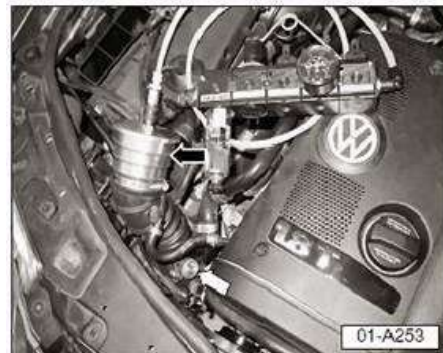
## Special tool KLI9210 (EVAP system leak detector)

- Install optional fitting KLI 9210/50 on hose of special tool KLI9210.
- Connect KLI9210 to VAG 1687/1 adapter (KLI 9210 is shown attached to VAG1687/1 at arrow on 1.8L Turbo).

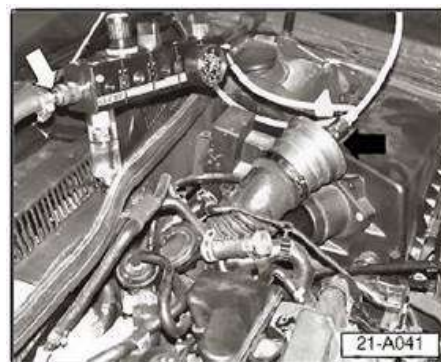
## **Special tool VAG 1687 connecting to pressure adapter 1687/10**

- VAG 1687 is shown connected to VAG 1687/10 (black arrow).
- Shop air supply connected to VAG 1687 at (white arrow).
- Perform pressure test.
