# Technical Service Bulletin

**SEAT WARMER DOES NOT OPERATE WHEN TURNING IGNITION ON WHILE CABIN TEMPERATURE AND/OR SEAT IS WARM**

**Bulletin No.: 09-012/23**

2019-2023 Mazda3 (Japan built) vehicles with VINs lower than JMI BP\*\*\*\* \*\* 604379 (Produced before Oct. 1, 2022)

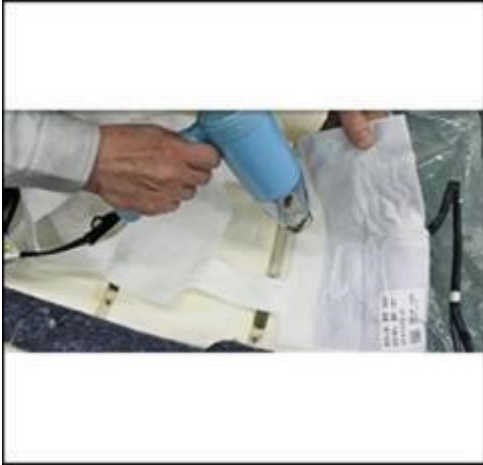
3. Replace the seat warmer unit of the seat cushion side according to the following steps.
- a. Remove the heater mat gently while using a hair dryer or an iron to warm up the adhesive parts (1).

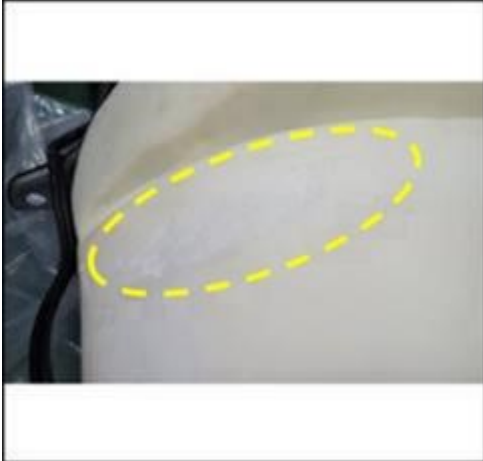
**NOTE:** If the adhesive surface is not warmed up sufficiently, the urethane pad may be damaged (example image below).

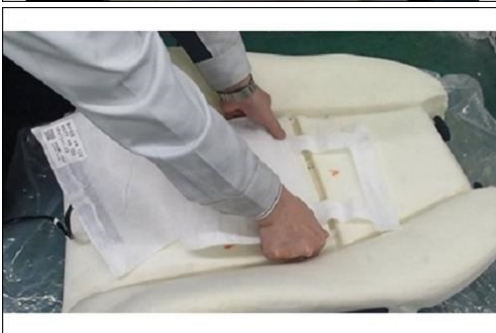
**NOTE:** Location of the markings of the urethane pad

c. Remove the three release papers on the seat warmer unit, and then apply it to the the urethane pad according to the markings on the pad (Refer to the procedure below).

**NOTE:** Align with the seat warmer and the markings on the urethane pad.
