2019-2020MY  
Optima P/HEV (JF P/HEV)  
w/Nu 2.0L GDI

PI2108Y/Z

August 2023

ENGINE REPLACEMENT INSTRUCTIONS  
FOR DTC P1326 (PI2108Y/Z)

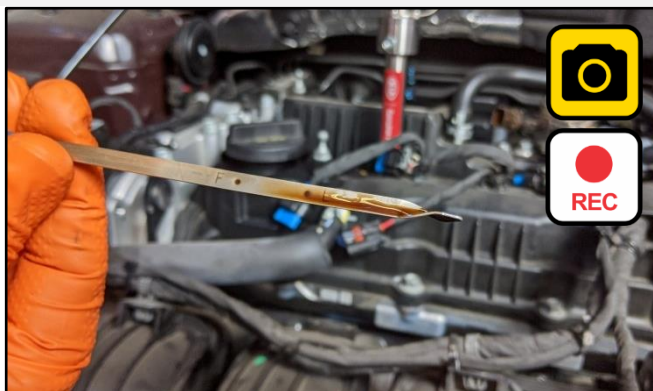
1. Start video showing vehicle and move in towards the dash VIN tag.
2. Measure and record oil dip stick level.
3. Note oil dip stick reading on the RO.
4. Take a picture of the oil reading on dipstick.
5. Inspect the inner/bottom of the oil cap and inside oil filler opening.

**Record/Note findings:** Oil sludge, varnish, burnt oil smell condition(s) found.

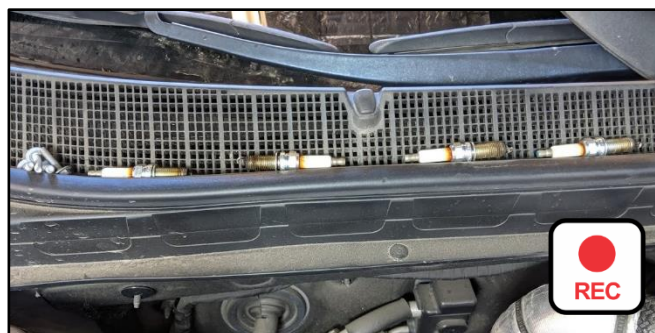
2. Show the removed spark plugs.

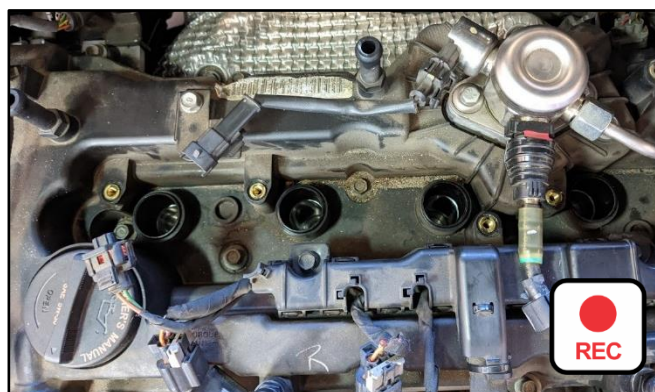
3. Show the empty spark plug holes from the engine.

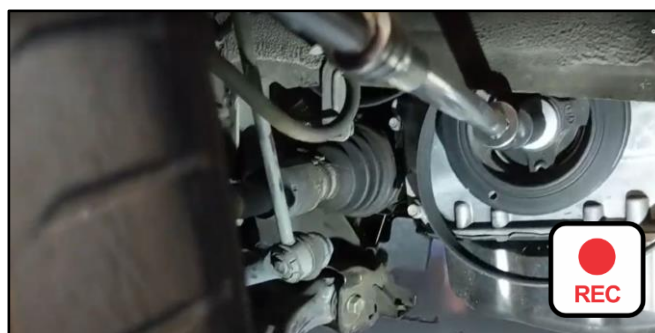
5. Show the removed drive belt and attached torque wrench to crank bolt.

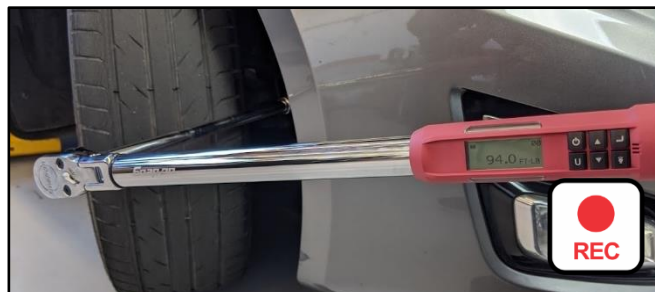
6. Show the engine being cranked and torque specification exceeding 94 lb.ft. torque.

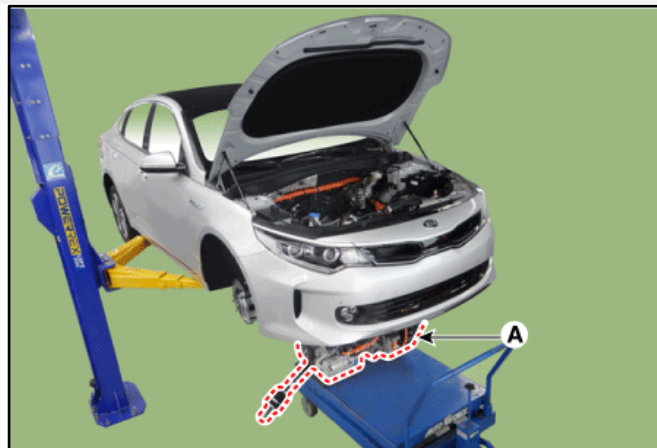
1. Replace the engine assembly by referring to the "Engine Mechanical System → Engine And Transaxle Assembly → Engine And Transaxle Assembly → Repair Procedures" chapter in the applicable Shop Manual on KGIS.

Refer to [TSB ENG190](#) for information regarding engine replacement practices.
