# Technical Service Bulletin

## 93 Charging door does not open when button pressed - B1A8FF0, B1A89F0, B1A8AF3, B1A88F3

93 23 28 2071343/1 September 13, 2023.

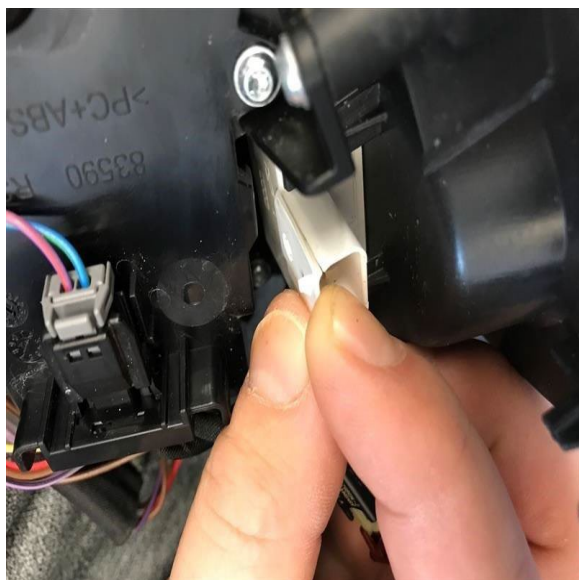
Quality issues in the production process may lead to a crack in the connector point of the charging indicator (Figure 1). Moisture can reach the contact pins in the charging indicator connector via this crack. As a result, a bypass can occur between the ground contact pin and the LIN contact pin. This leads to a communication fault between the components of the charging door and the charging unit for high-voltage battery. In this circumstance, the electric operation of the charging door does not work.

**Figure 1:** Crack in the connector point of the charging indicator.

3. Check the connector point on the charging indicator for cracks (Figure 1).

If the connector point is cracked or the pins are oxidized (Figure 7), replace the damaged charging door unit as described under the heading **“Removing and installing charging door unit”** below.

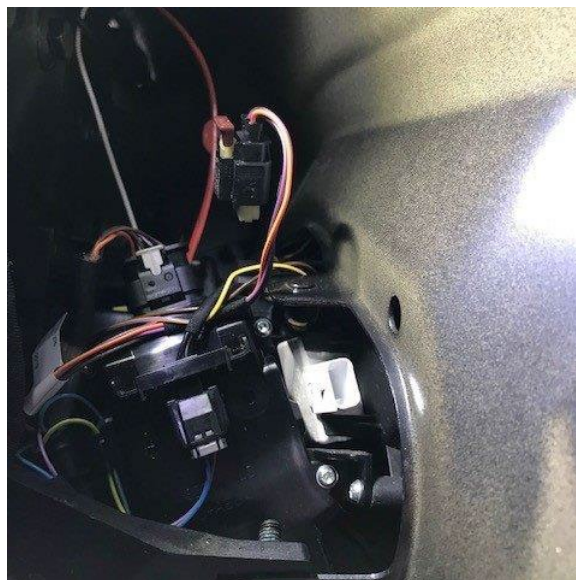
1. Unplug the connector from the charging indicator (Figure 4).

*Figure 4: The connector has been unplugged.*

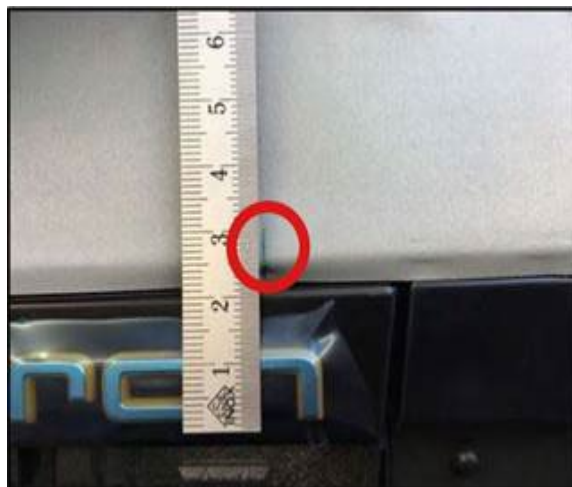
2. Open the charging door, and mask off the upper section of the charging door with adhesive tape (see Figure 12).
3. Close the charging door and mark at the middle of the “n” of the “e-tron” emblem (driver’s side). The mark should be made vertically on the adhesive tape (Figure 10).

**Figure 10:** Make a vertical mark in the middle of the “n” of the e-tron emblem.

For a charging door unit on the right (passenger) side of the vehicle, make a mark at the middle of the letter “e” of the emblem.

The drill hole is NOT to be placed directly at the letter “n” (left side of vehicle) or “e” (right side of the vehicle). The letters only serve as an orientation aid for drilling the hole subsequently inside the charging door.

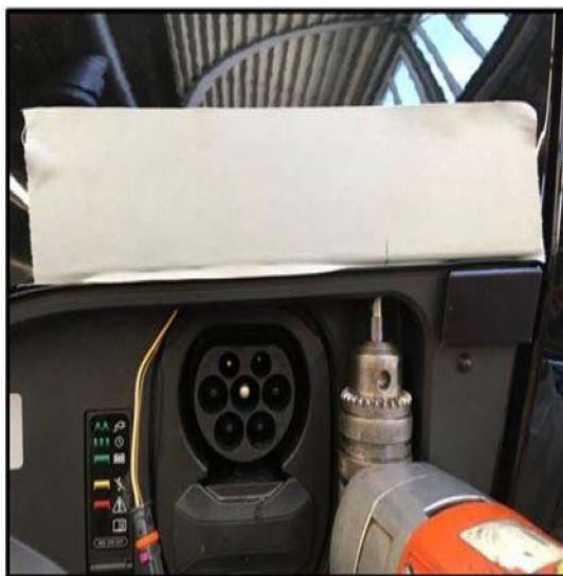
5. Drill through the retaining lug from the inside using an angled drill/angled bit and a short commercially available spot weld drill (diameter approximately 7mm) to a depth of approximately 15 mm at the marked location (Figure 12).

**Figure 12:** Use an angled drill/angle bit to drill to a depth of 15mm at the marked location.

***Remove the drilling residue at the charging socket using a compressed air gun.***

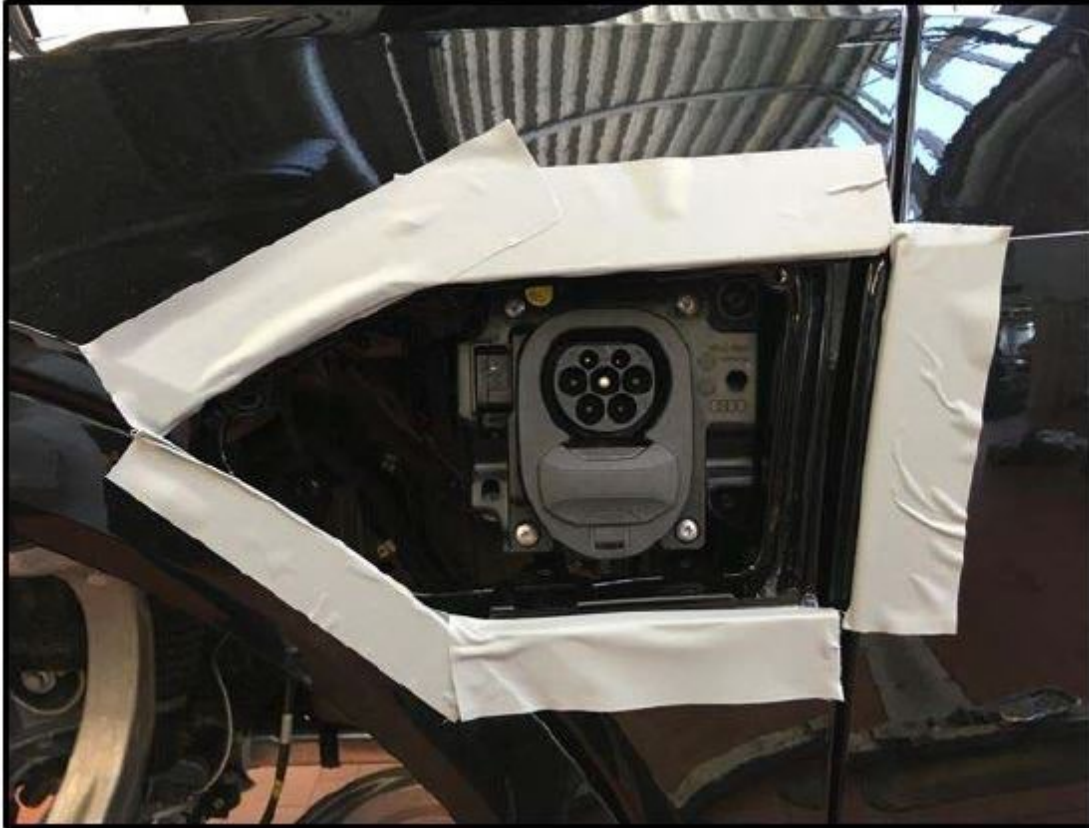
**To avoid paintwork damage, mask off the area around the charging door in advance using adhesive tape (Figure 18). The adhesive tape can be removed when the charging door has been installed.**

**Figure 18:** *Adhesive tape applied around the charging door to protect the paint.*

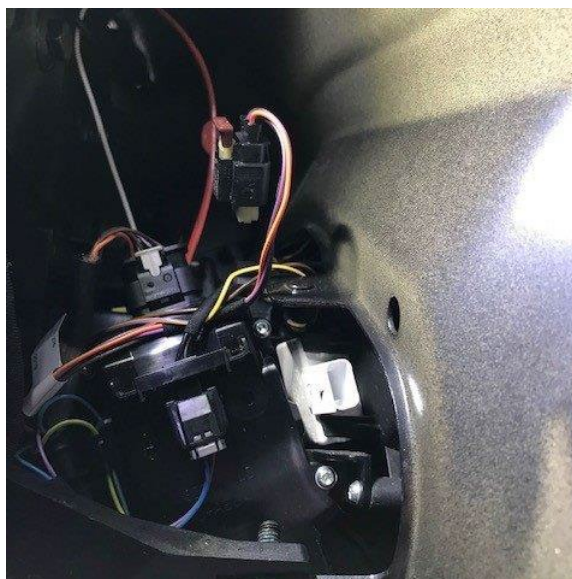
1. Unplug the connector from the charging indicator (Figure 20).

**Figure 20:** The connector is unplugged from the charging indicator.

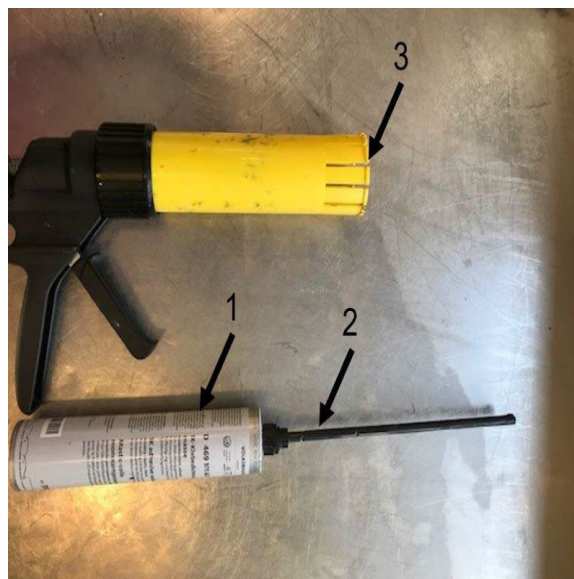
2. Screw the application hose (2) (order number: ASE33522600000) onto the cartridge of the component adhesive sealant (1) (Part number D 469101A3) (Figure 21).

**Figure 21:** Component adhesive sealant and tool.

The application hose (order number: ASE33522600000) can be left on the cartridge of the component adhesive sealant (part number: D 469101A3) after use and can be reused as the adhesive sealant (butyl) does not harden.

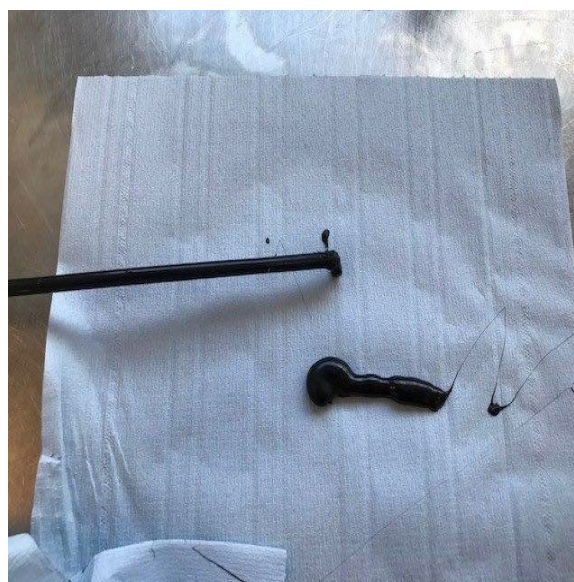
3. In order to ensure that the adhesive sealant has the same consistency at each use after it has not been used for a longer period (several days) use cartridge (3, Figure 21) to press out a sealant bead with a length of approximately 5 cm (Figure 22) before each use of the component adhesive sealant.

**Figure 22:** Clearing the component adhesive sealant after prolonged storage.

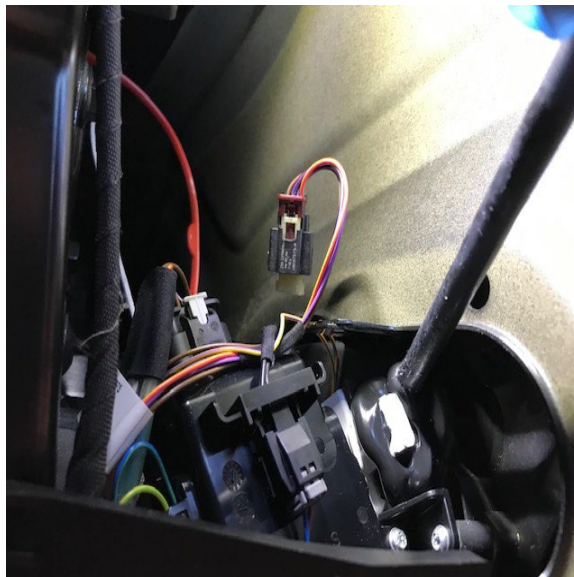
4. Apply a sealant bead (at least 8 mm thick) all around at the beginning of the connector point of the charging indicator (Figure 23).

**Figure 23:** Sealant bead applied at the connector.

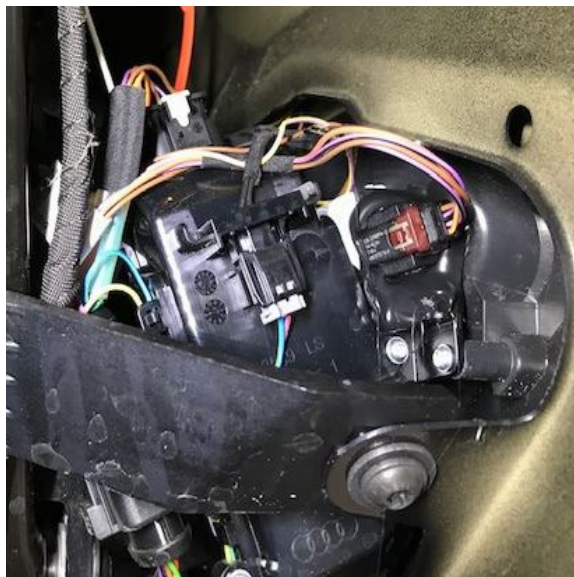
5. Plug the connector into the charging indicator and press it into the adhesive sealant. Press in the release tab on the connector to ensure it is fully engaged.

Plug the connector into the charging indicator. The connector should then be completely surrounded by the adhesive sealant (Figure 24).

**Figure 24:** The connector should be completely surrounded by the adhesive sealant.

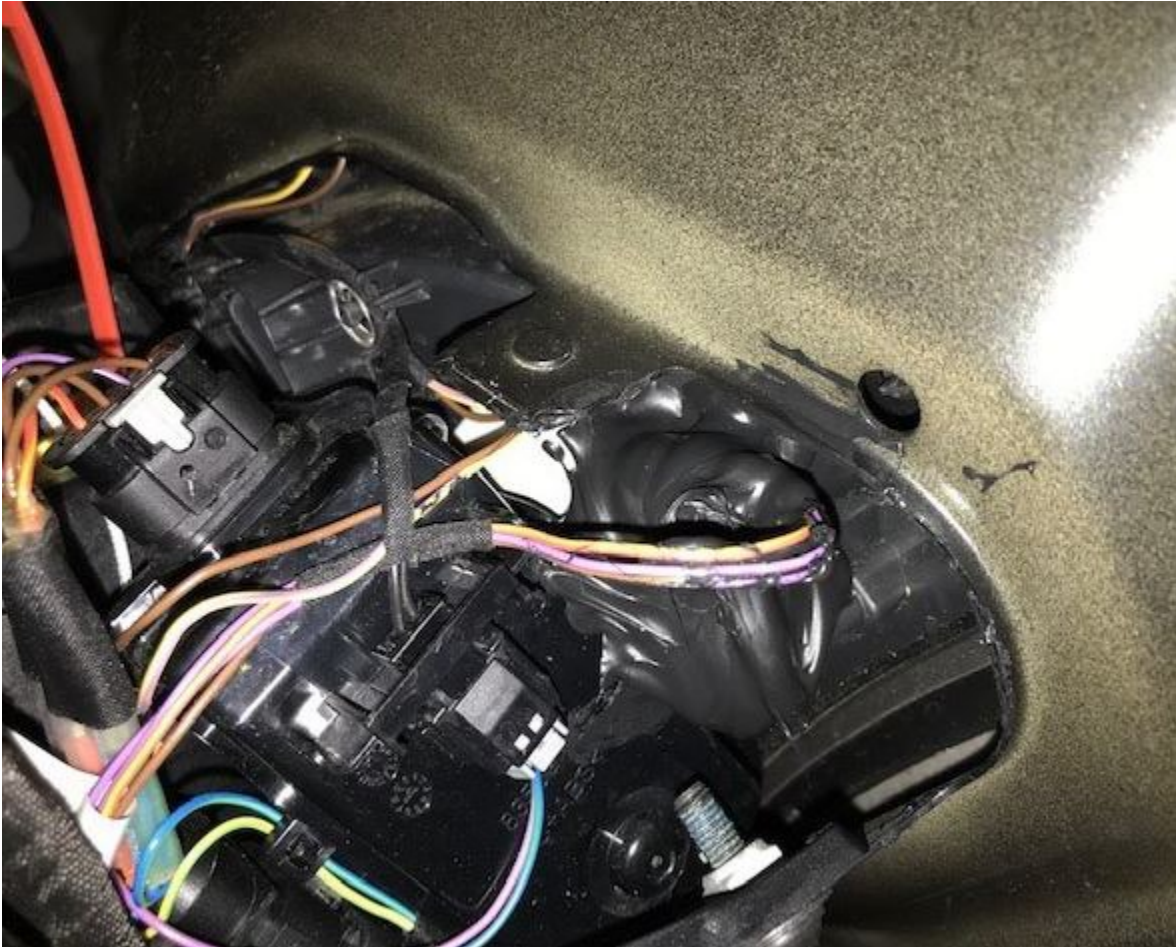
The entire connector and connector point of the charging indicator and parts of the charging indicator must be covered with adhesive sealant to ensure protection against moisture ingress (Figure 25).

**Figure 25:** The entire connector and the connector point of the charging indicator must be covered with adhesive sealant.

The adhesive sealant is very soft and flows into itself immediately after application.

- Some of the adhesive sealant may run off shortly after application. This does not affect the sealing function; instead, it is a sign that sufficient adhesive sealant has been applied.
- The adhesive sealant hardens and reaches its final elastic consistency over time.
- The vehicle can then be reassembled and returned to the customer.
- No waiting time is necessary as the initial strength of the adhesive sealant can withstand everyday use.
