# TECHNICAL SERVICE BULLETIN

## Front Seat Cushion Sagging - Built On Or Before 11-Feb-2021

**23-2235**

| <b>Ford</b><br>2019-2021 Transit | Built on or before 11-Feb-2021 |

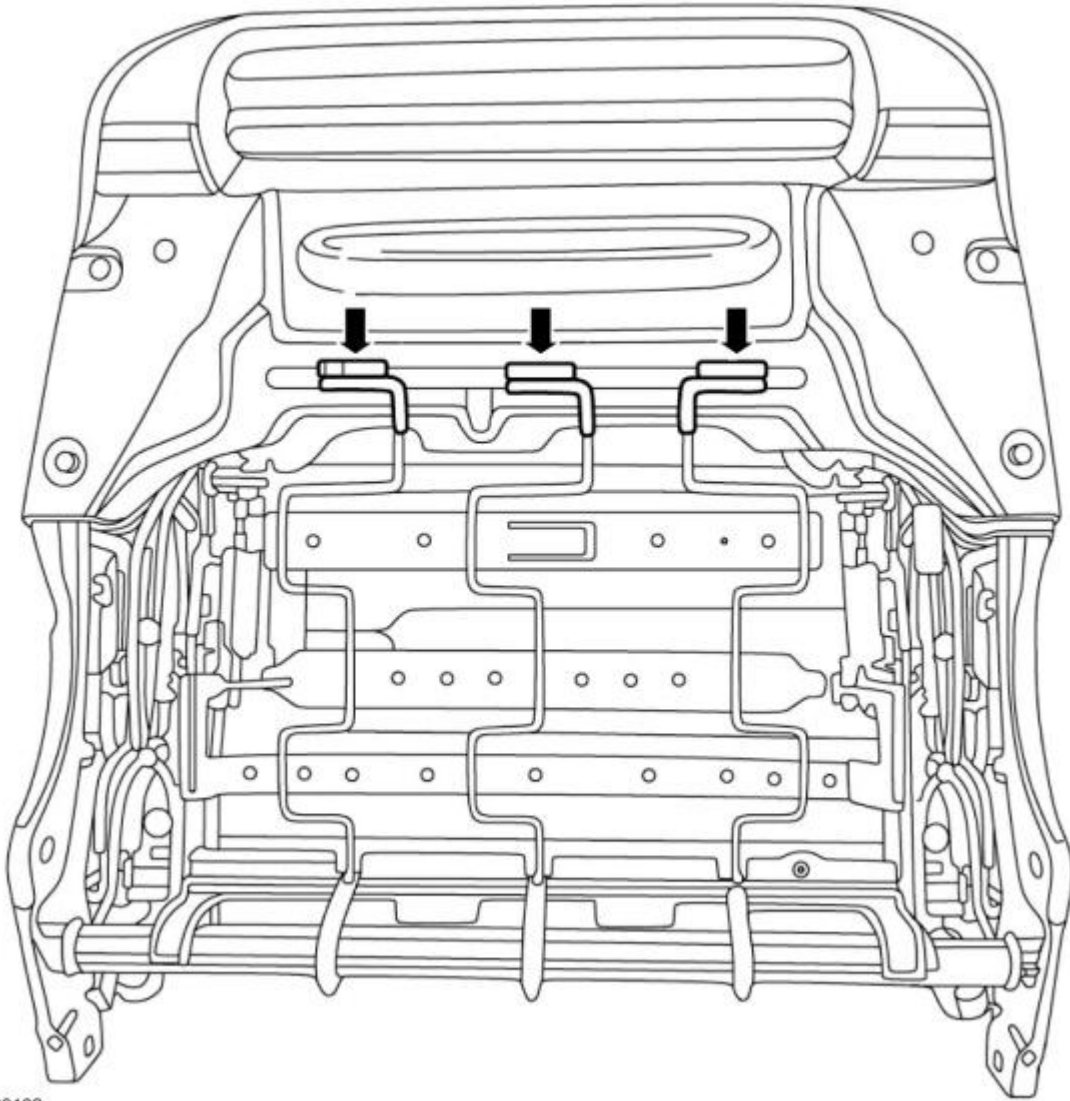
Figure 3

(2). Disengage the 3 suspension mat assembly forward attachments from the cushion pan. (Figure 3)

(3). Remove the suspension mat assembly 3 rearward attachments. The suspension mat assembly has a snap fit on the rear tube. (Figure 3)

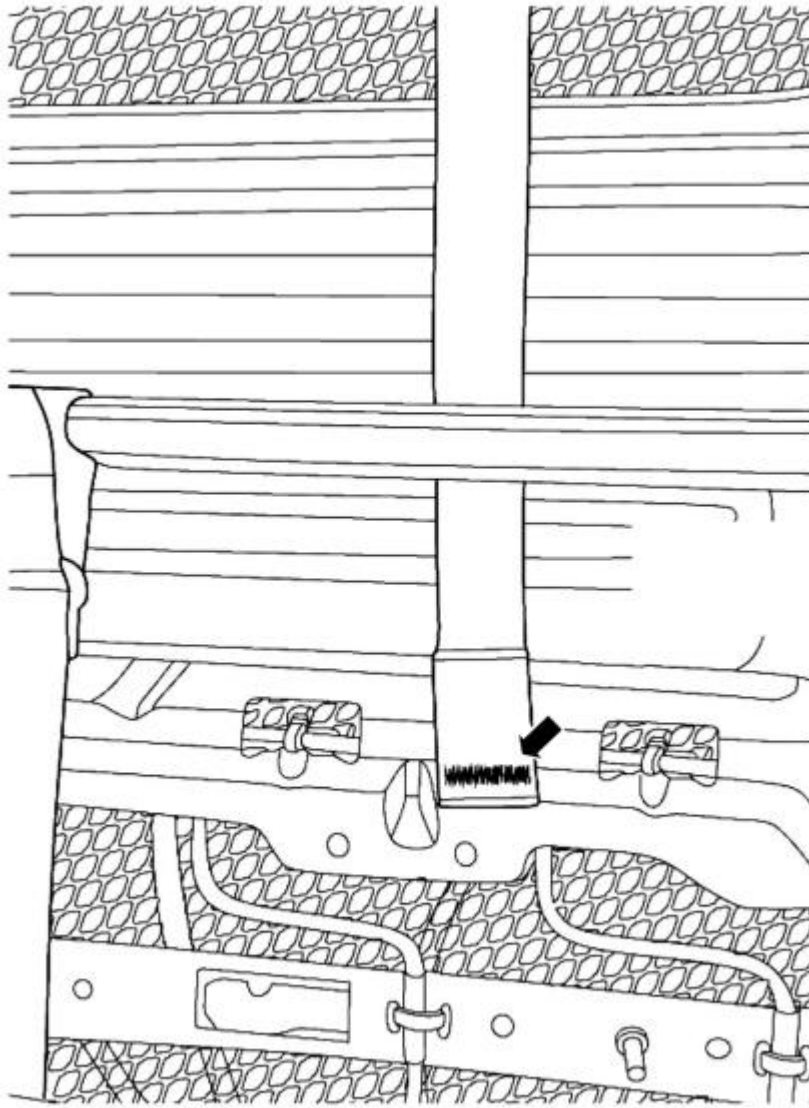
Figure 4

(1). With the red thread visible, route the end of the 1st webbing strap assembly without the metal ring between the cushion pan and the front cross-car tube. (Figure 4)

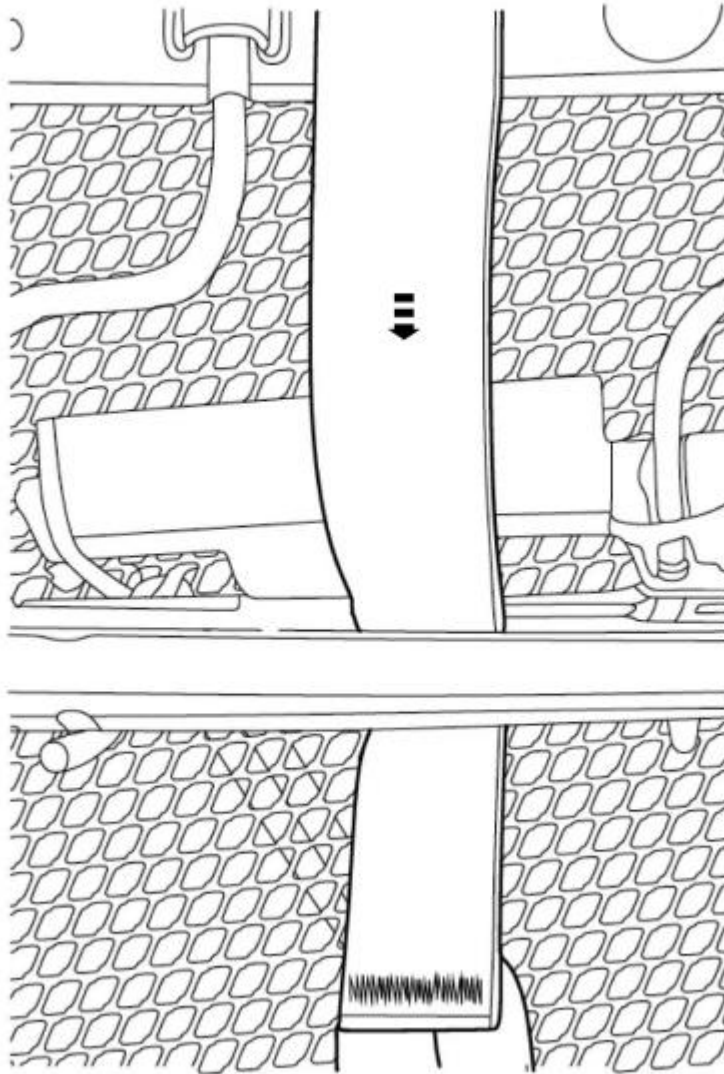
Figure 5

(2). Continue rearward and route the webbing strap assembly between the suspension mat assembly and the rear tube. (Figure 5)

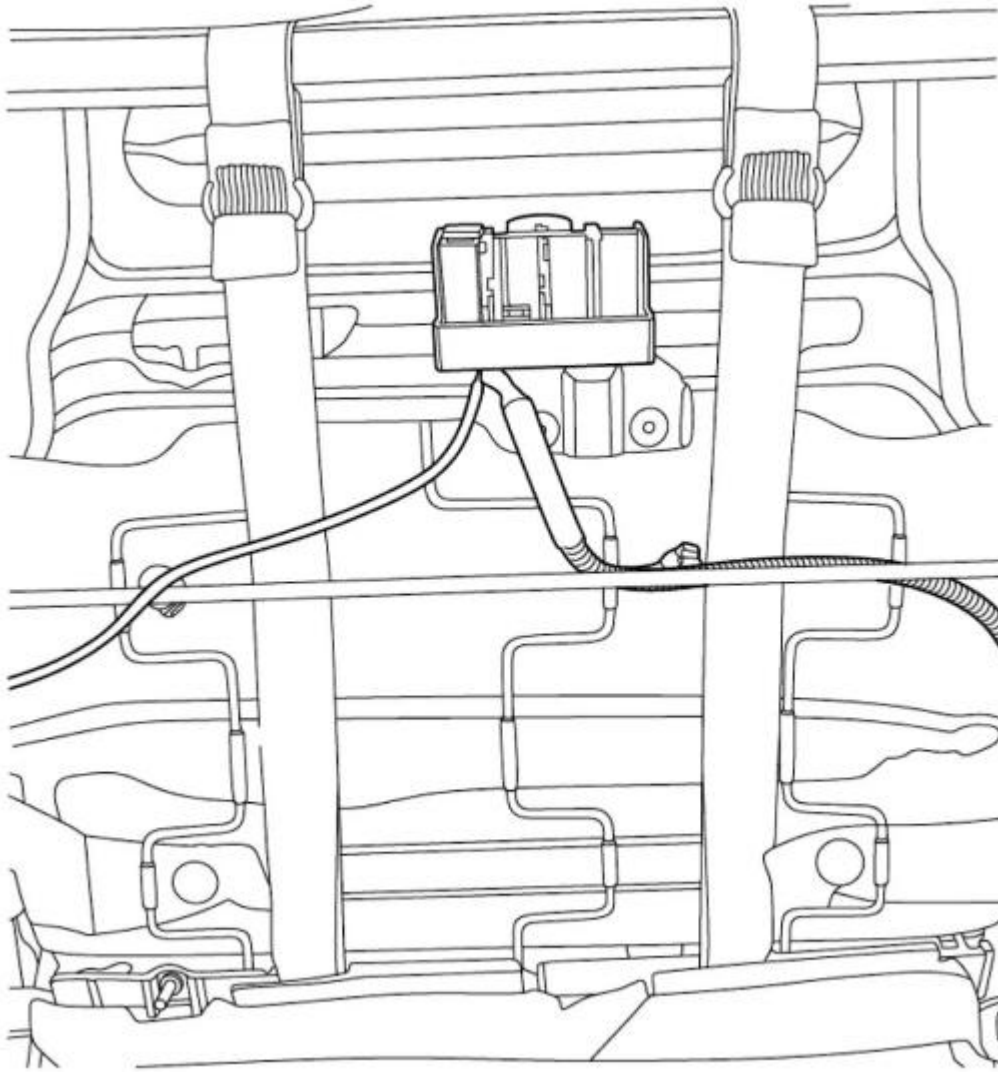
Figure 6

(3). Make sure all electrical harnesses are below the webbing. The final assembly will have the suspension mat on top (closest to the seat cushion), then the webbing straps, and then the wire harnesses on the bottom. (Figure 6)

**NOTE:** Make sure all electrical harnesses hang below the webbing and not between the webbing and suspension mat. When the final assembly is installed in the vehicle, it will have the suspension mat on top (closest to the cushion), then the webbing straps, and then the wire harnesses on the bottom. (Figure 6)

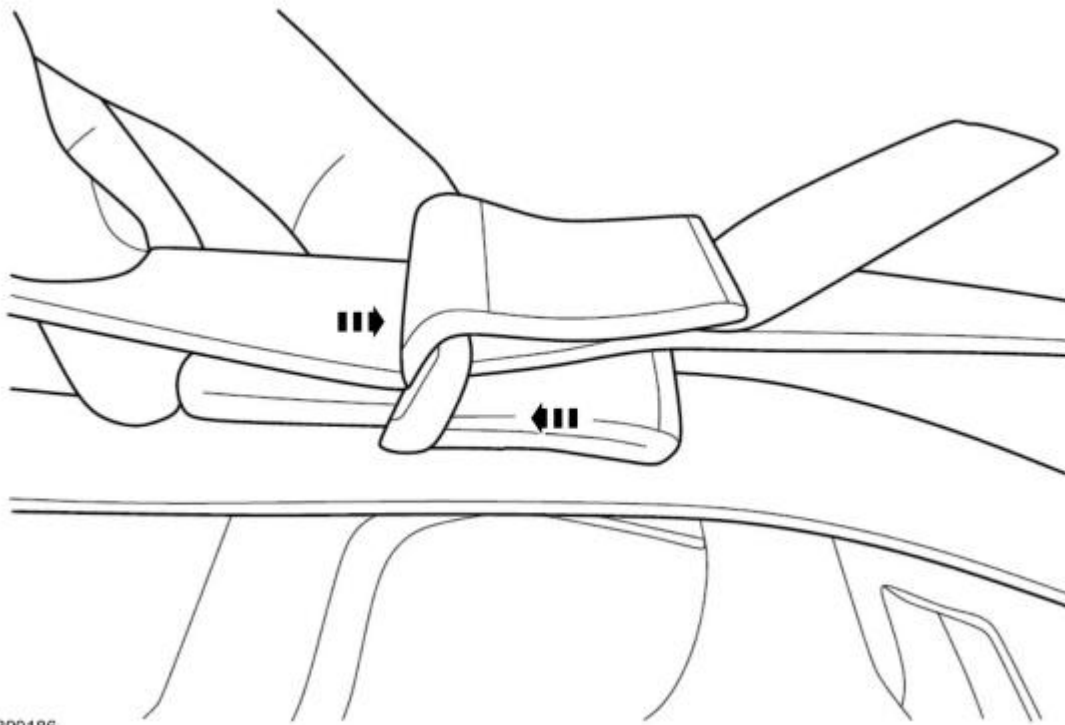
Figure 7

(4). Bring the webbing strap assembly to the metal ring and insert it. After the fold is all the way through the ring, pull the retention fold back and into position. (Figure 7)

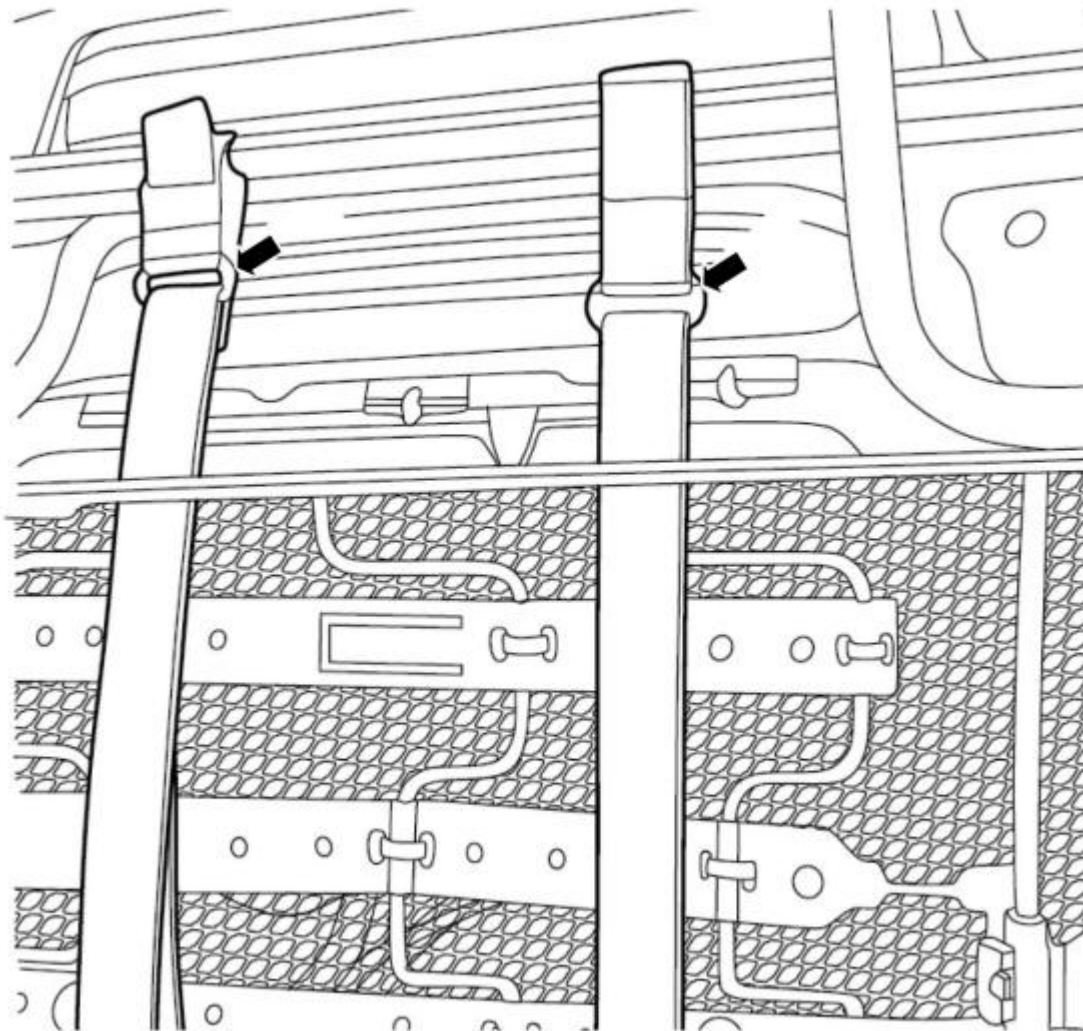
Figure 8

(6). The metal ring should be positioned forward in vehicle. (Figure 8)

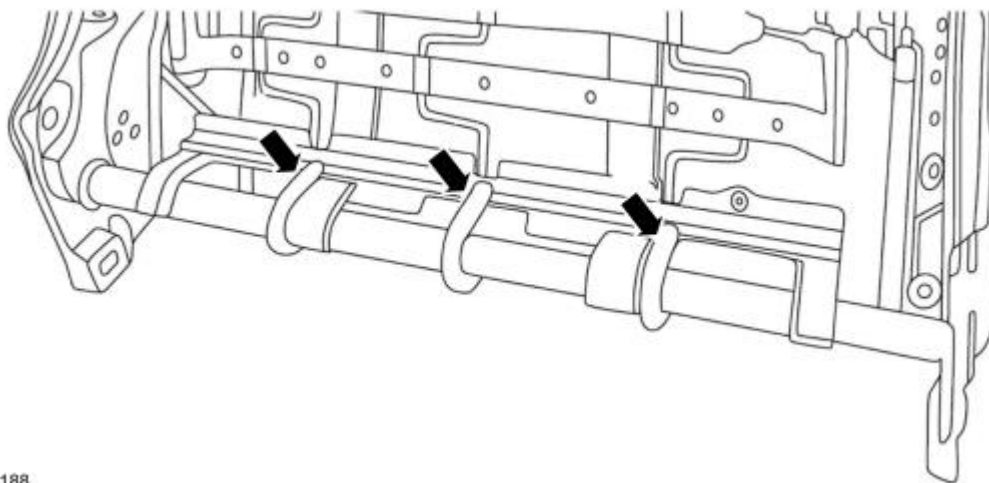
Figure 9

- (1). Locate the suspension mat to the cushion and webbing assembly.
- (2). At the rear tube verify one webbing is located between the left and center suspension attachment and the other is between the center and right suspension attachment. (Figure 9)

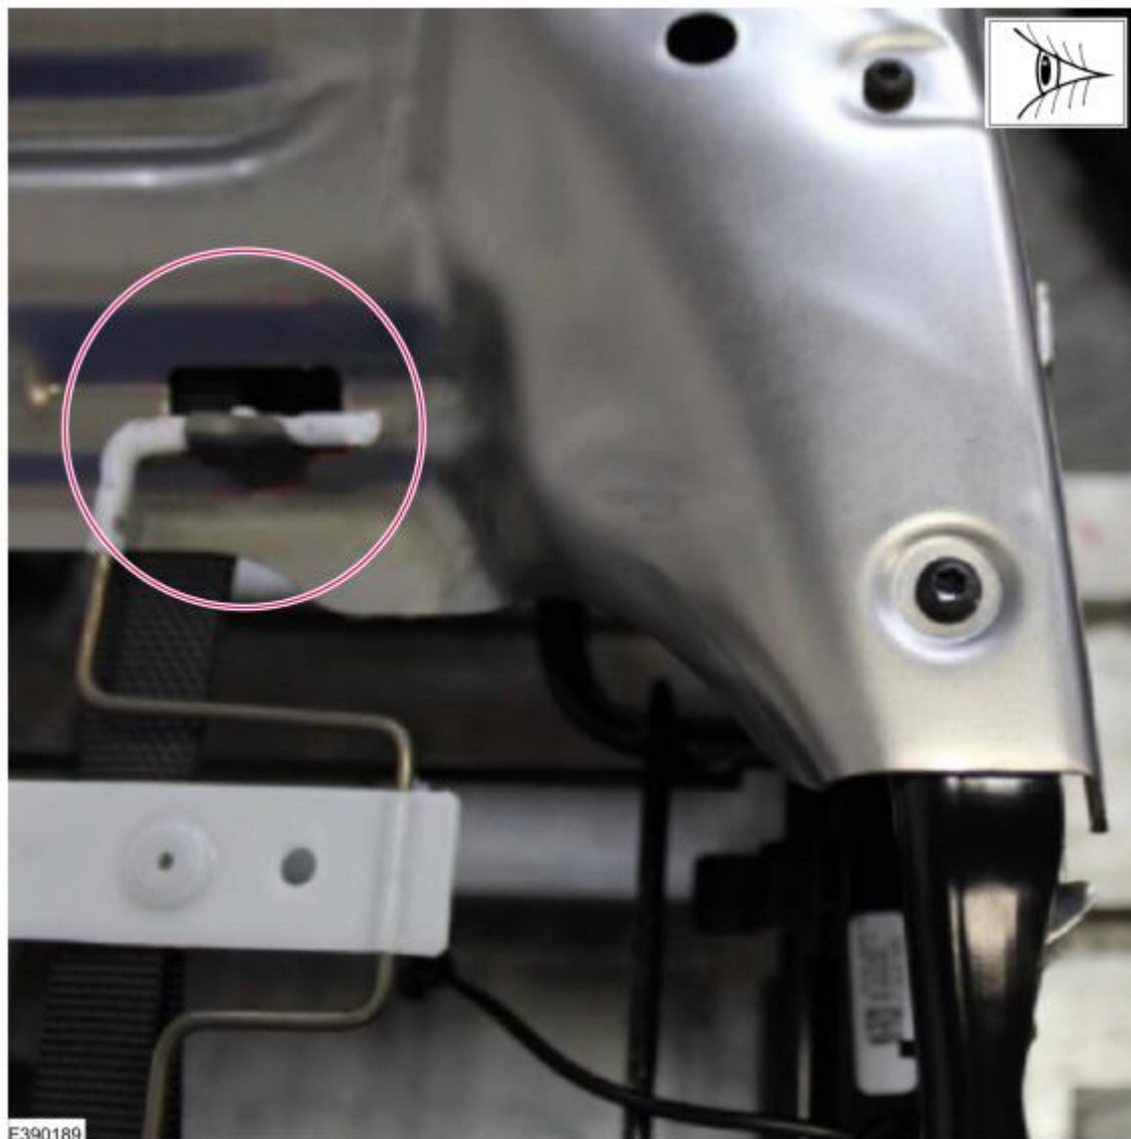
Figure 10

(4). Secure the front of the suspension mat to the retaining tabs on the cushion pan (no tools required). (Figure 10)

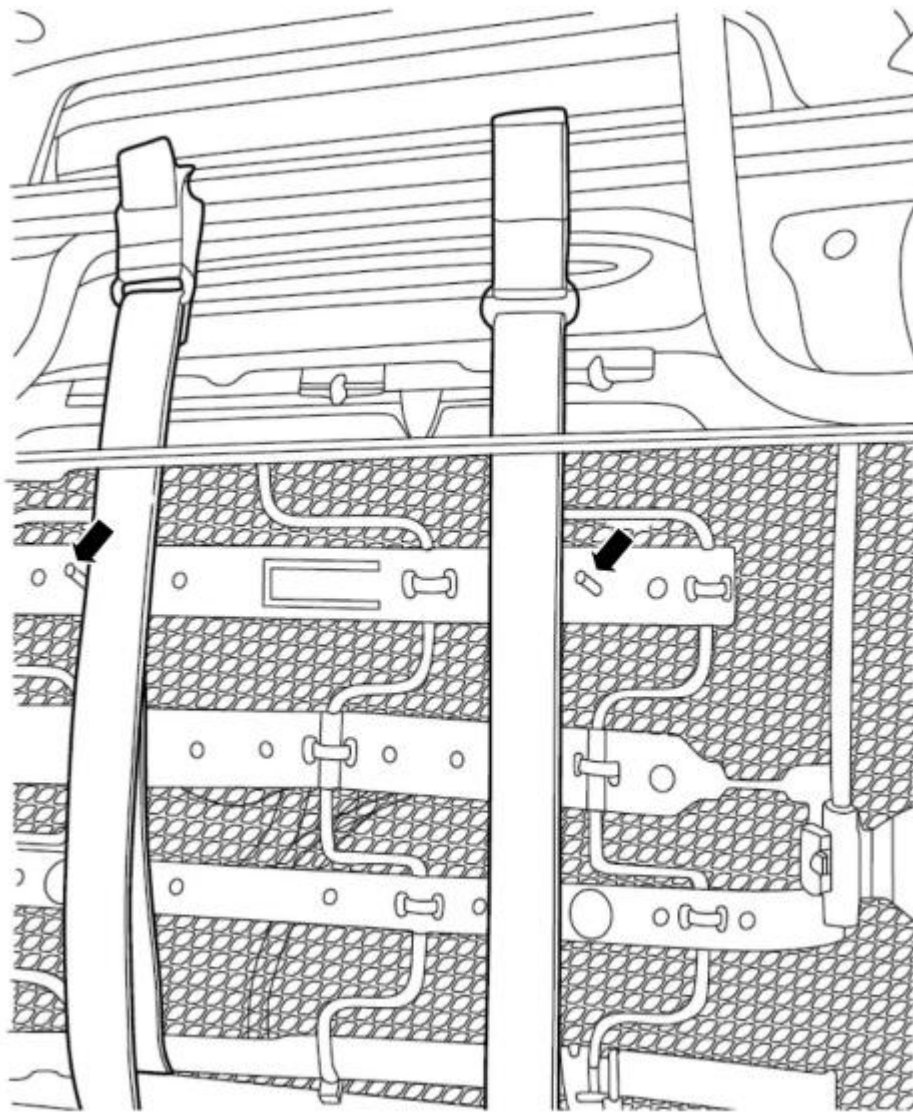
Figure 11

(5). Verify the cross-car position of the webbings. The position should be aligned with the stud on the suspension mat. (Figure 11)

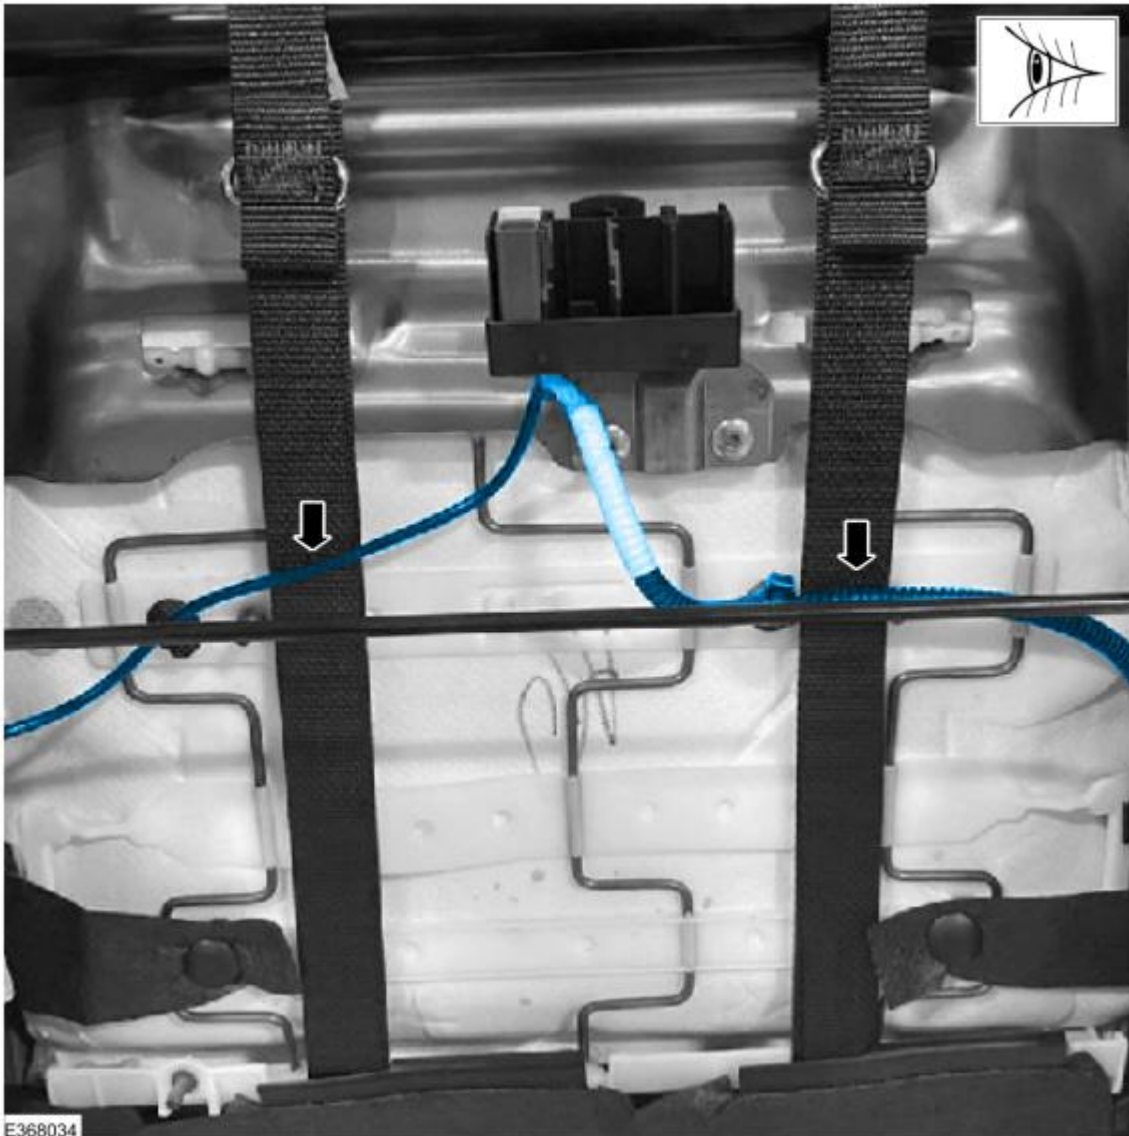
Figure 12

(6). Secure the wire harness(es) to the suspension mat. (Figure 12)
