# Technical Service Bulletin

## 69 Airbag warning light on, DTC B120E1B

69 23 02 2072023/1 November 15, 2023.

| Model(s) | Year | VIN Range | Vehicle-Specific Equipment |
|---|---|---|---|
| Q5, Q5 e quattro,<br>Q5 Sportback,<br>SQ5, SQ5<br>Sportback | 2021 – 2024 | All | Not Applicable |

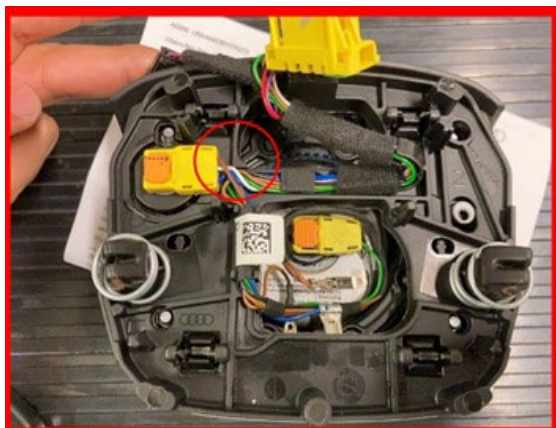
The wire routing of the driver airbag release valve igniter, N490, is not optimal causing tension on the release valve igniter connector. During vibrations, this tension leads to an increased electrical resistance.

*Figure 1. Tension on connector for airbag release valve igniter.*

| 2. | Check the routing of the driver airbag wire harness. Pay close attention to the wire routing of the driver airbag release valve igniter, N490 (Figure 1, 2). |

3. Replace the driver airbag wire harness. Route the new wire harness without causing tension on the airbag connectors.
4. After reinstalling the driver airbag, clear all fault codes.

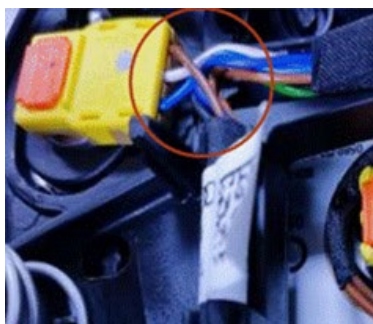
*Figure 2. Tension on connector for airbag release valve igniter.*
