# Technical Service Bulletin

## 35 Gearbox Malfunction warning on, DTC P17F900 is stored in the TCM

35 23 47 2064312/5 December 11, 2023. Supersedes Technical Service Bulletin Group 35 number 23-45 dated September 20, 2023 for reasons listed below.

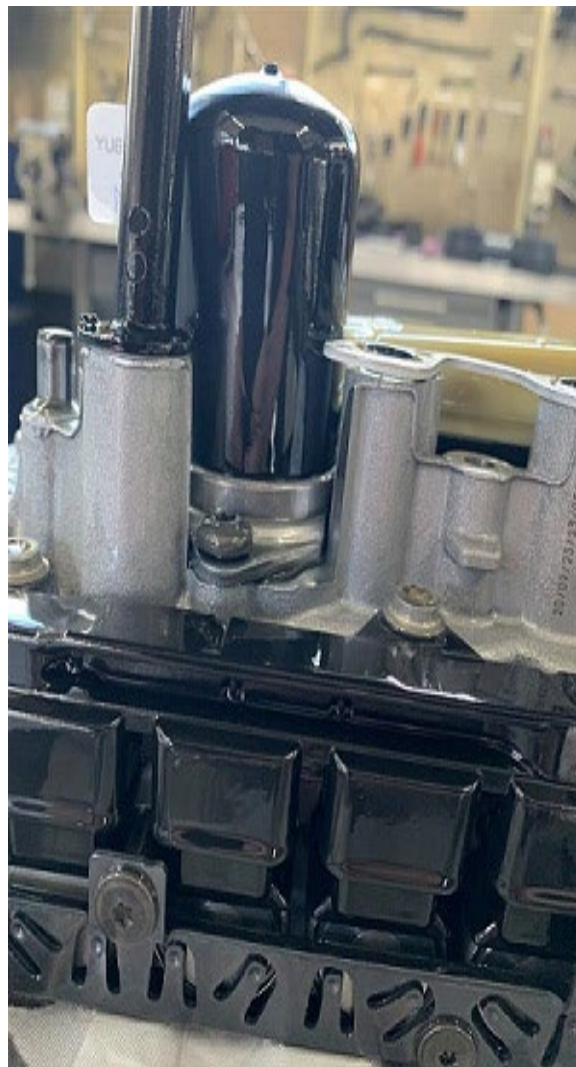
**Figure 4.** Loose bolts.

One or more bolts are loose (Figure 4).

You may also see the securing ring is not flush to the valve body which would mean the bolts are loose.

If the bolts are loose, replace pressure filter 2 along with the bolts as described in the Workshop Manual. Claim Option 1 in the Warranty Table below.

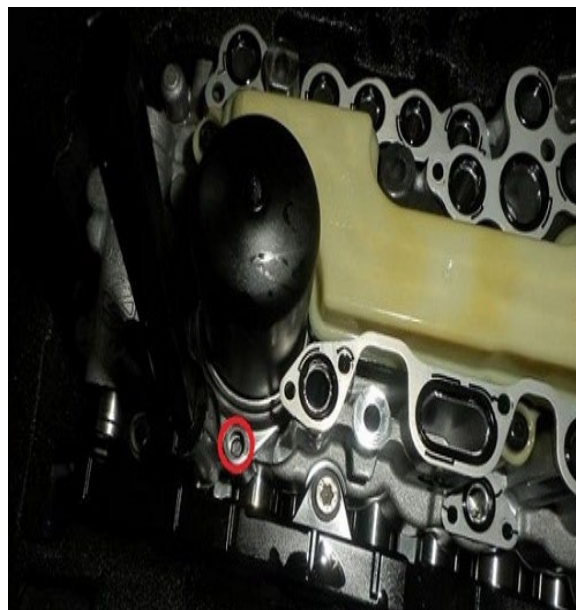
**Figure 5.** The bolt head is missing.

One or more bolt heads are broken off or missing (Figure 5).

If any of the bolts are broken, replace the Valve Body and reuse the Transmission Control Module per the Elsa Repair Manual. (If no valve body is available for your vehicle replace the Mechatronics unit and note this on the repair order). Claim Option 2 in the Warranty Table below.
