# Technical Service Bulletin

## 13 Starter/generator drive belt is noisy or came off, DTC P2BA300 may be stored in the ECM

13 24 24 2061461/9 March 8, 2024. Supersedes Technical Service Bulletin Group 13 number 23-20 dated October 13, 2023 for reasons listed below.

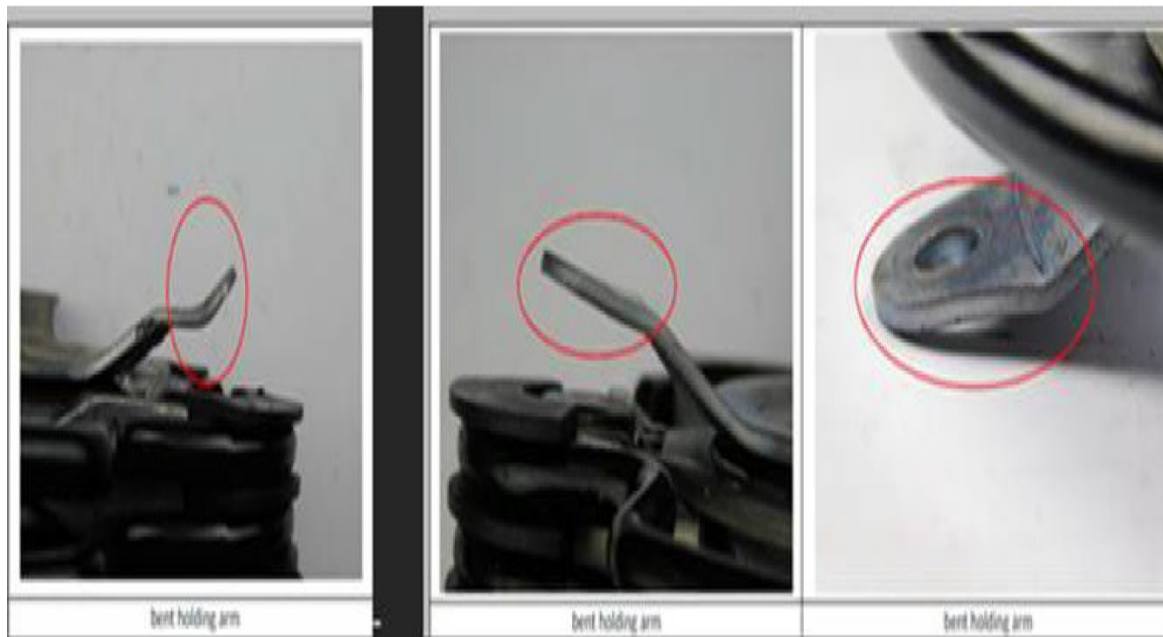
Example of damaged parts:

Please ensure that the belt tensioner (including the retaining tab) is not damaged during removal. Damage to the component would make analyzing the parts impossible. In such cases, we may charge back the damaged parts.
