## TECHNICAL SERVICE BULLETIN

### 2019-2021 Transit - Driver Seat Cushion Sagging - Built On Or Before 11-Feb-2021

**24-2053**

**Issue:** Some 2019-2021 Transit vehicles built on or before 11-Feb-2021 may experience a front seat cushion sagging. The vehicle may also exhibit an illuminated air bag warning indicator with DTCs B1408, B1405, B1407, B0001, B0010 and/or B1404 stored in the RCM. To correct this condition, follow the Service Procedure to replace the suspension mat assembly and install additional webbing strap assemblies to the seat frame.

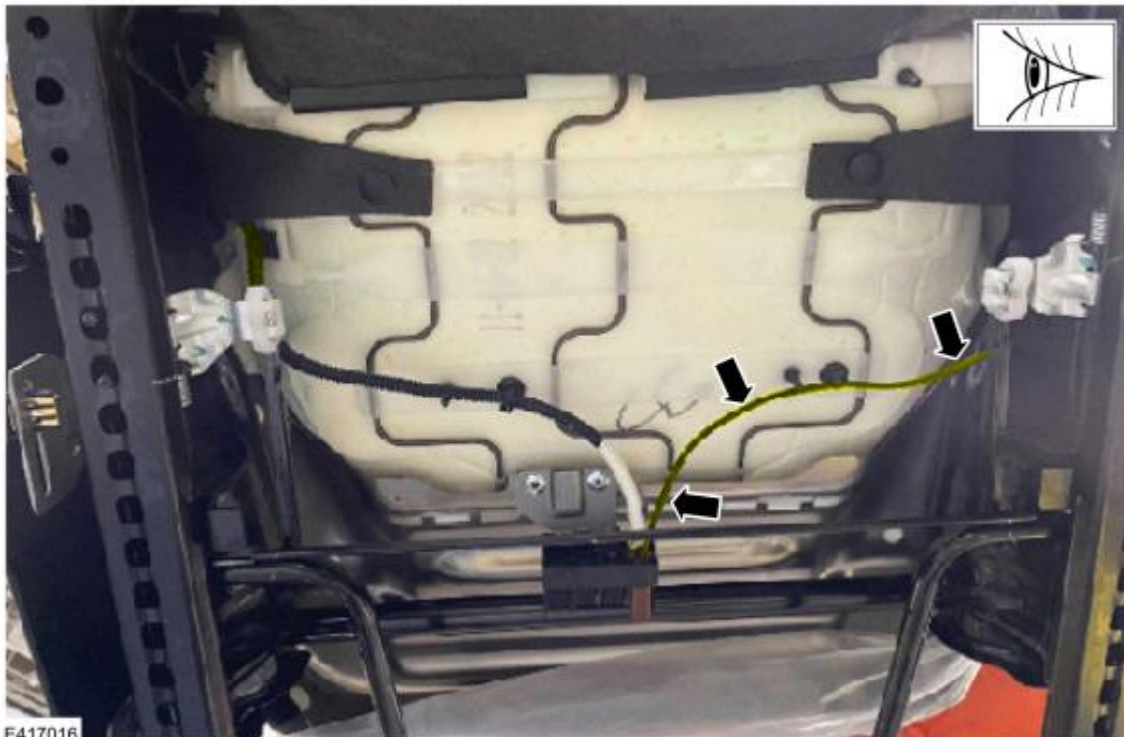
Figure 1

1. Remove the affected driver seat track. Refer to WSM, Section 501-10A, starting with Step 2.
2. Inspect the seat airbag deployment circuit for damage as shown in Figure 1. If damage is present, replace the side airbag. Refer to WSM, Section 501-20B.

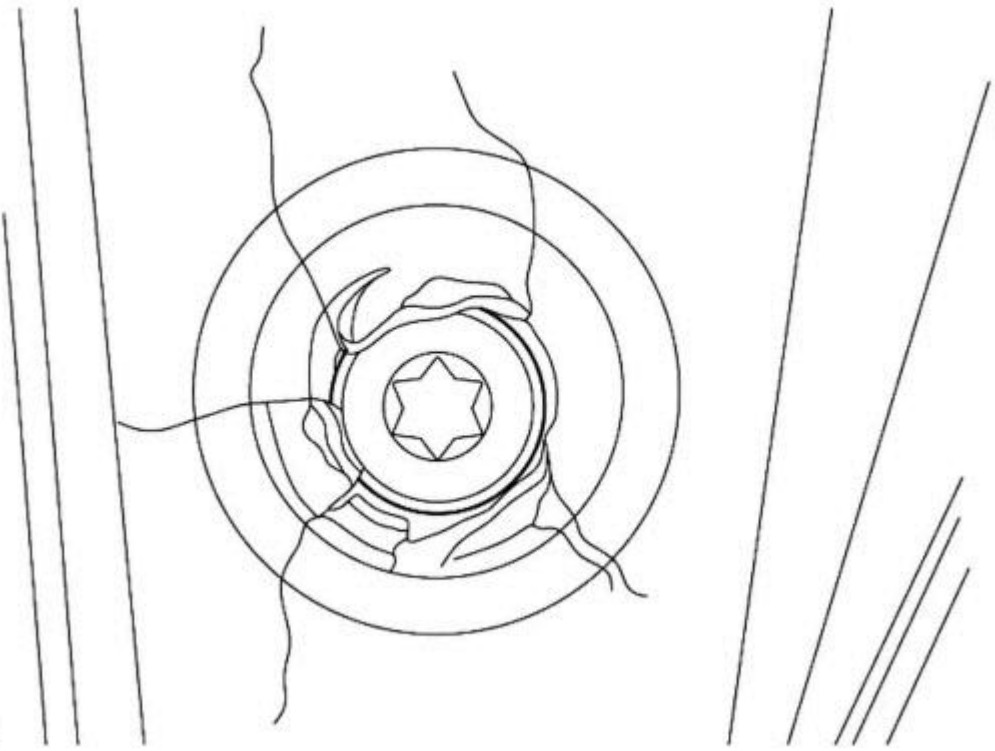
Figure 2

3. Inspect the driver seat track assembly for damage. Is the driver seat track assembly damaged?

**NOTE: Small cracks around the bolt are considered normal. (Figure 2)**

(1). Yes - replace the seat track assembly. Refer to WSM, Section 501-10A Front Seats > Removal and Installation > Front Seat Track. Proceed to Step 5.

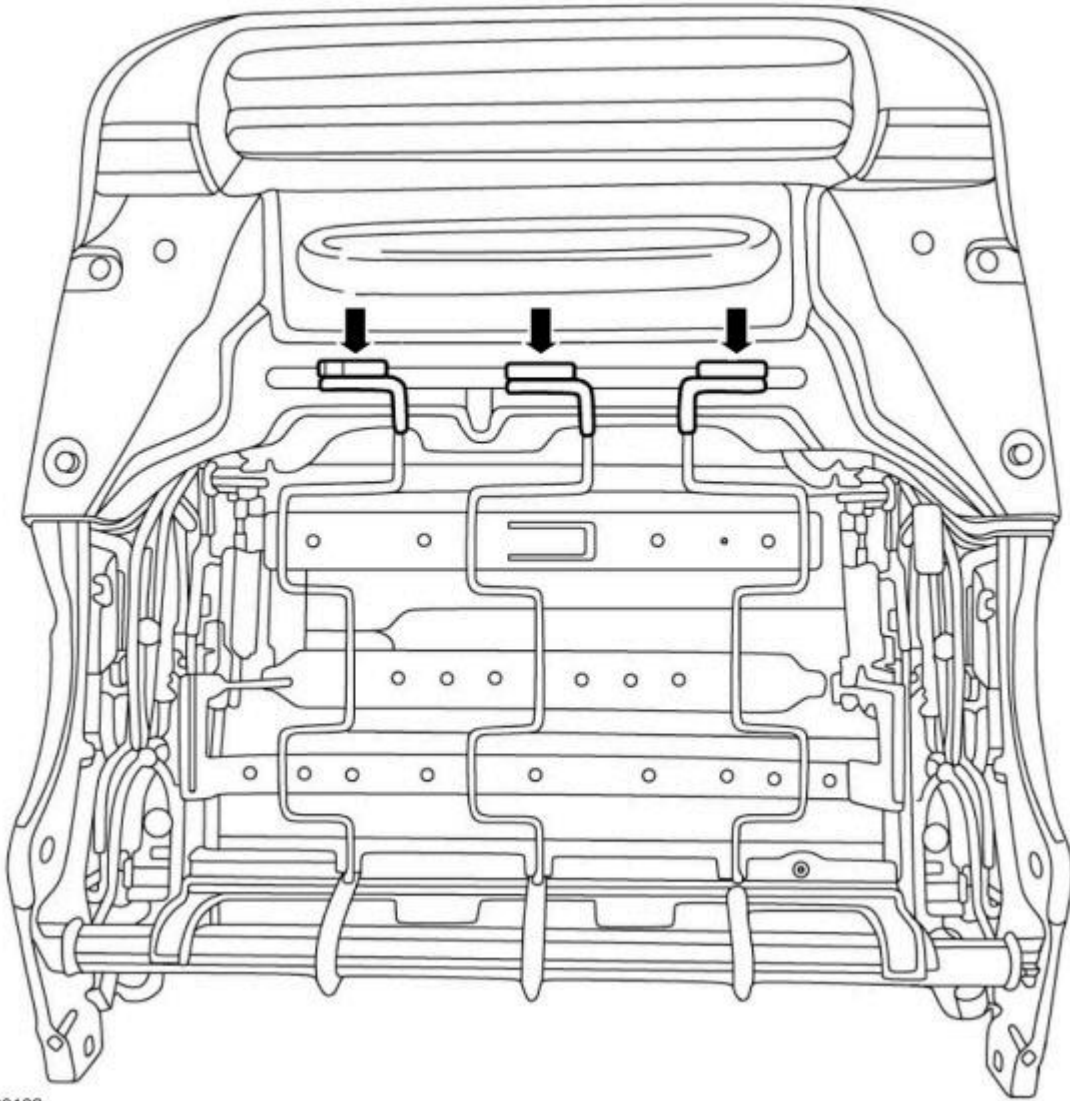
Figure 3

(2). Disengage the 3 suspension mat assembly forward attachments from the cushion pan. (Figure 3)

(3). Remove the suspension mat assembly 3 rearward attachments. The suspension mat assembly has a snap fit on the rear tube. (Figure 3)

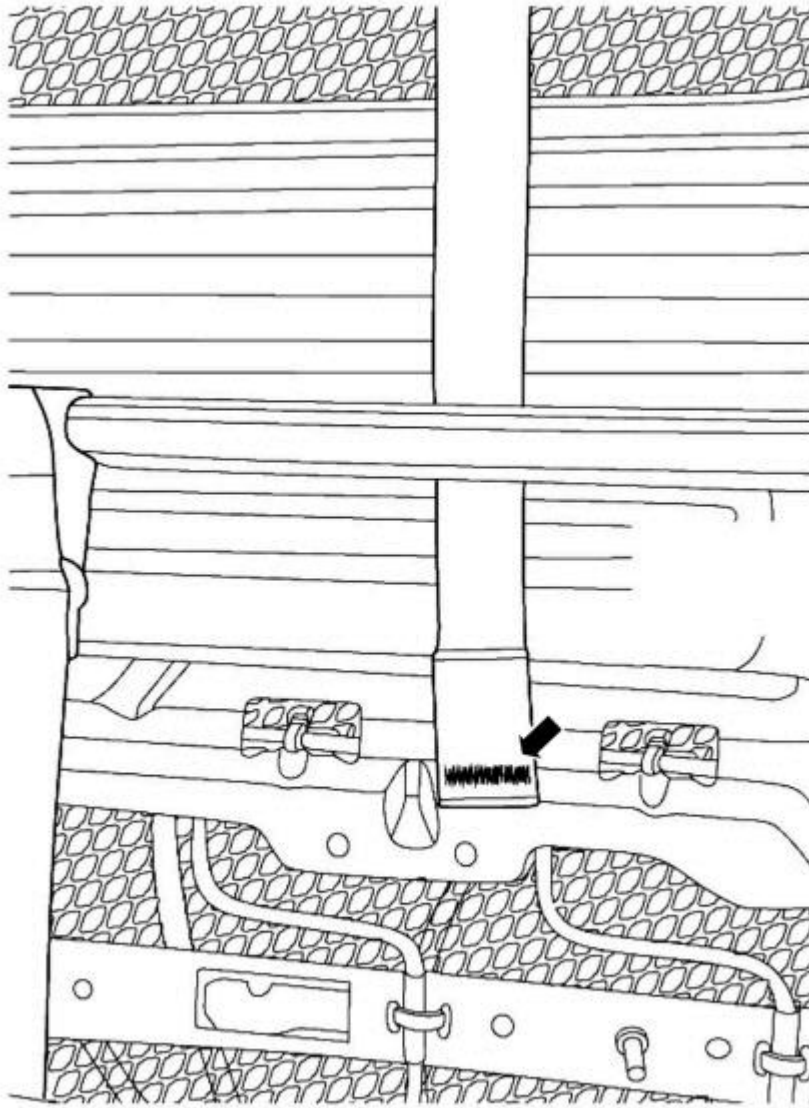
Figure 4

(1). With the red thread visible, route the end of the 1st webbing strap assembly without the metal ring between the cushion pan and the front cross-car tube. (Figure 4)

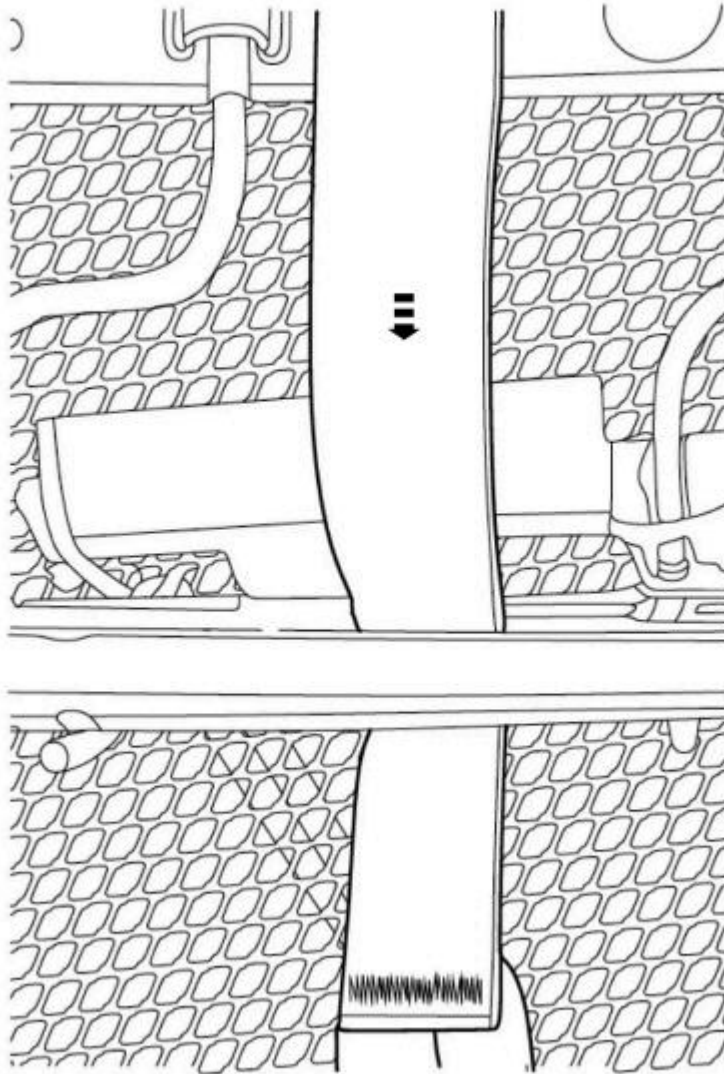
Figure 5

(2). Continue rearward and route the webbing strap assembly between the suspension mat assembly and the rear tube. (Figure 5)

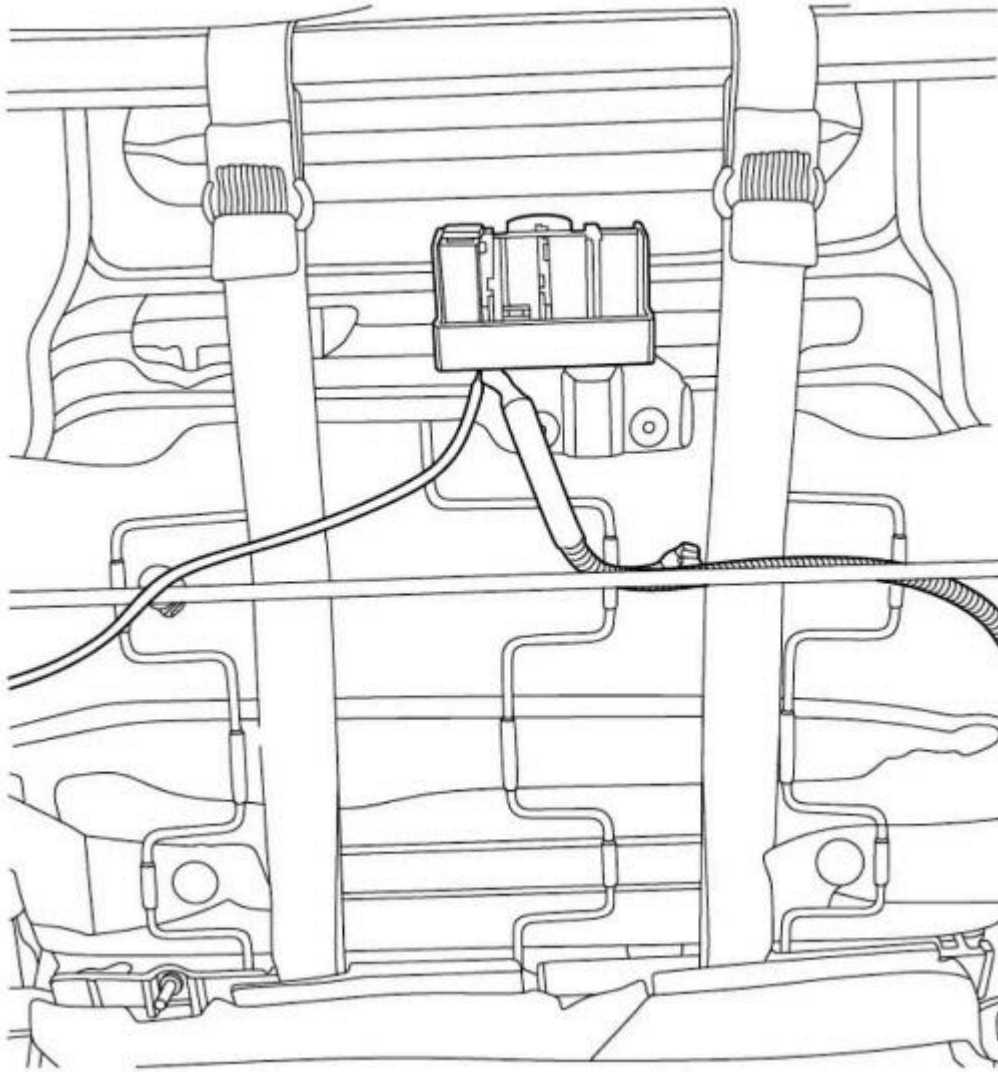
Figure 6

(3). Make sure all electrical harnesses are below the webbing. The final assembly will have the suspension mat on top (closest to the seat cushion), then the webbing straps, and then the wire harnesses on the bottom. (Figure 6)

**NOTE:** Make sure all electrical harnesses hang below the webbing and not between the webbing and suspension mat. When the final assembly is installed in the vehicle, it will have the suspension mat on top (closest to the cushion), then the webbing straps, and then the wire harnesses on the bottom. (Figure 6)

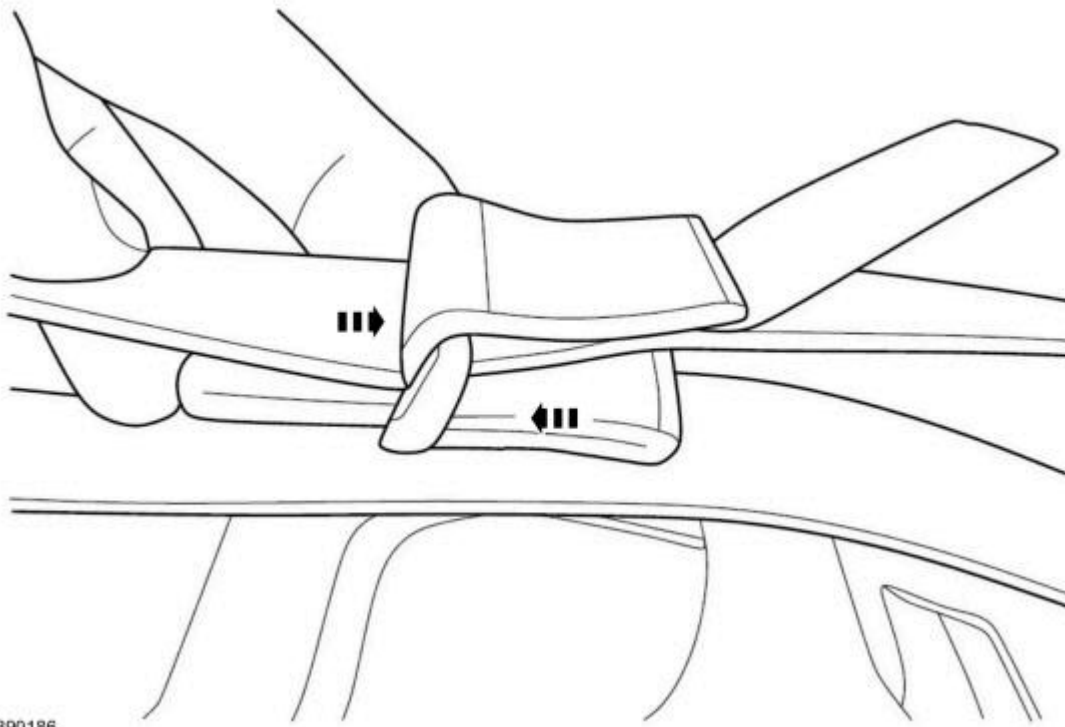
Figure 7

(4). Bring the webbing strap assembly to the metal ring and insert it. After the fold is all the way through the ring, pull the retention fold back and into position. (Figure 7)

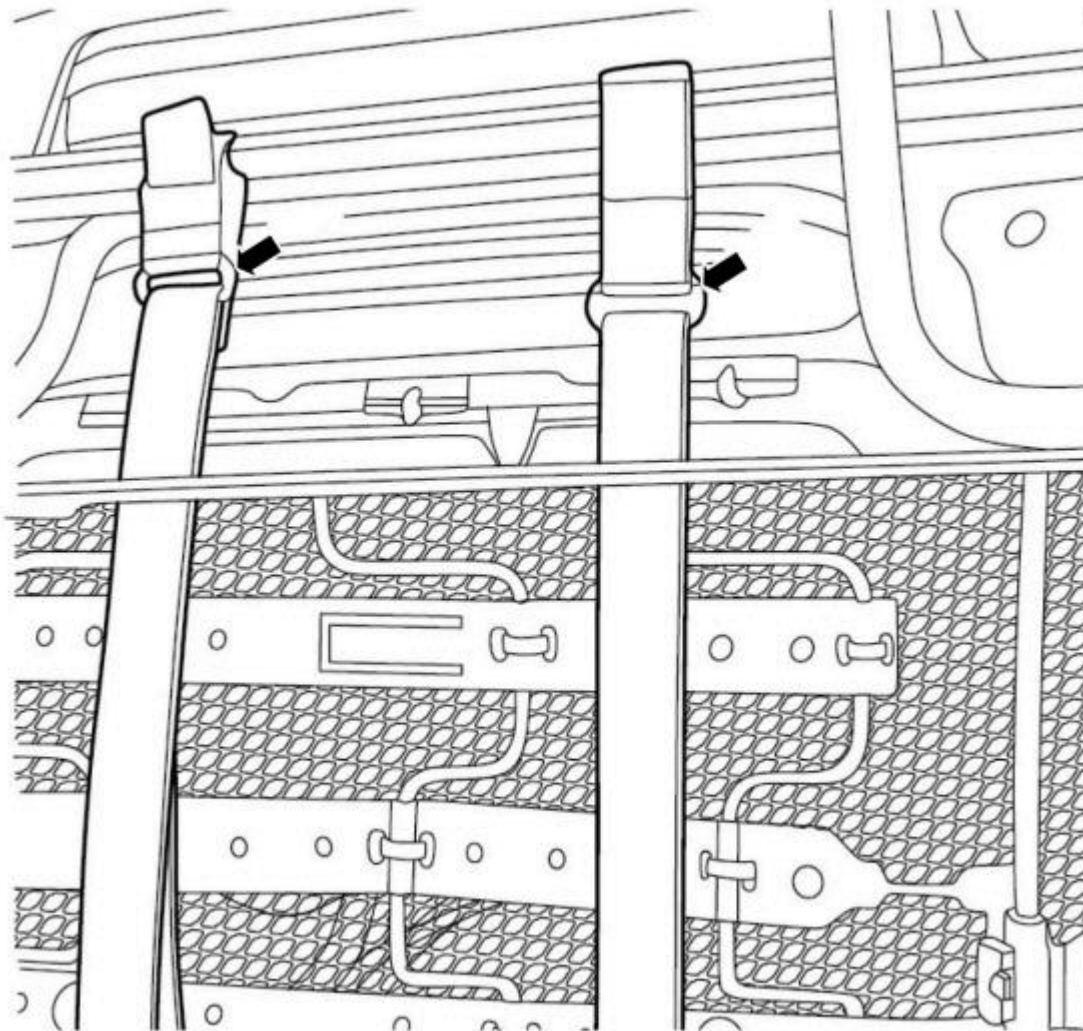
Figure 8

(6). The metal ring should be positioned forward in vehicle. (Figure 8)

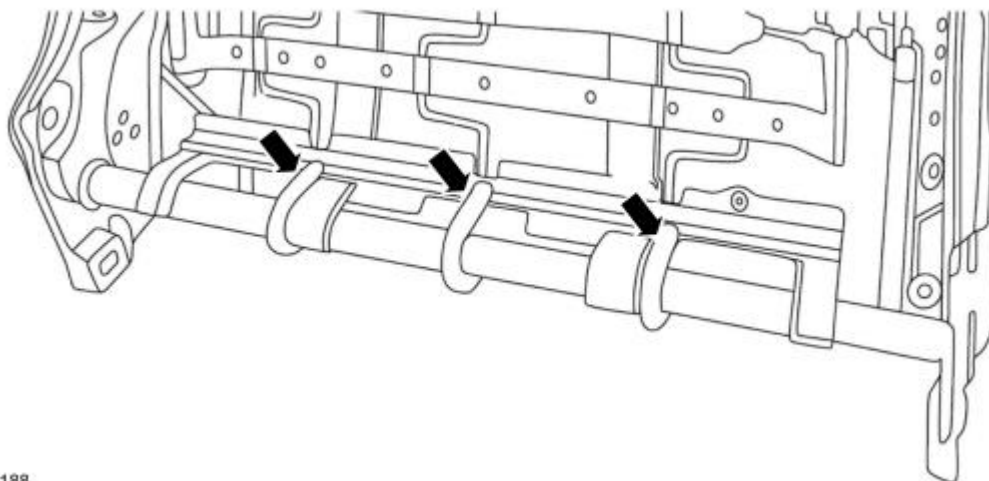
Figure 9

- (1). Locate the suspension mat to the cushion and webbing assembly.
- (2). At the rear tube verify one webbing is located between the left and center suspension attachment and the other is between the center and right suspension attachment. (Figure 9)

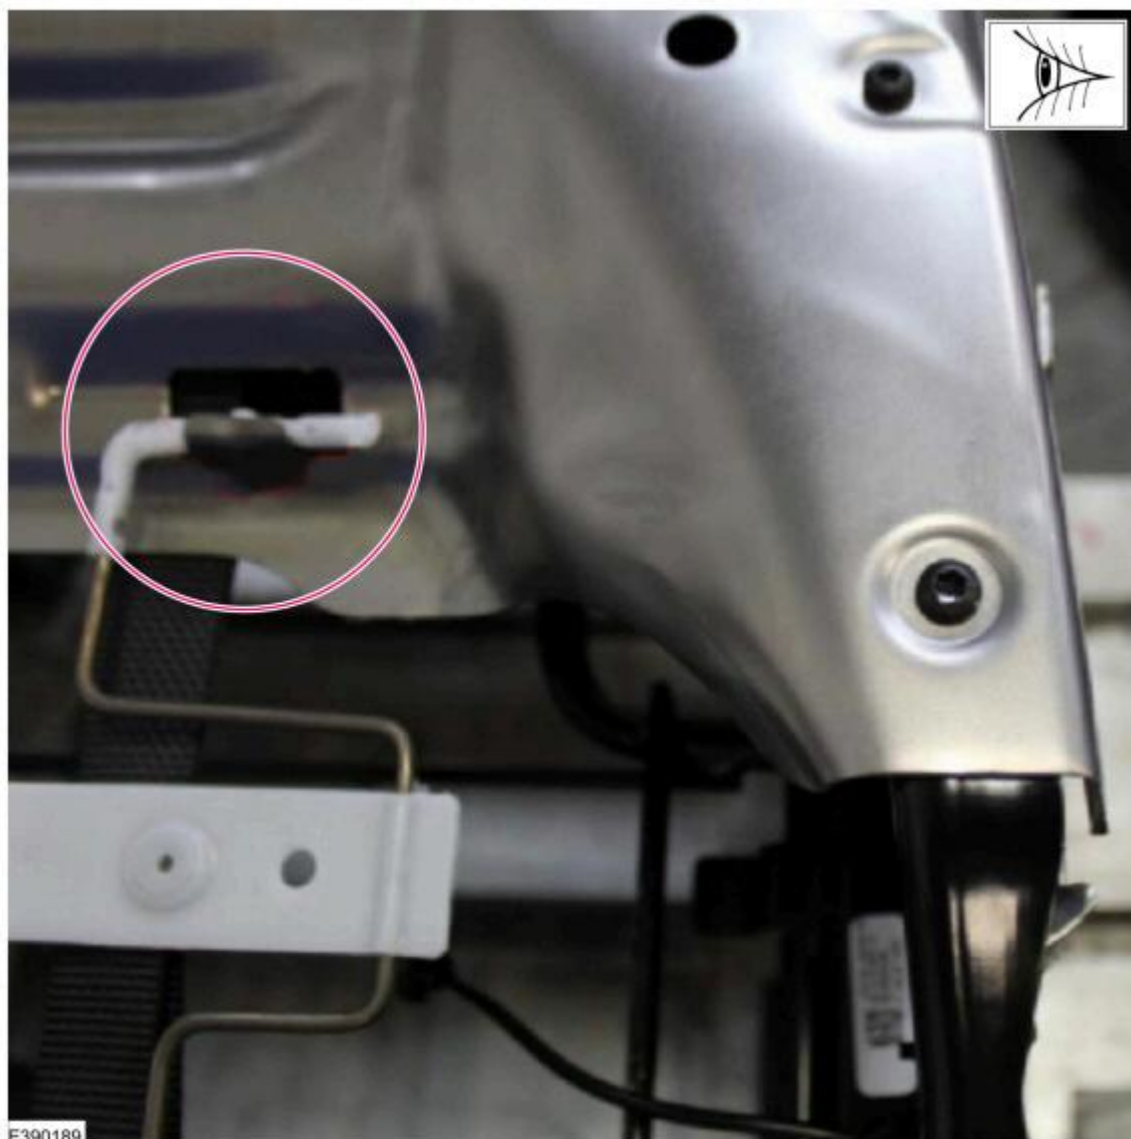
Figure 10

(4). Secure the front of the suspension mat to the retaining tabs on the cushion pan (no tools required). (Figure 10)

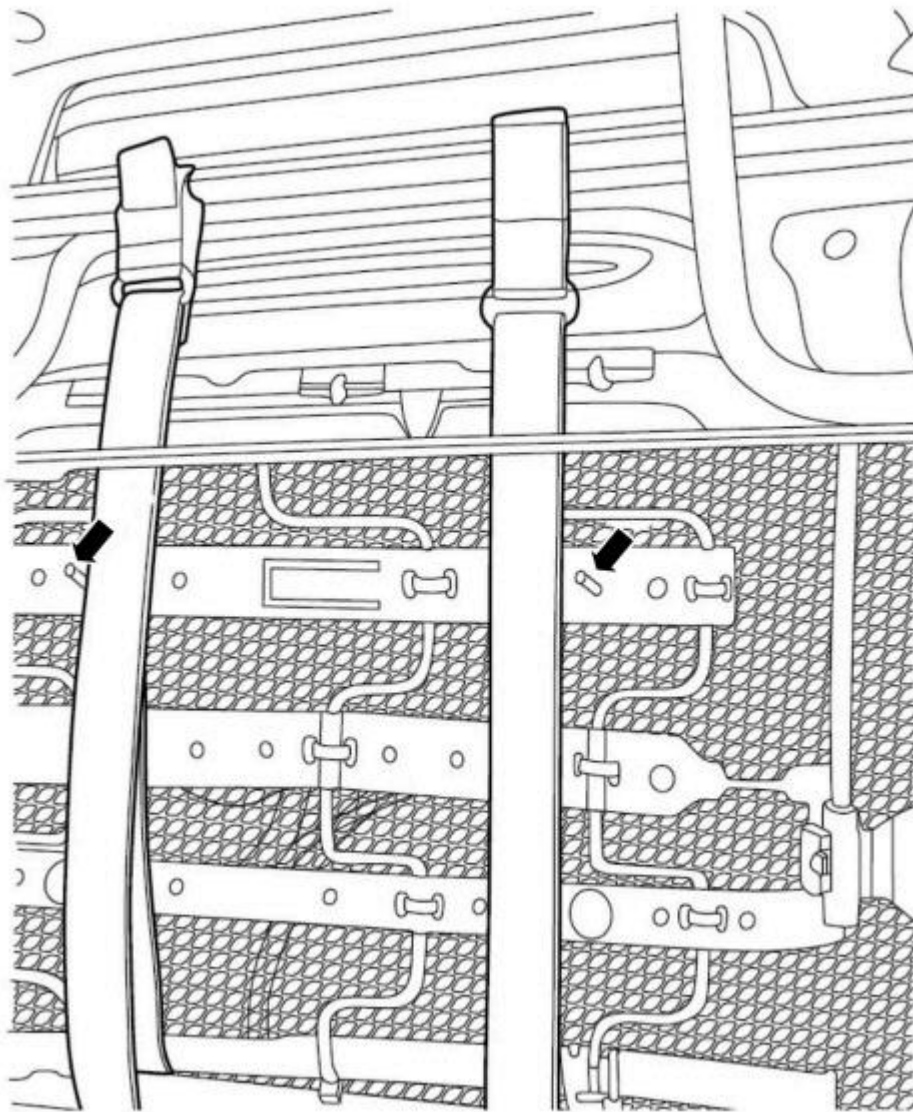
Figure 11

(5). Verify the cross-car position of the webbings. The position should be aligned with the stud on the suspension mat. (Figure 11)

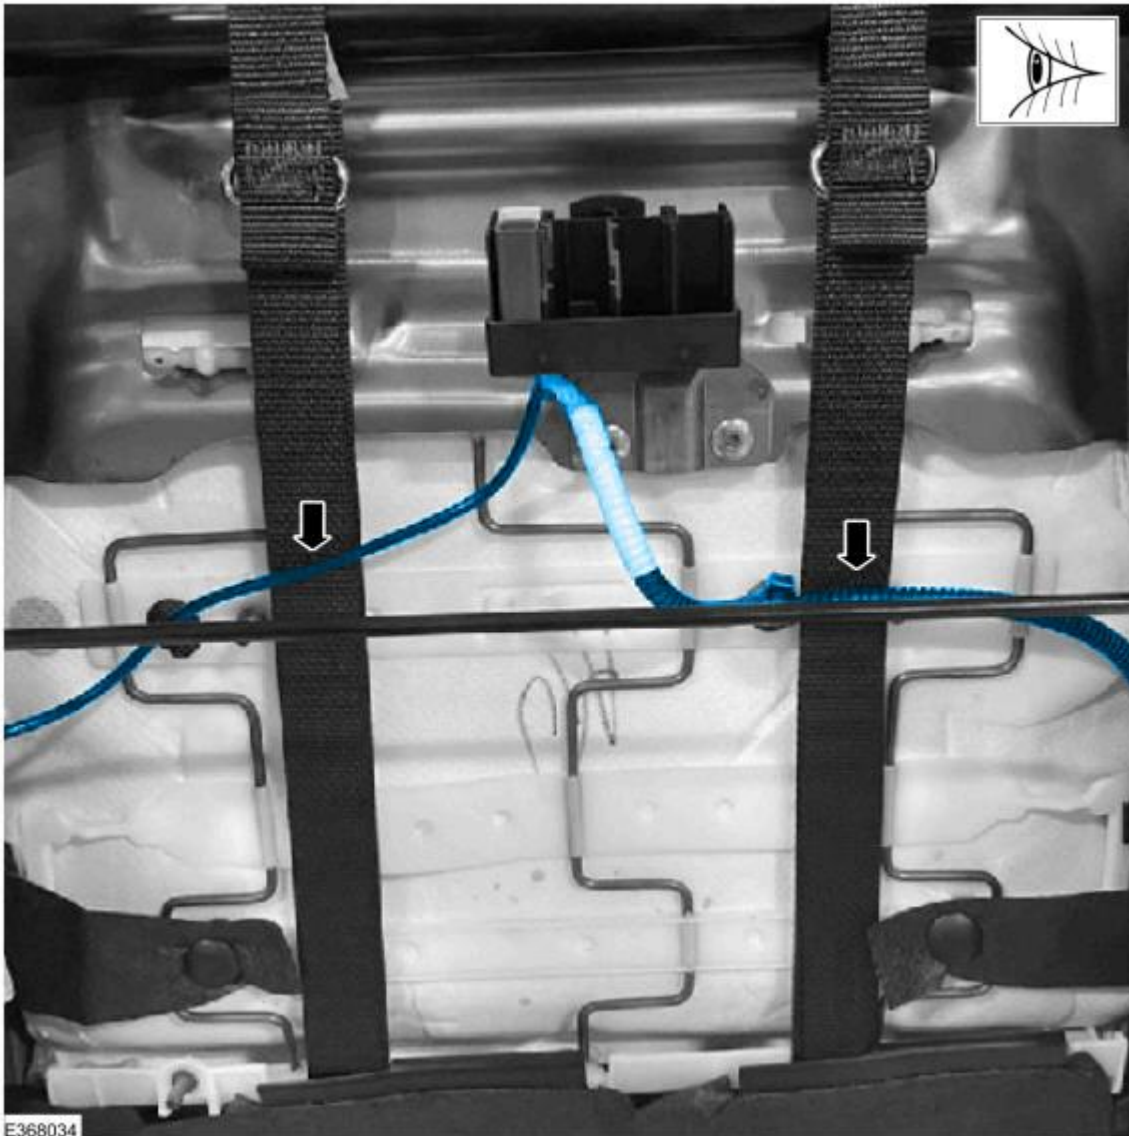
Figure 12

(6). Secure the wire harness(es) to the suspension mat. (Figure 12)

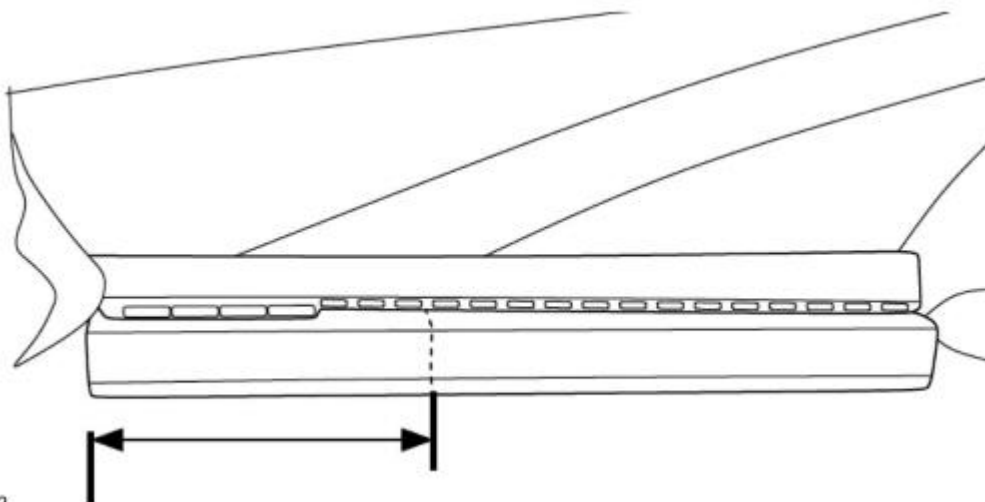
Figure 13

(1). Measure 1 3/4 in. (45 mm) and cut with a knife along the dotted line. (Figure 13)

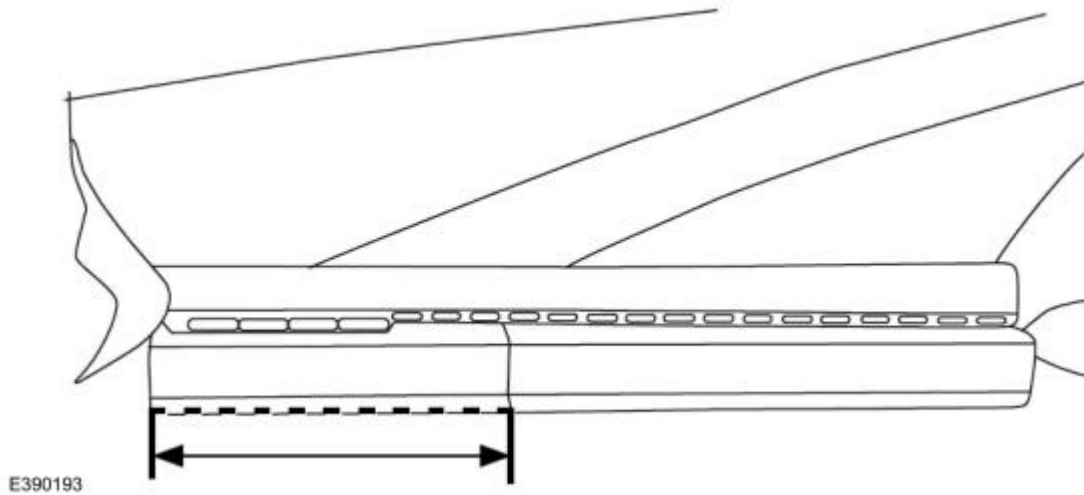
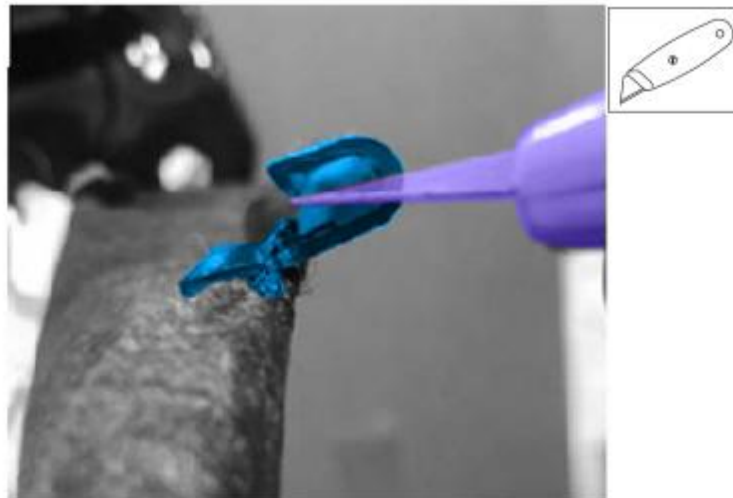
(2). Cut along the dotted line (Figures 14-15), perpendicular to the previous cut, so that the portion of the J retainer in Figures 16 and 17 can be removed.
