# Technical Service Bulletin

## 94 Third brake light inoperative. DTC B12C615

90 24 12 2074275/1 July 5, 2024.

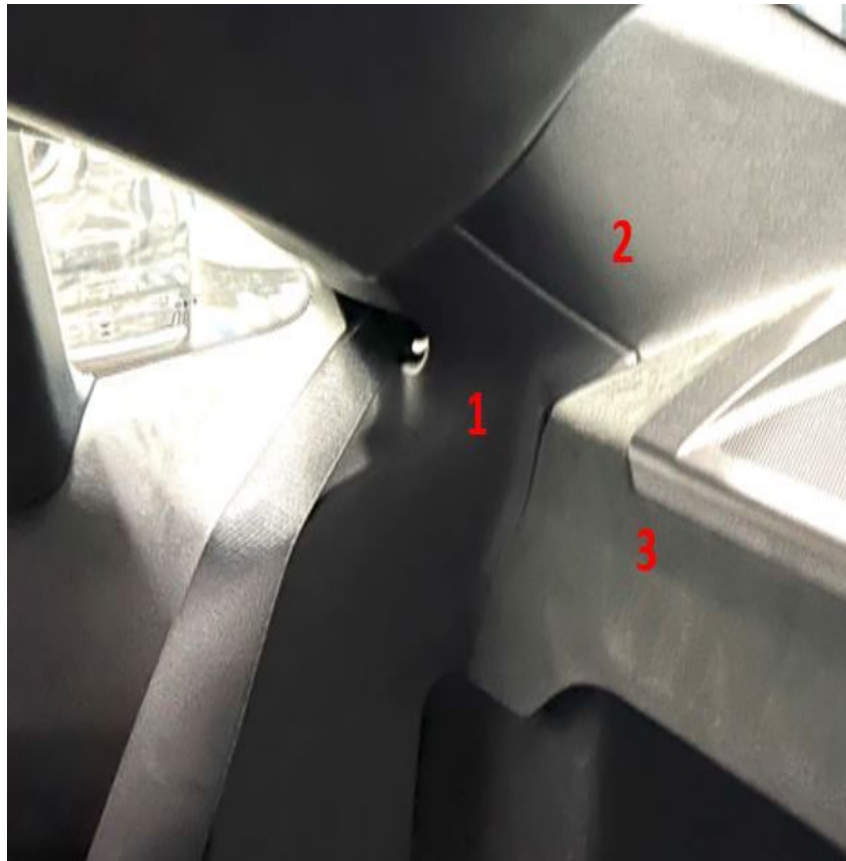
*Figure 1: Trim to remove.*

Remove the seat belt feeder trim, C-pillar trim and rear shelf as indicated by position 1,2 and 3 in Figure 1.

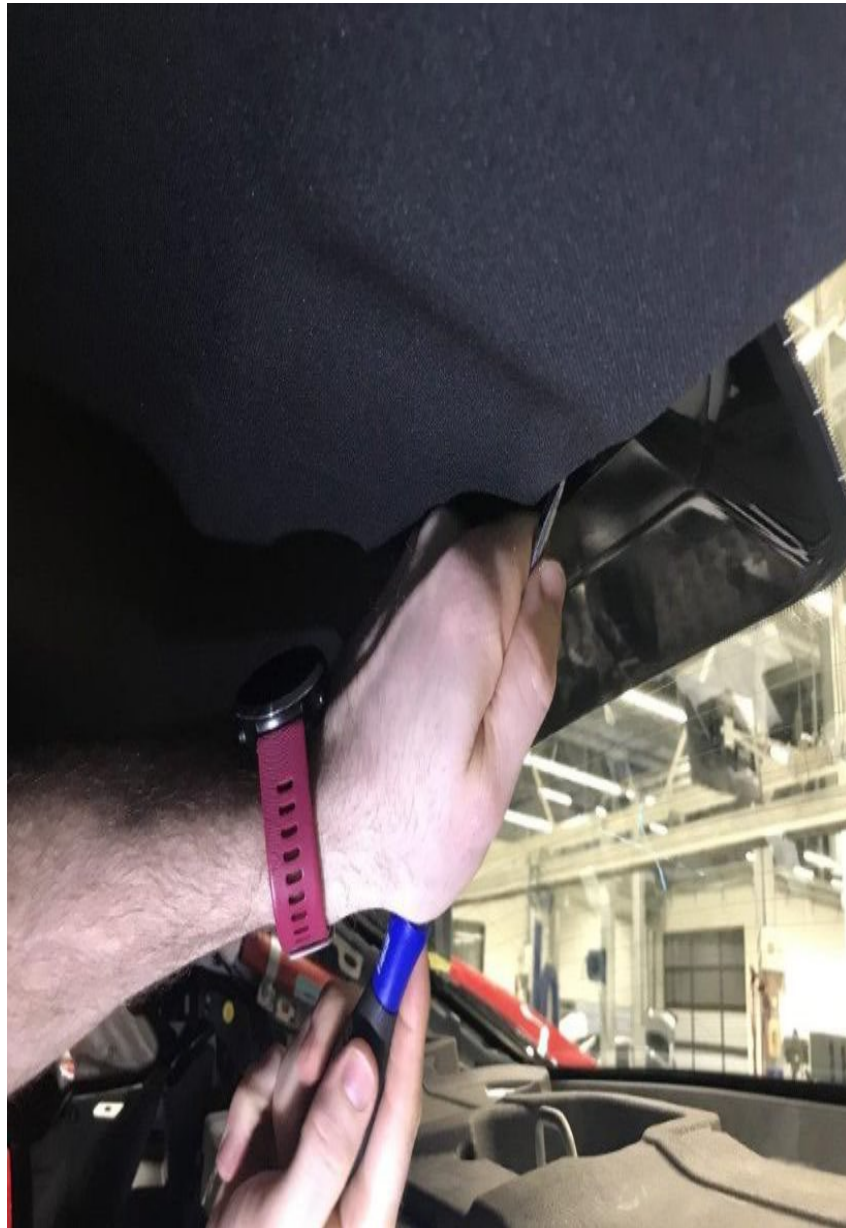
*Figure 2: Remove 3<sup>d</sup> brake light.*

Remove the 3rd brake light  
and unplug the lamp.

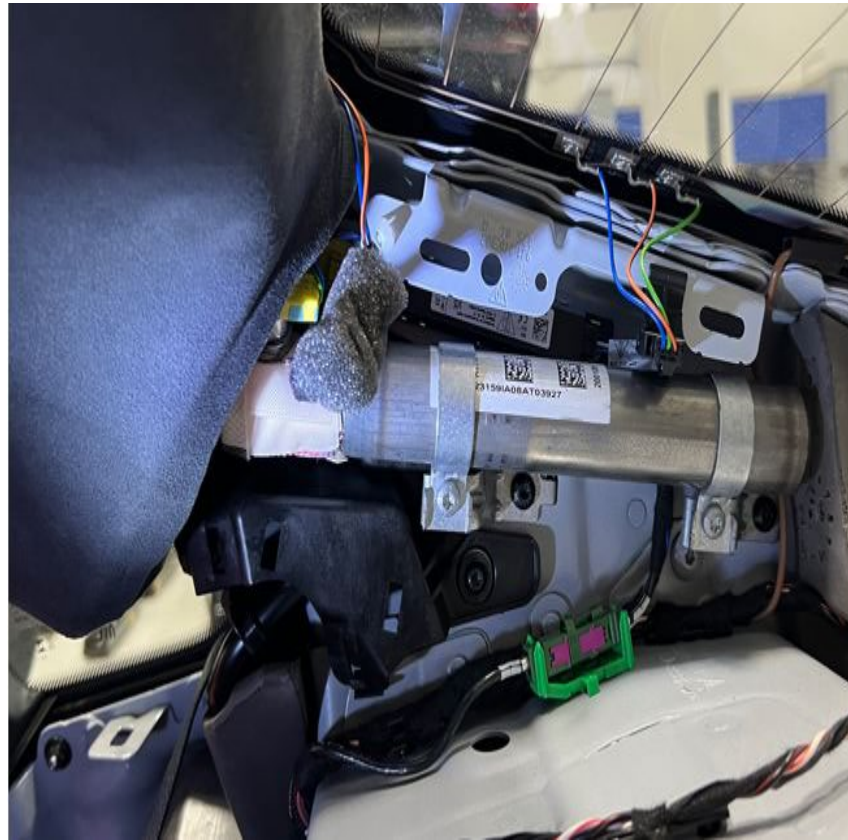
*Figure 3: Access the 3<sup>d</sup> brake light connector.*

Pull the foam insulated connector for the 3<sup>rd</sup> brake light circuit from behind the C-pillar.

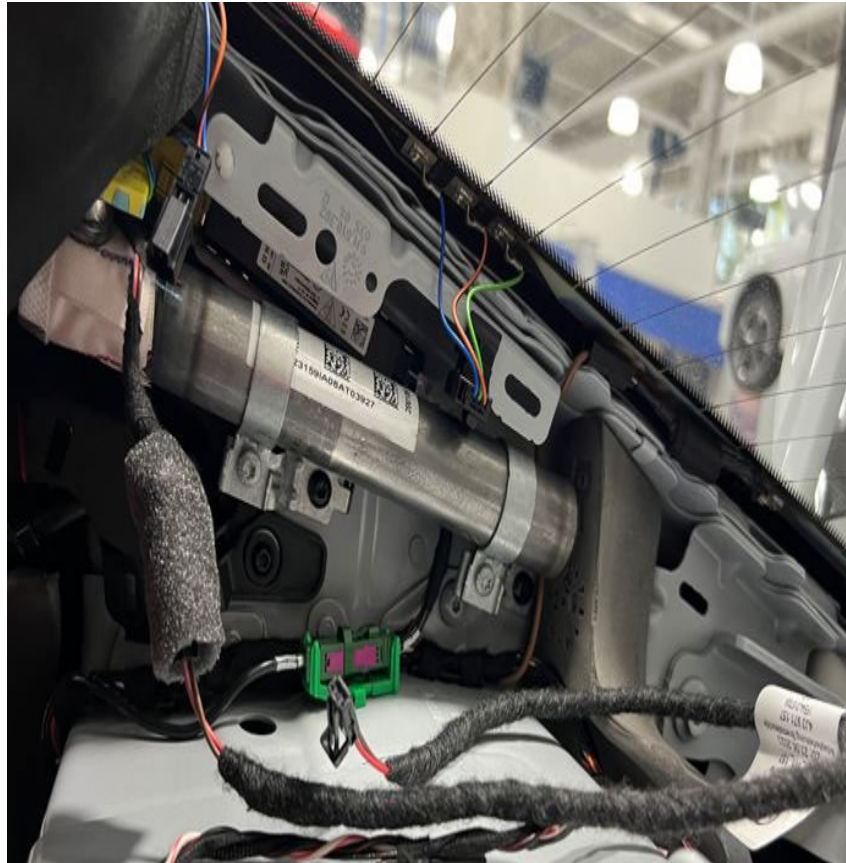
*Figure 4: Install adapter harness.*

Separate the connection and insert **4J3 971 157** into the vehicle side of the wire harness only.

In this step the wires leading to the welded points on the glass will remain unused.

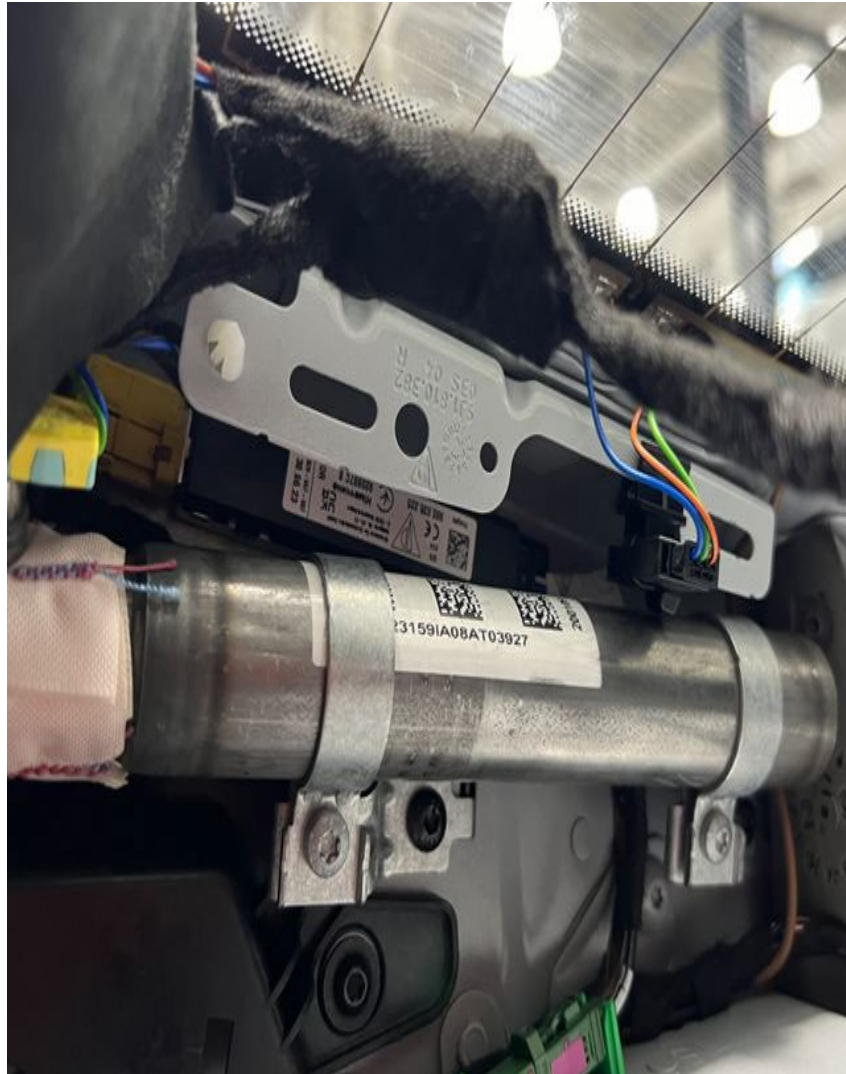
*Figure 5: Insulate connector and harness.*

Wrap the unused connector end from the glass to the new harness.

Insulate as needed to prevent noise and future chaffing.

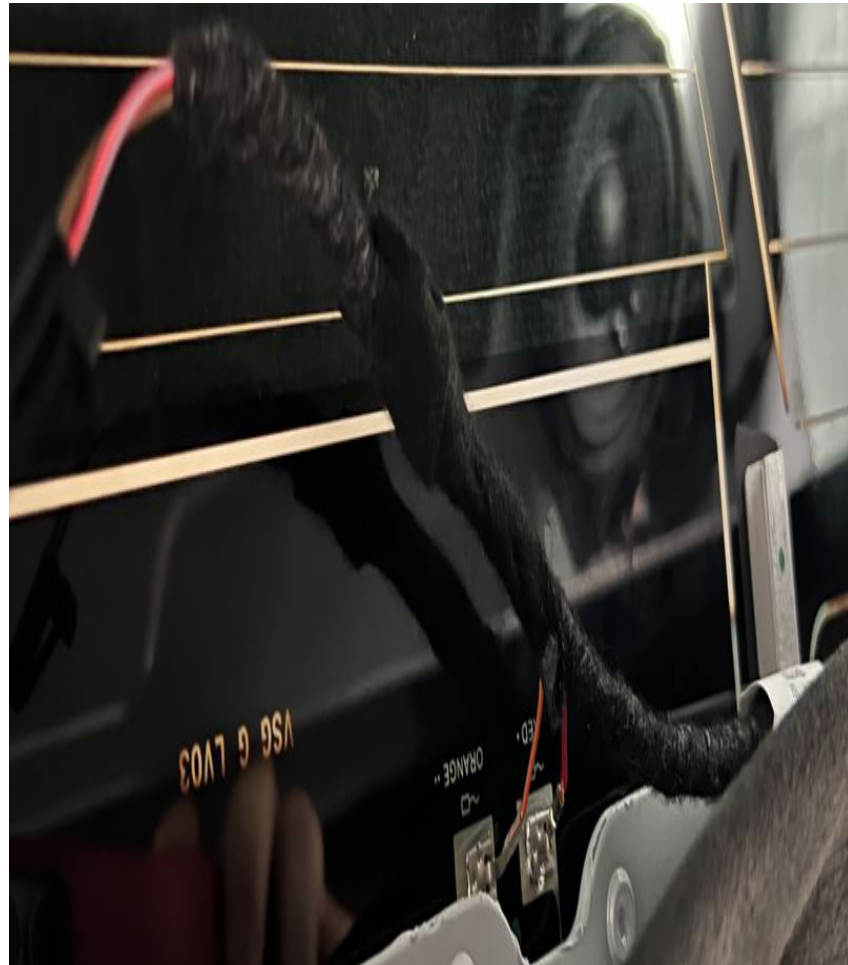
*Figure 6: Insulate connector and harness.*

Loosely route the replacement harness **4J3 971 157** along the space between the headliner and glass.

Wrap the old connector end for the 3<sup>rd</sup> brake lamp to the new harness approx.. 90mm behind the new harness connector.

**Ensure enough length of the new harness is available to facilitate installation/removal of the 3<sup>rd</sup> brake lamp.**

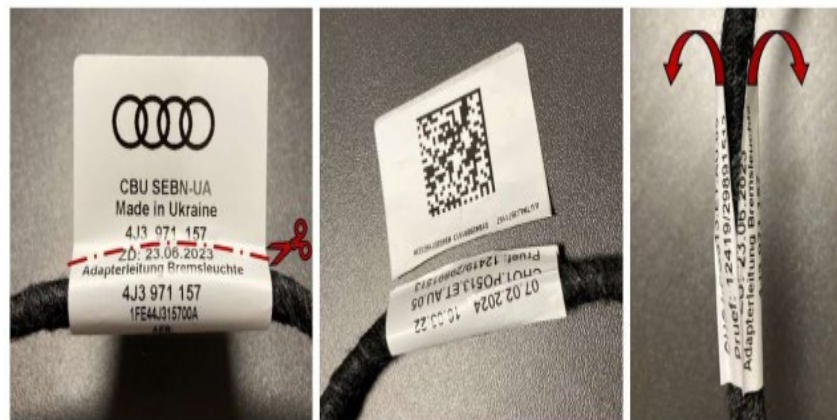
*Figure 7: Remove label.*

Remove the label on the new harness to reduce risk of noise.

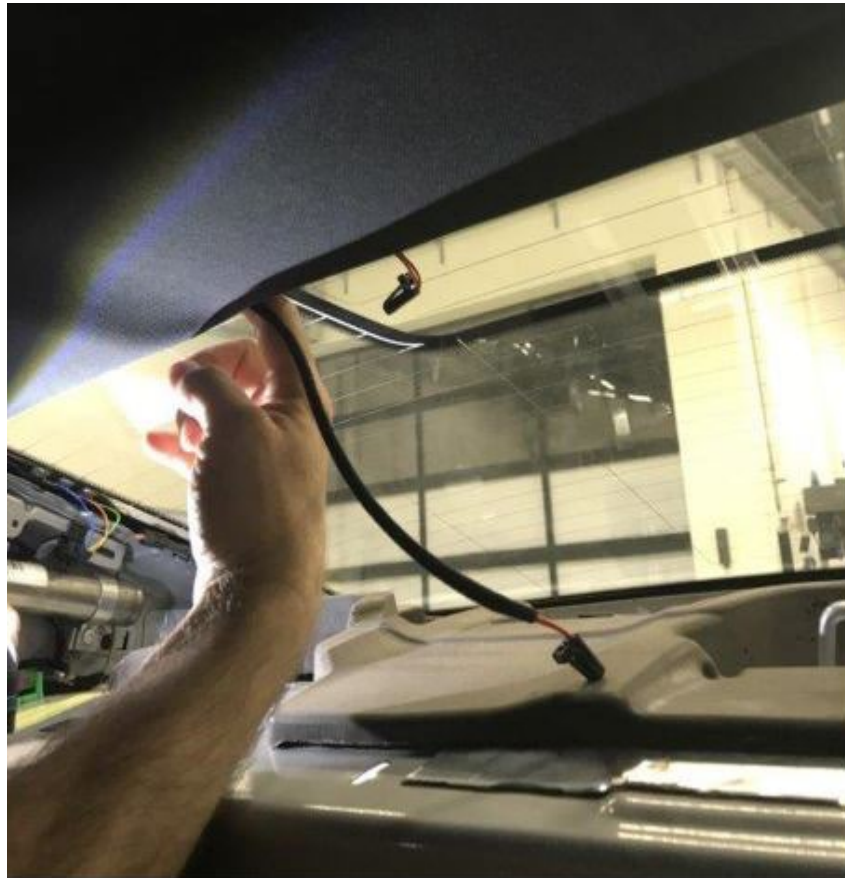
*Figure 8: Route adapter harness.*

Insert the new harness **4J3**

**971 157** into the space

between headliner and metal flange of the body.

Connect the new harness to the 3<sup>rd</sup> brake lamp.

Position/secure harness as needed to prevent noise and protrusion from behind the headliner.
