# Technical Service Bulletin

## 93 Q4 e-tron - yellow electrical system warning lamp B1581F4 / B168A00

93 24 64 2074258/1 July 1, 2024.

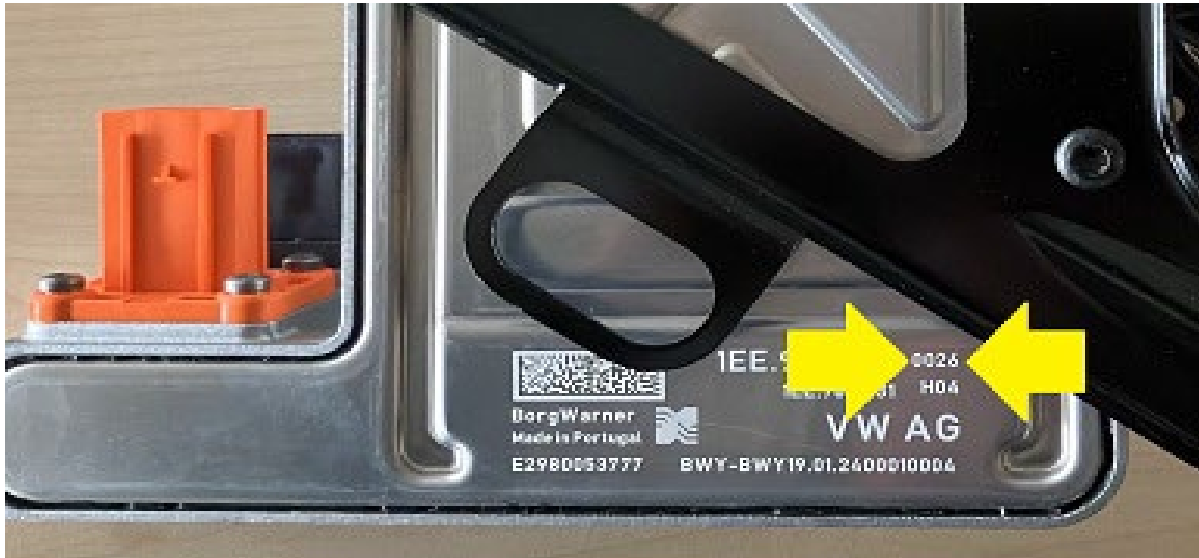
- The software version number is indicated on the label/embossing (refer to figure 2, yellow arrows).

**Figure 2.** Example of software version number (0026) on label/embossing on high-voltage heater Z132

- Replace high-voltage heater Z132 according to the → [Workshop Manual/parts catalogue](#).

**Please make sure that the new high-voltage heater Z132 has software version number 0026 (or higher)!**

- The Genuine Parts department in Kassel now only supplies high-voltage heaters Z132 with software version number 0026 (or higher).
