2016MY  
Forte, Forte Koup (YD)  
w/Nu 2.0L GDI

PI2105Y/Z (Rev 1, 11/07/2024)

ENGINE REPLACEMENT INSTRUCTIONS  
FOR DTC P1326 (PI2105Y/Z)

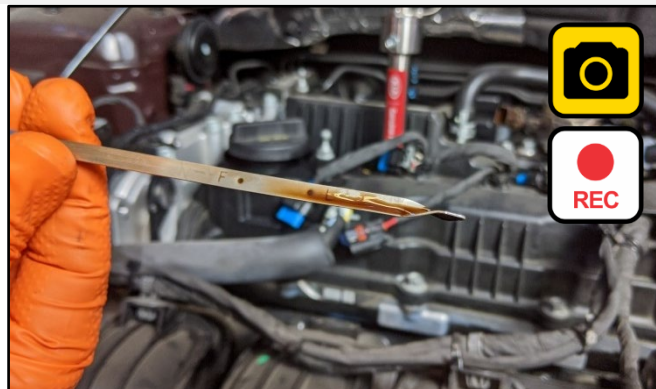
1. Start video showing vehicle and move in towards the dash VIN tag.
2. Measure and record oil dip stick level.
3. Note oil dip stick reading on the RO.
4. Take a picture of the oil reading on dipstick.
