2017-18MY  
Forte (YD, YDm)  
w/Nu 2.0L GDI

PI2106Y/Z (Rev 1, 11/07/2024)

ENGINE REPLACEMENT INSTRUCTIONS  
FOR DTC P1326 (PI2106Y/Z)

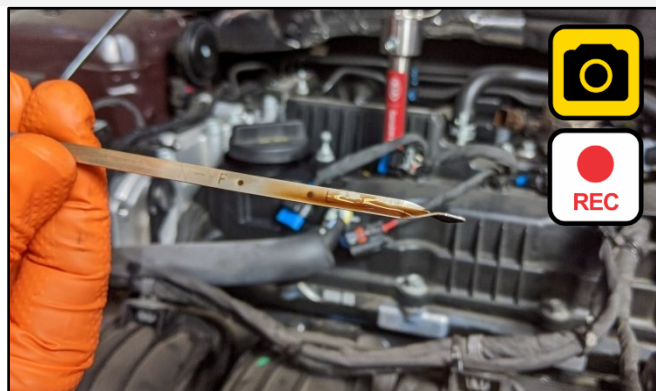
1. Start video showing vehicle and move in towards the dash VIN tag.
2. Measure and record oil dip stick level.
3. Note oil dip stick reading on the RO.
4. Take a picture of the oil reading on dipstick.

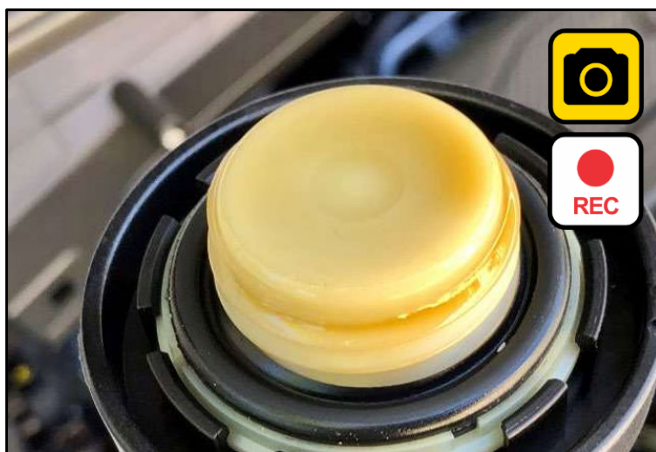
5. Inspect the inner/bottom of the oil cap and inside oil filler opening.

6. Take a picture of both, the bottom of the oil cap and oil filler opening.

**Record/Note findings:** No oil, oil sludge, varnish, burnt oil smell condition(s) found.

If NO oil is registered on the dipstick, or oil lacquering, oil sludge and/or oil varnish is present (NG), then the engine is therefore suspect to maintenance neglect. Review of the vehicle's maintenance history is required.

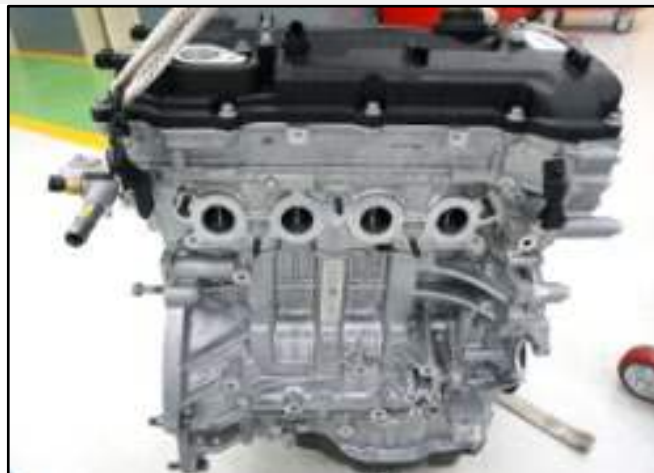
1. Replace the engine assembly by referring to the "Engine Mechanical System → Engine And Transaxle Assembly → Engine And Transaxle Assembly → Repair procedures" chapter in the applicable Shop Manual on KGIS.

2. After removal of the engine from the vehicle, remove all components that will need to be transferred by referring to the applicable Shop Manual on KGIS.
3. **Install all removed components from the old engine block onto the new engine block utilizing all parts from Service Kit(s).**
